Transmittal Letter

SUBJECT
Operation, Monitoring, and
Maintenance Field Notes - 12075 Brewster

Attached are the interim preemptive mitigation (IPM) system Operation, Monitoring, and Maintenance (OM&M) field notes. These field notes were recorded during OM&M visits at the property between March 31, 2020 and March 31, 2022. Please let me know if you have any questions.

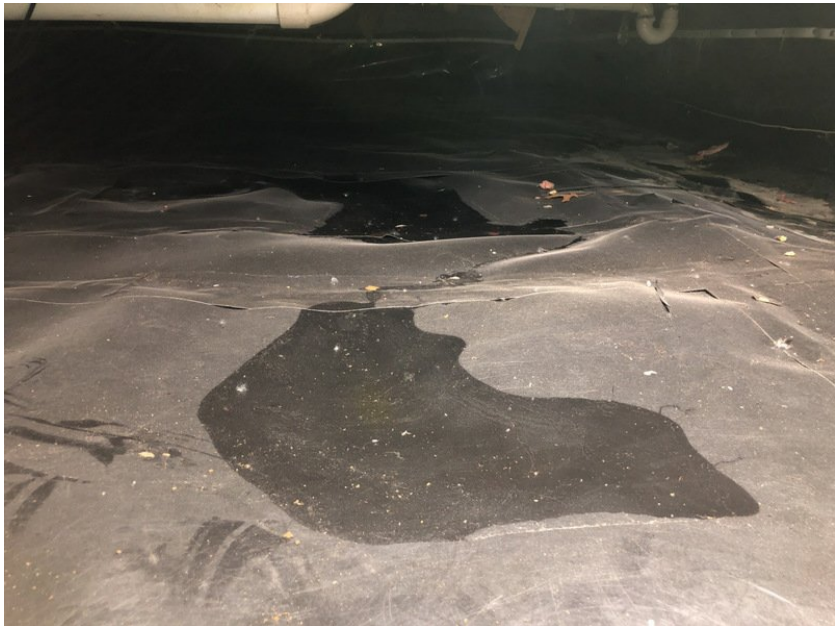
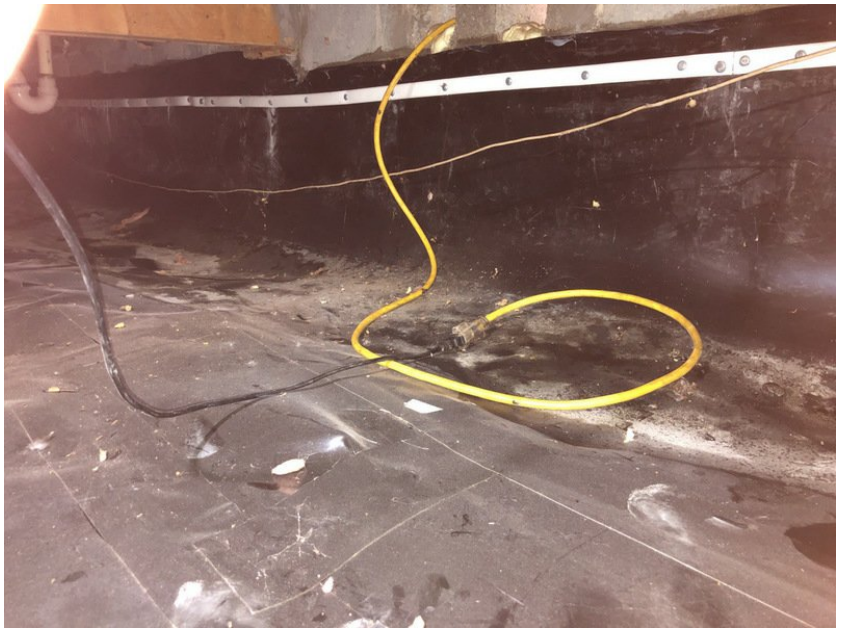
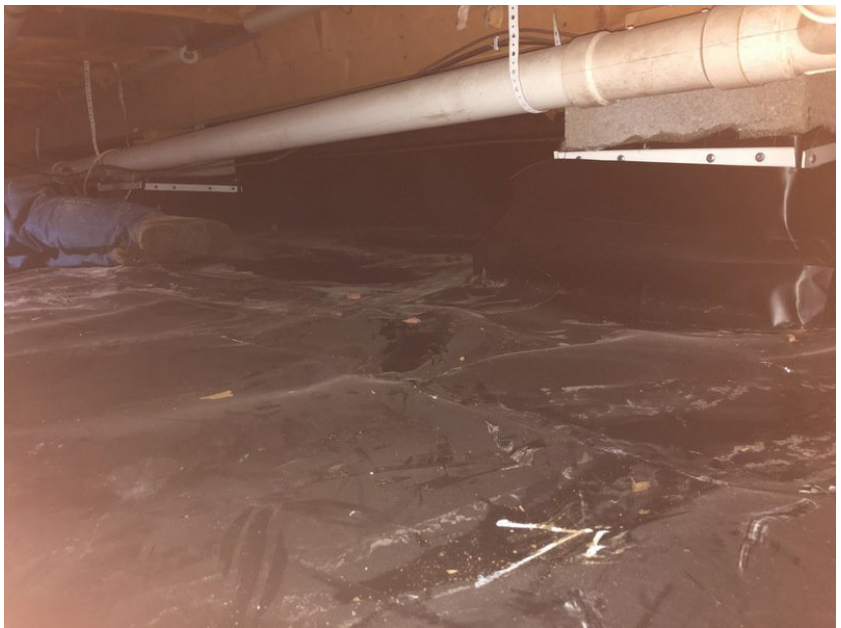
Is water observed on the barrier?	Yes
Location of Water on Barrier	Low spots on barrier
Can the source of water be identified?	No
Water on Barrier

Volume of Water on Barrier (gal)	1
Can water be felt under the barrier?	No
Do barrier seams need addition sealing or repair?	Yes
Describe Repair Location and Mark	Tape peeling up

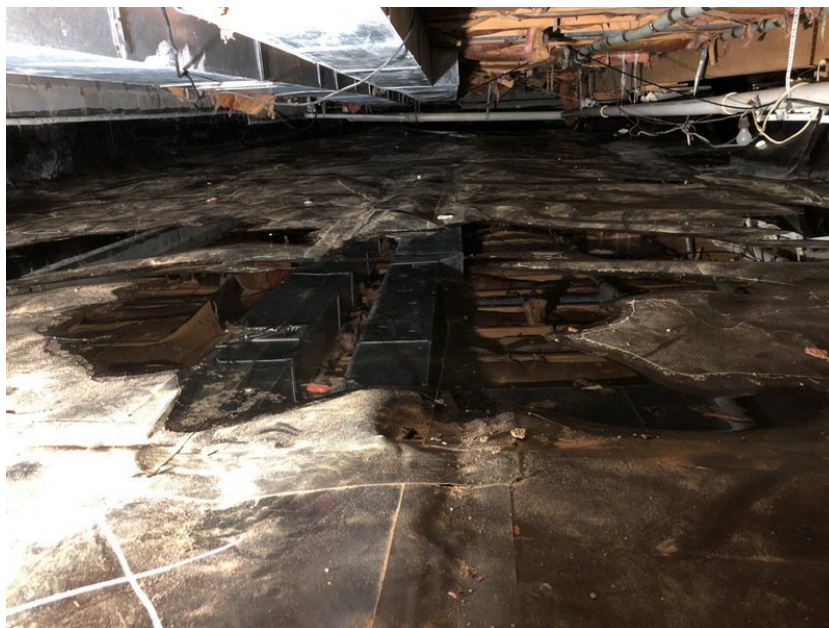
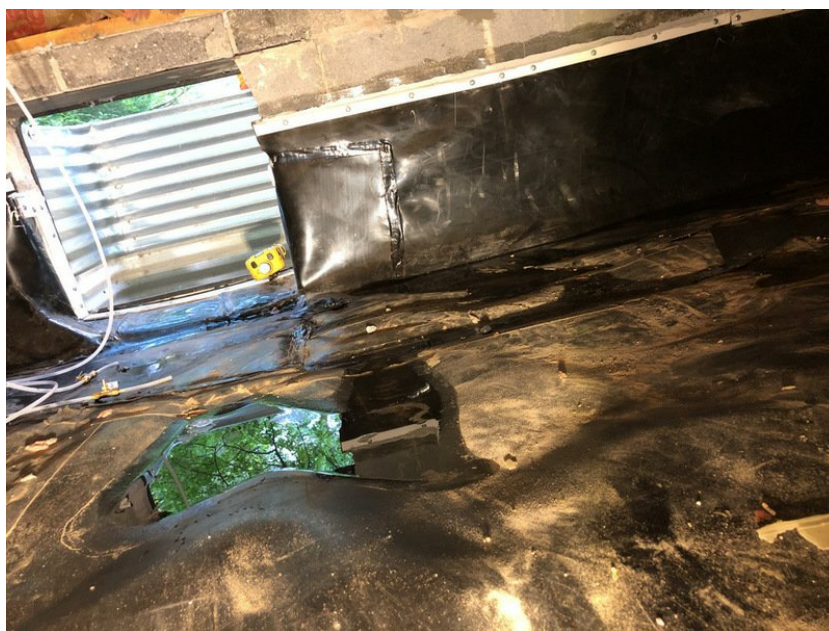
Is water observed on the barrier?	Yes
Location of Water on Barrier	Southwest corner
Can the source of water be identified?	Yes

Volume of Water on Barrier (gal)	10
Can water be felt under the barrier?	No
Describe Source Location	Unknown, most likely from under liner
Do barrier seams need addition sealing or repair?	No

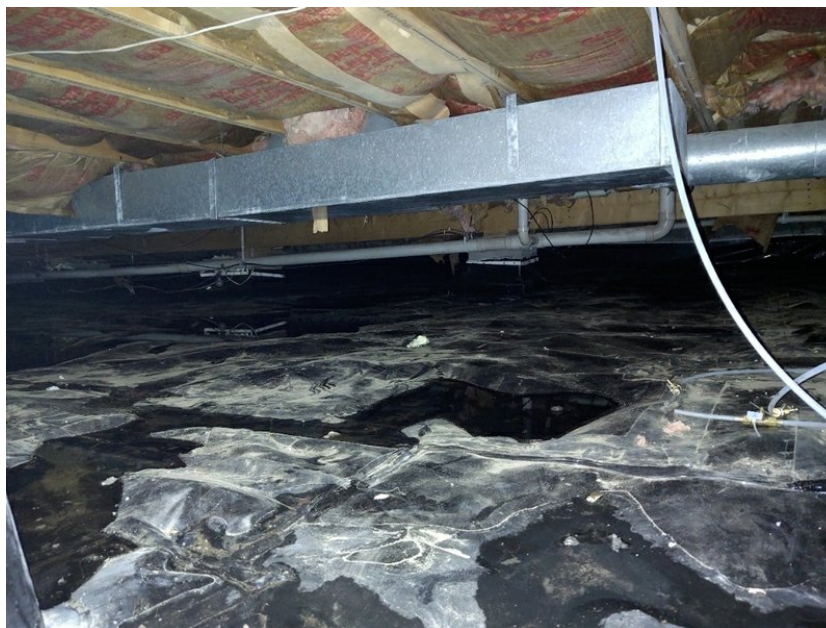
Is water observed on the barrier?	Yes
Location of Water on Barrier	Entrance
Can the source of water be identified?	No
Water on Barrier

Volume of Water on Barrier (gal)	10
Can water be felt under the barrier?	No
Do barrier seams need addition sealing or repair?	No

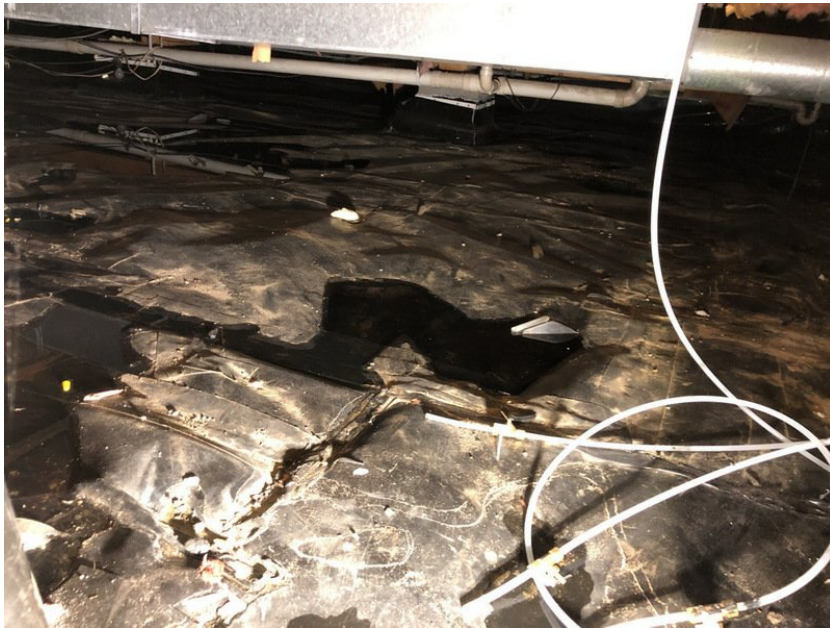
Is water observed on the barrier?	Yes
Location of Water on Barrier	SE corner/middle. Close to exterior entrance.
Can the source of water be identified?	Yes
Water on Barrier

Volume of Water on Barrier (gal)	8
Can water be felt under the barrier?	No
Describe Source Location	Loose seams
Do barrier seams need addition sealing or repair?	No

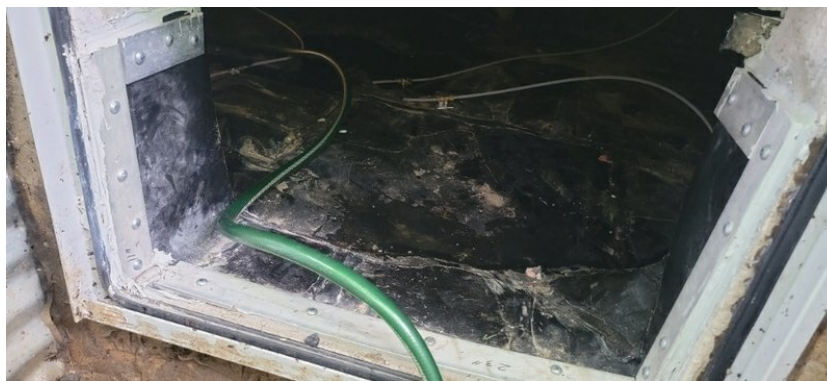
Is water observed on the barrier?	Yes
Location of Water on Barrier	By entrance
Can the source of water be identified?	Yes
Water on Barrier

Volume of Water on Barrier (gal)	2
Can water be felt under the barrier?	No
Describe Source Location	Vent outside
Do barrier seams need addition sealing or repair?	No

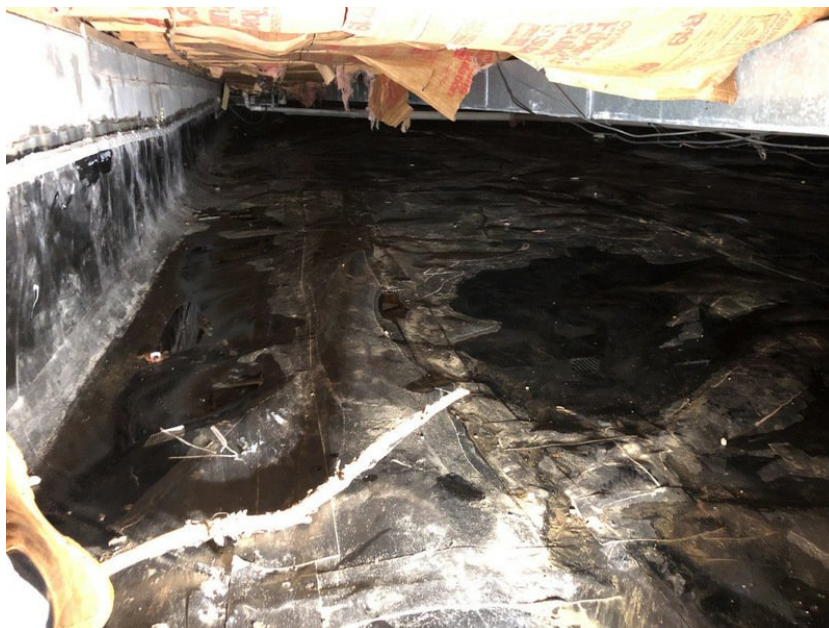
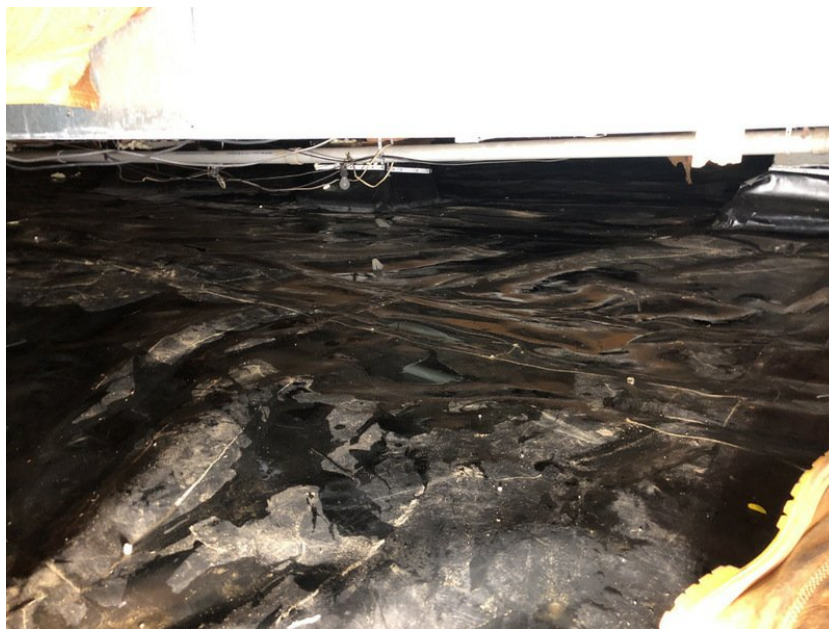
Is water observed on the barrier?	Yes
Location of Water on Barrier	South side of crawl space
Can the source of water be identified?	No

Volume of Water on Barrier (gal)	10
----------------------------------	----

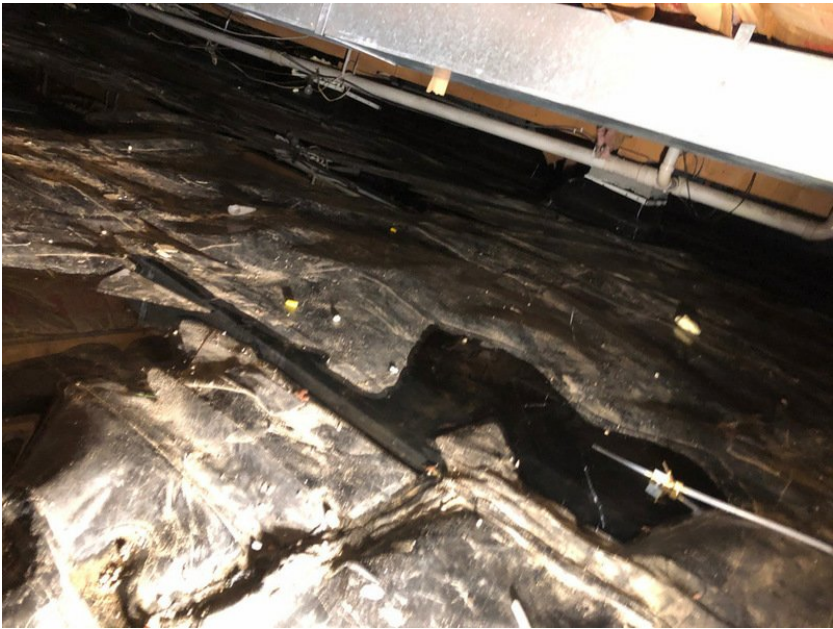
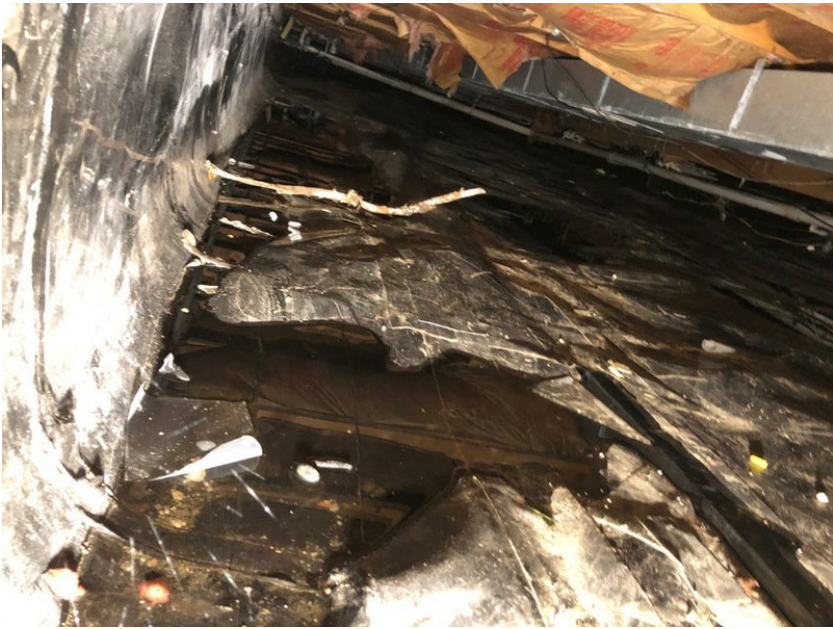
Is water observed on the barrier?	Yes
Location of Water on Barrier	SE corner of crawl space
Can the source of water be identified?	No

Volume of Water on Barrier (gal)	5
Can water be felt under the barrier?	No
Do barrier seams need addition sealing or repair?	No

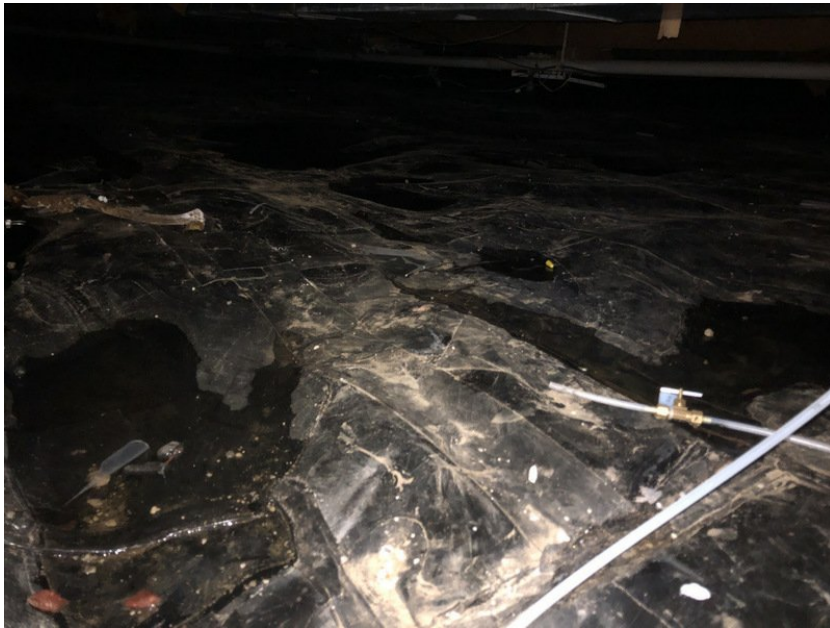
Is water observed on the barrier?	Yes
Location of Water on Barrier	South side of crawl space
Can the source of water be identified?	No
Water on Barrier

Volume of Water on Barrier (gal)	5
Can water be felt under the barrier?	No
Do barrier seams need addition sealing or repair?	No

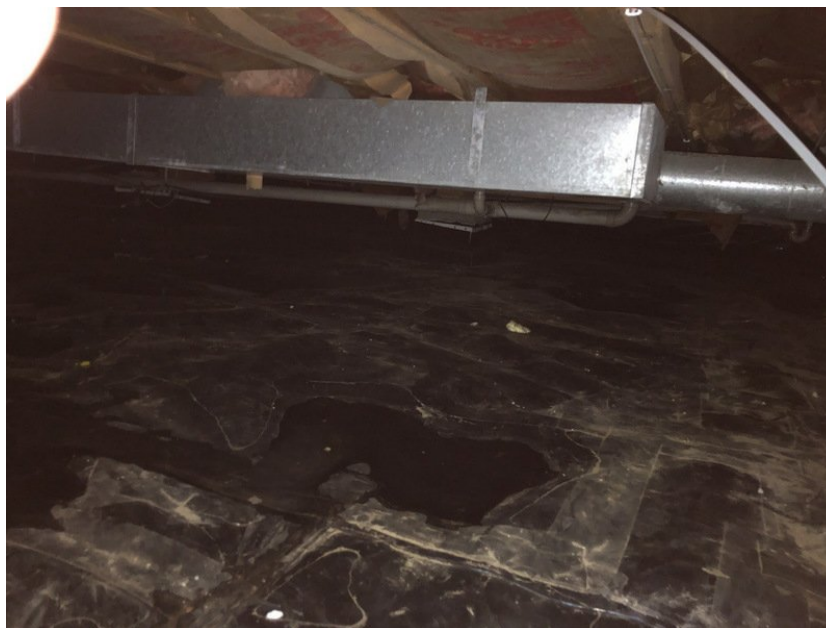
Is water observed on the barrier?	Yes
Location of Water on Barrier	SE corner
Can the source of water be identified?	No

Volume of Water on Barrier (gal)	5
Can water be felt under the barrier?	No
Do barrier seams need addition sealing or repair?	No

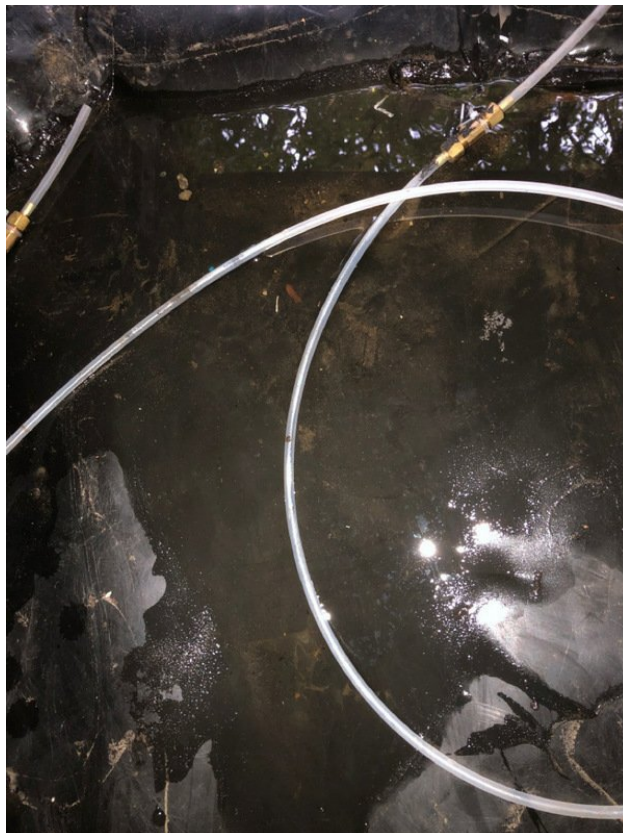
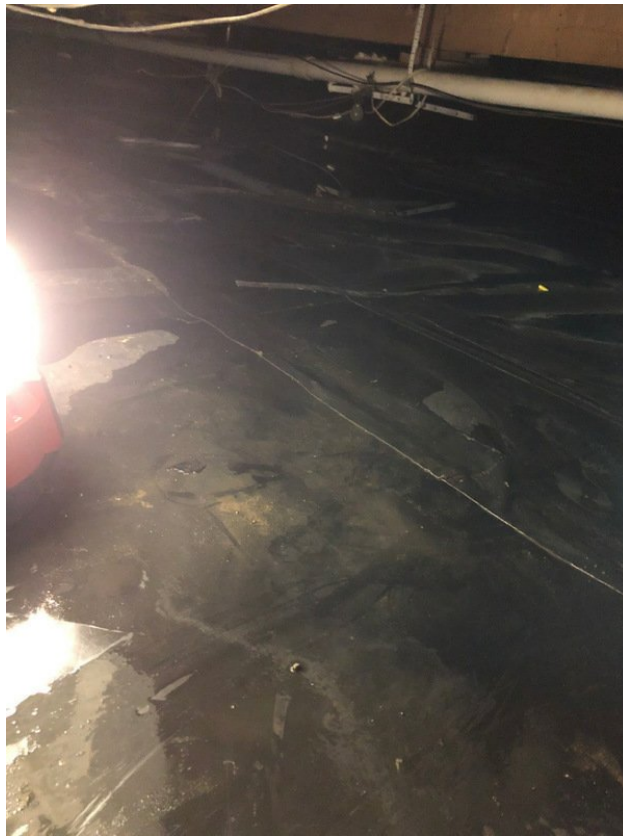
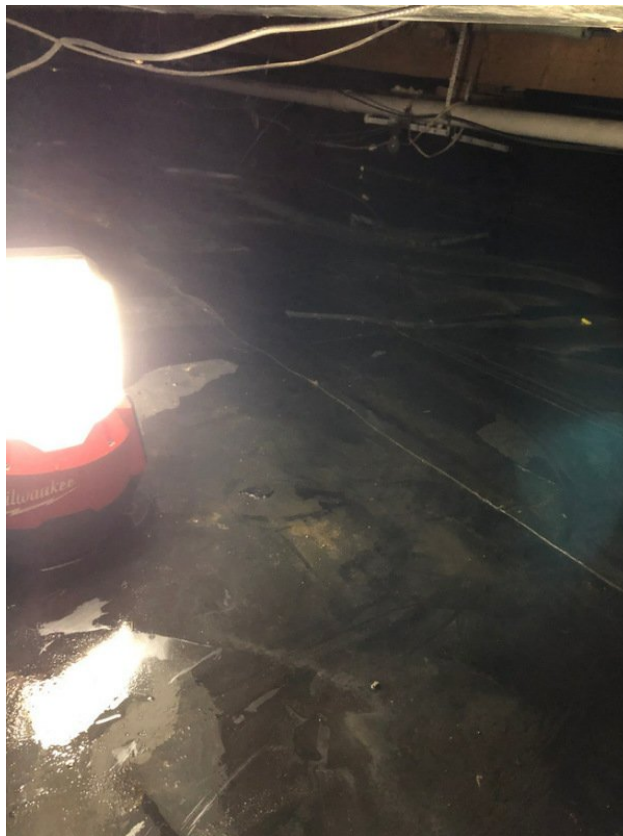
Is water observed on the barrier?	Yes
Location of Water on Barrier	South side of crawlspace
Can the source of water be identified?	No

Volume of Water on Barrier (gal)	30
Can water be felt under the barrier?	No
Do barrier seams need addition sealing or repair?	No

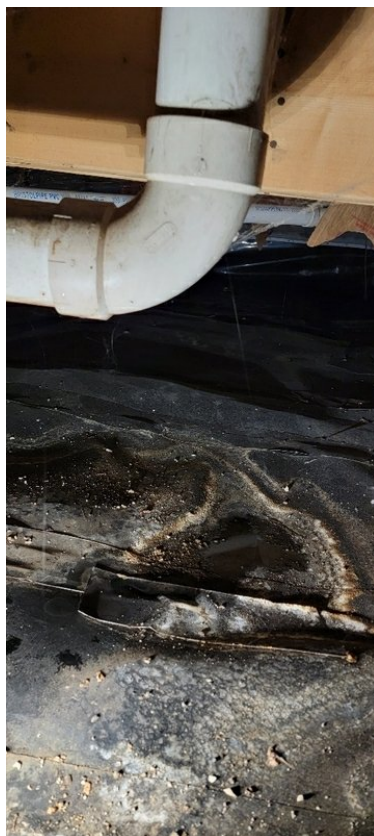
Barrier Repair Needed	
-----------------------	--

Barrier Comments	1/4 cup of water, wiped up.
------------------	-----------------------------
