Transmittal Letter

SUBJECT
Operation, Monitoring, and
Maintenance Field Notes - 12088 Brewster

12088 Brewster, 2020-05-19, Water Inspection

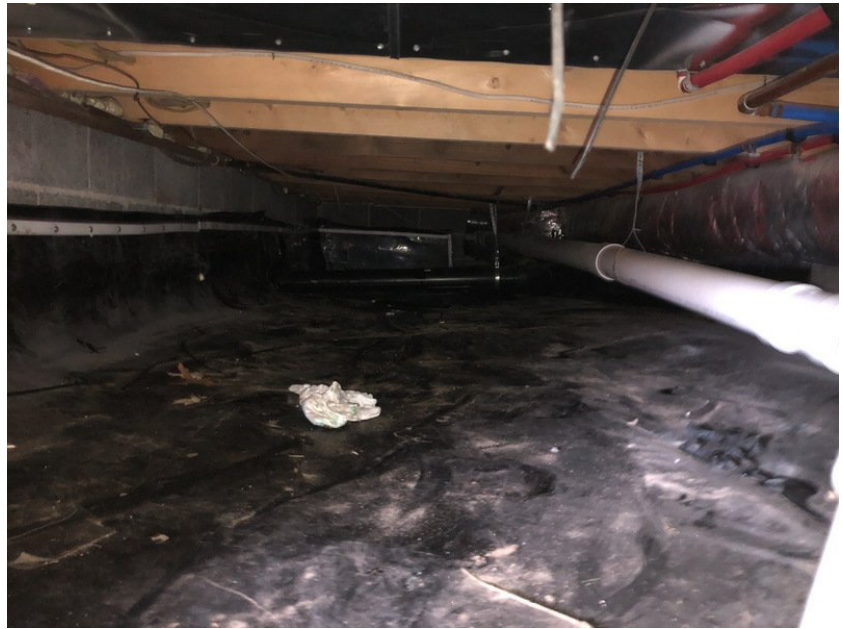
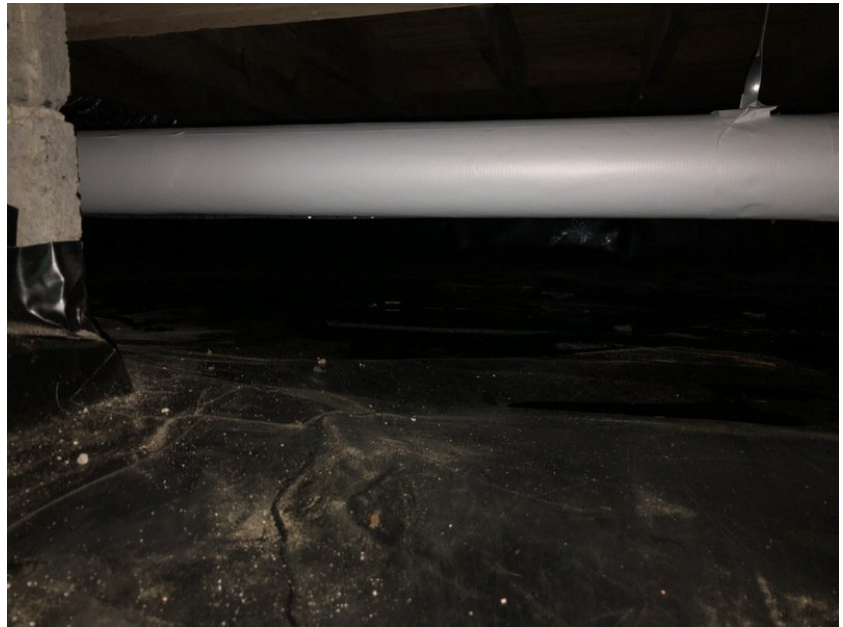
Is water observed on the barrier?	Yes
Location of Water on Barrier	Middle west side and south wall of crawlspace.
Can the source of water be identified?	No

Volume of Water on Barrier (gal)	30
Can water be felt under the barrier?	Yes
Do barrier seams need addition sealing or repair?	No

How much water was removed? 23 gallons

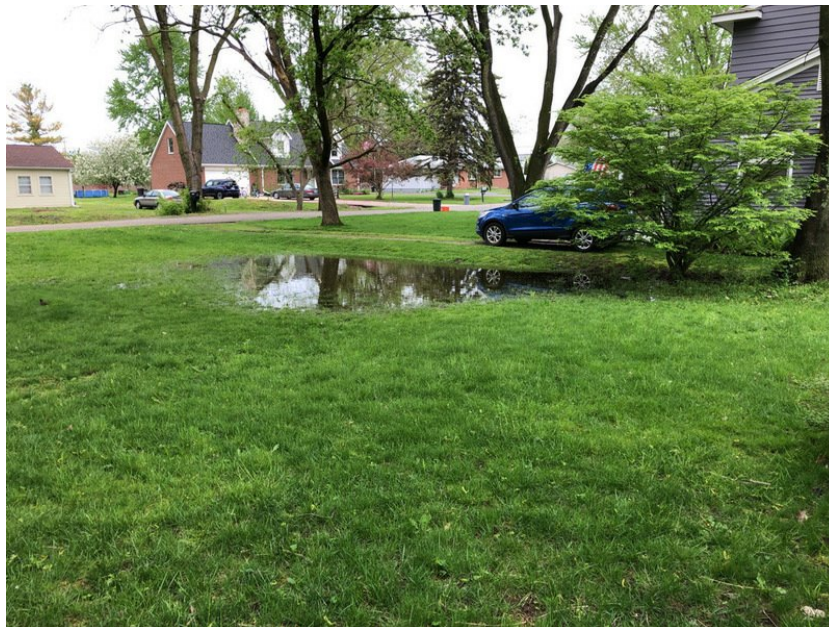
Could not find source of water, most likely source is a loose seam.

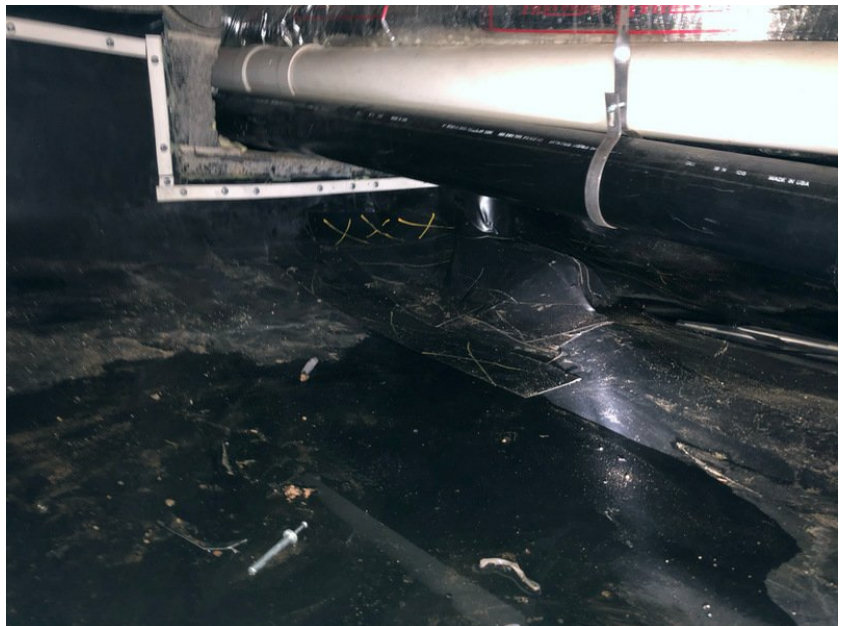
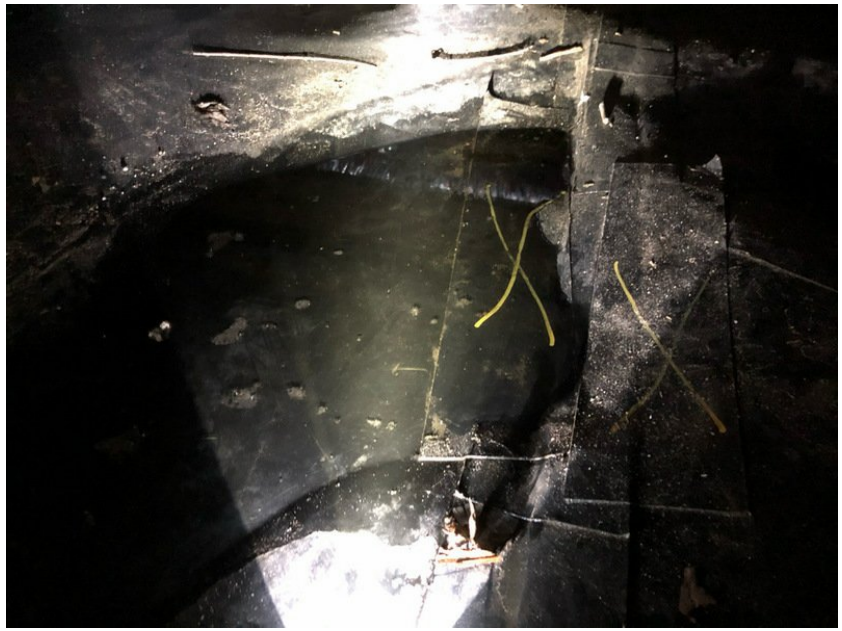
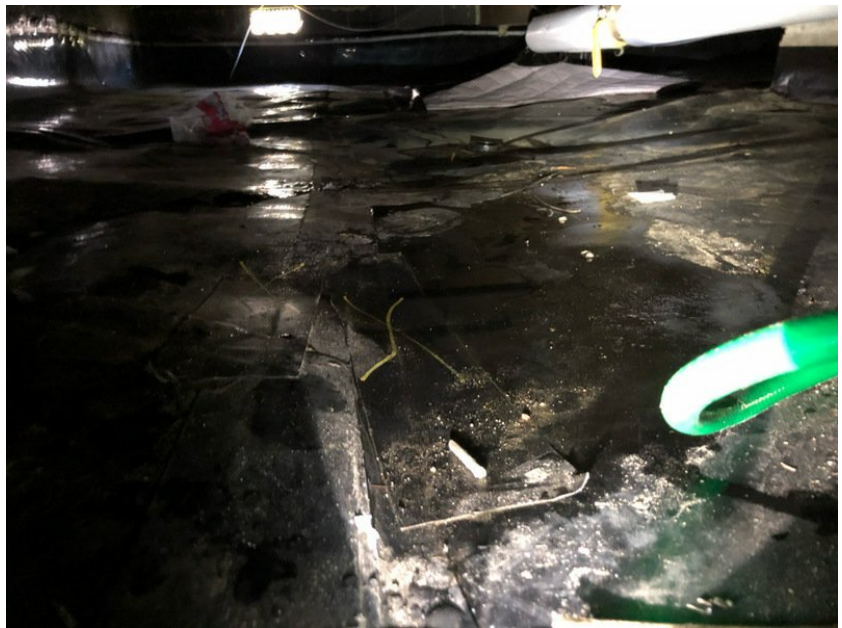
Is water observed on the barrier?	Yes
Location of Water on Barrier	Middle of west wall and south wall.
Can the source of water be identified?	No

Volume of Water on Barrier (gal)	3
Can water be felt under the barrier?	No
Do barrier seams need addition sealing or repair?	No

How much water was removed? 3 gallons

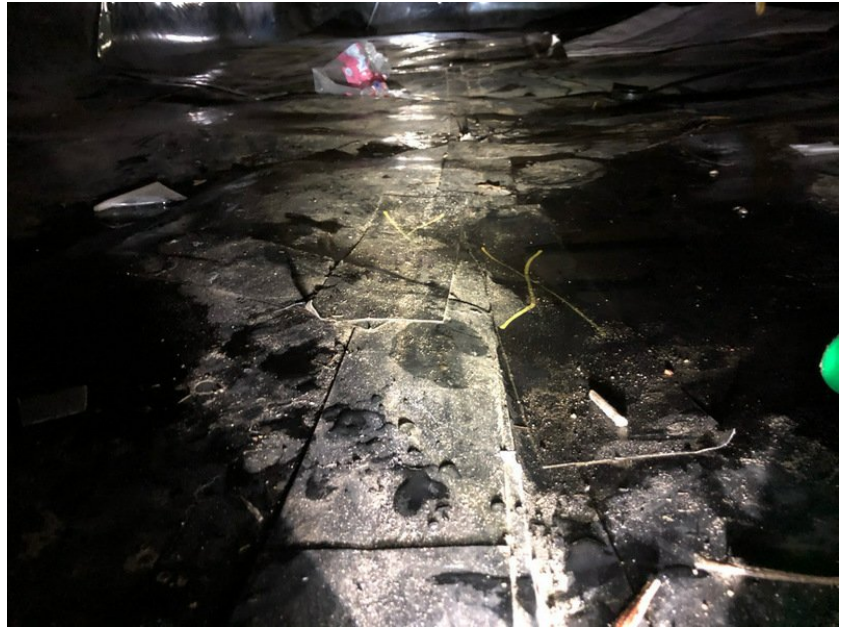
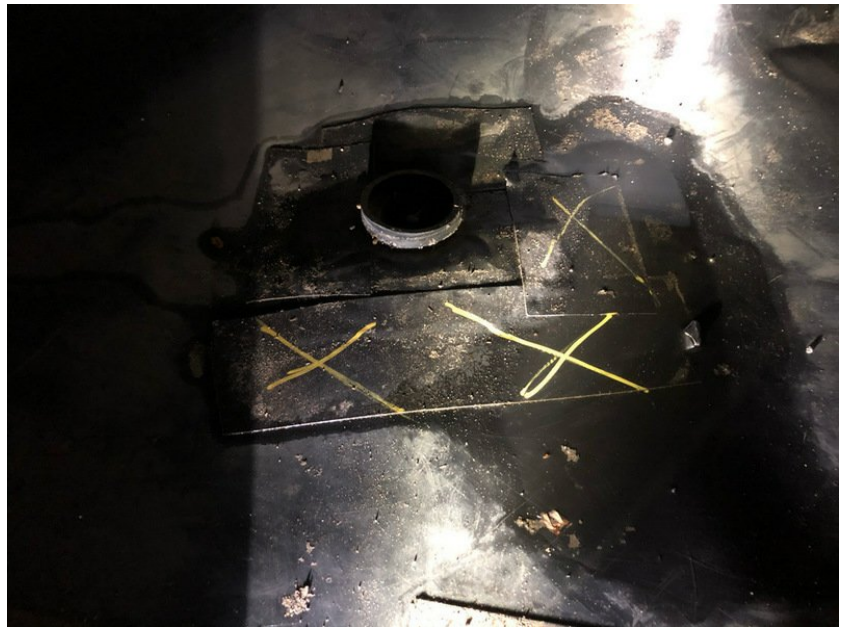
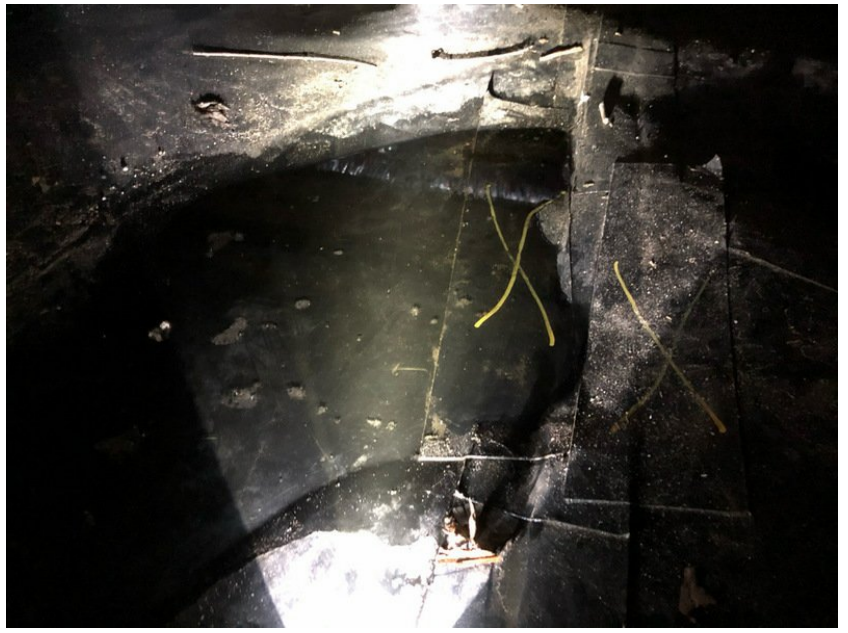
Water likely coming from seam shown in pictures below.

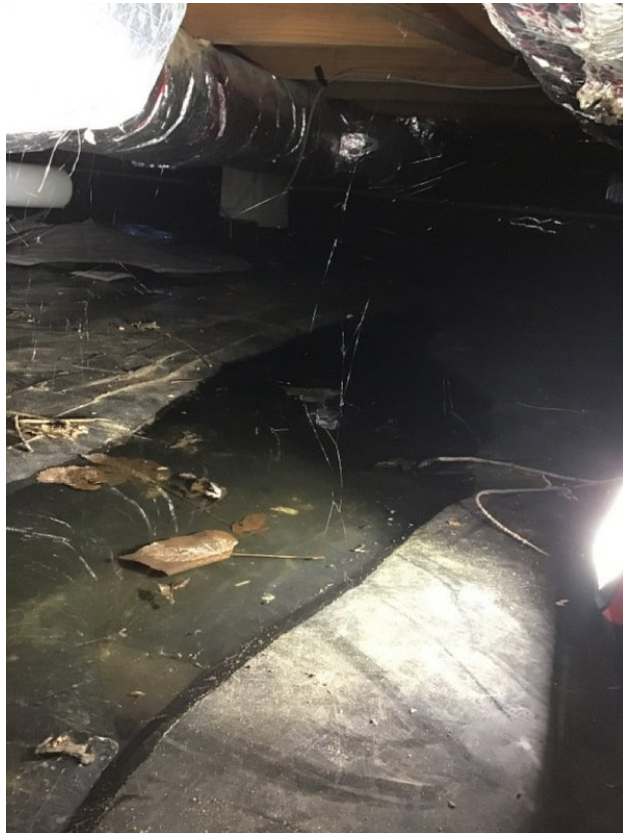
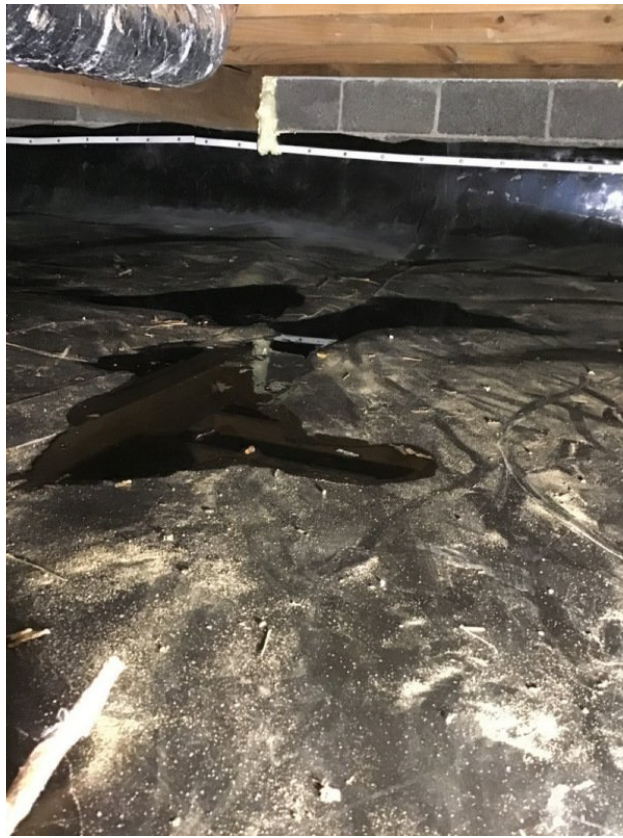
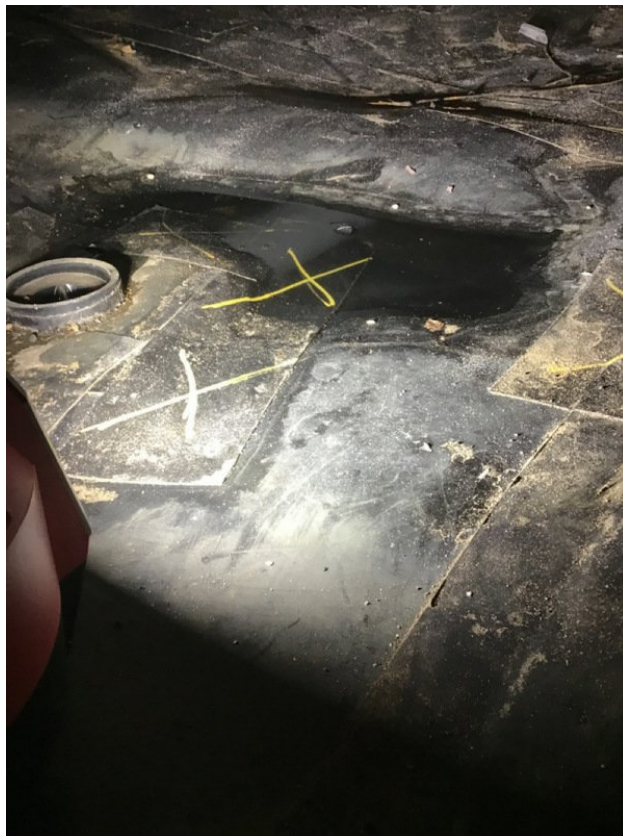
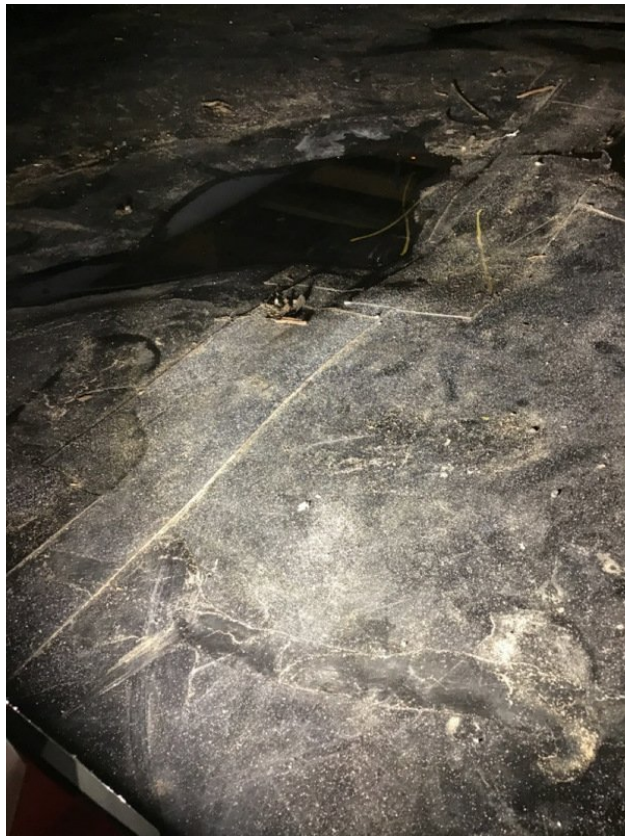
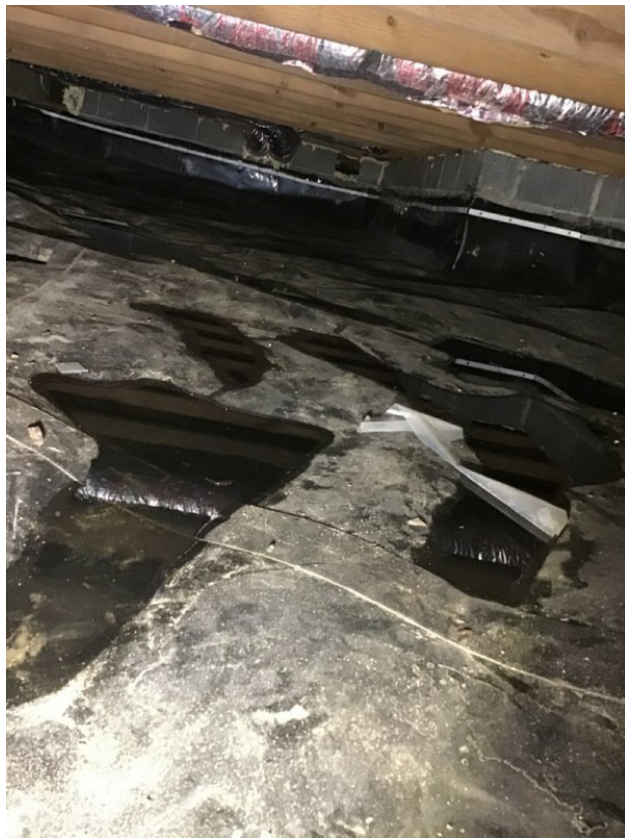
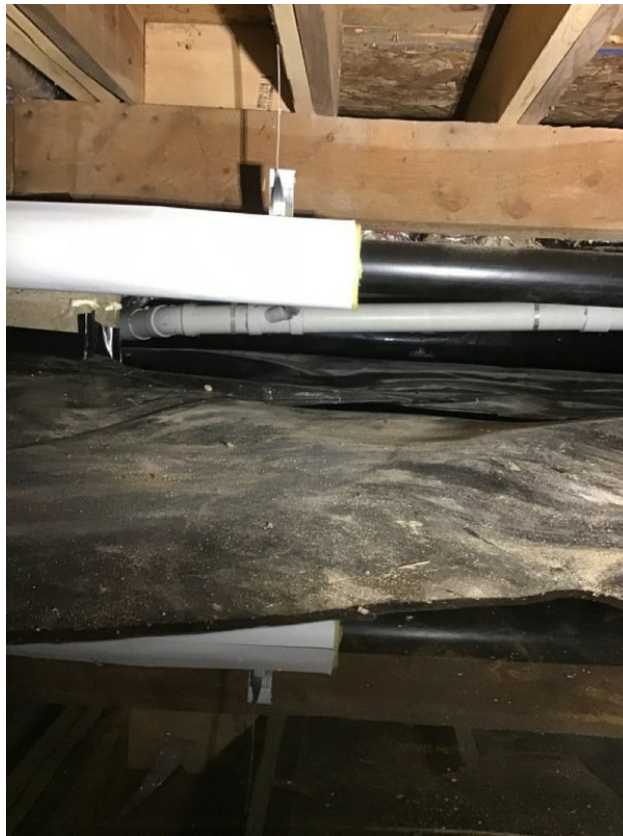
Is water observed on the barrier?	Yes
Location of Water on Barrier	In front of crawl space entrance, center of crawl space low spots
Can the source of water be identified?	No

Volume of Water on Barrier (gal)	2
Can water be felt under the barrier?	No
Do barrier seams need addition sealing or repair?	No

Has water been removed today?	Yes
How much water was removed?	4.5 gal

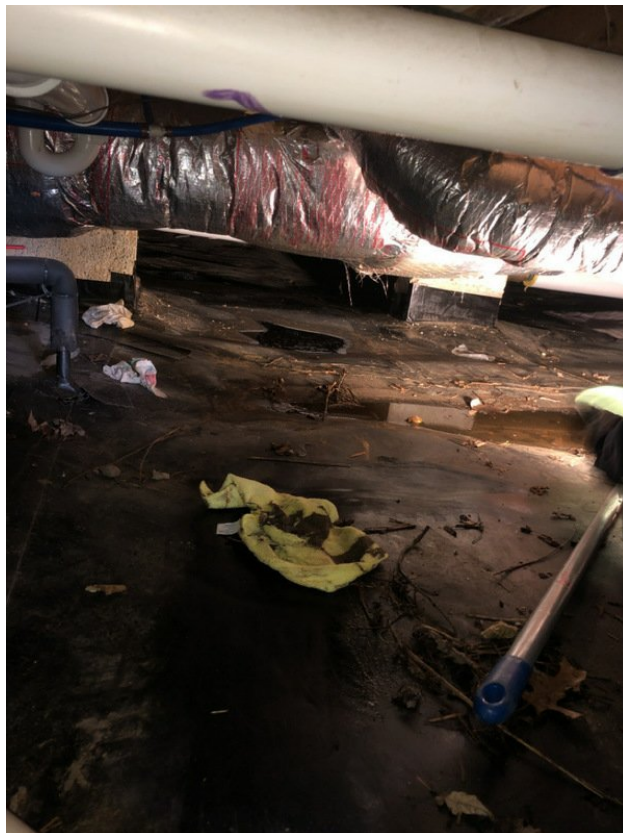
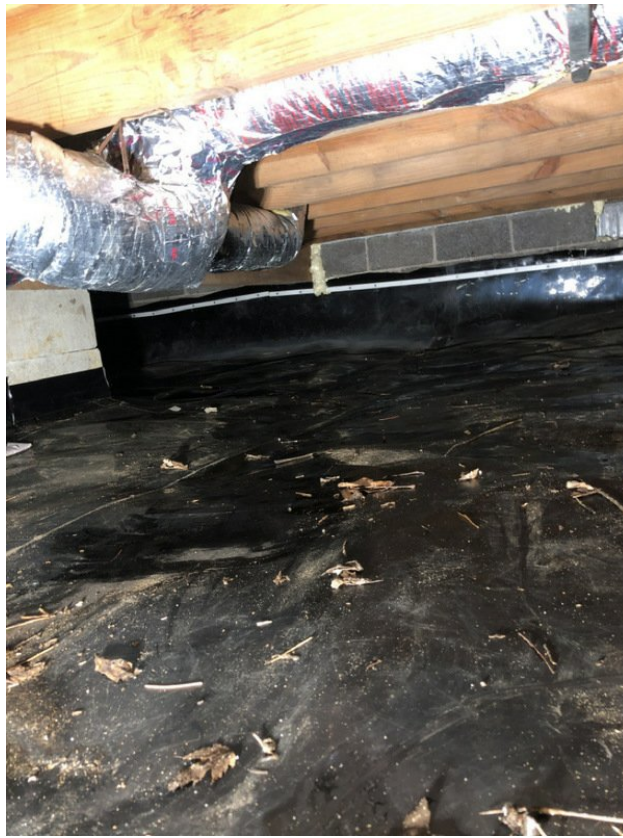
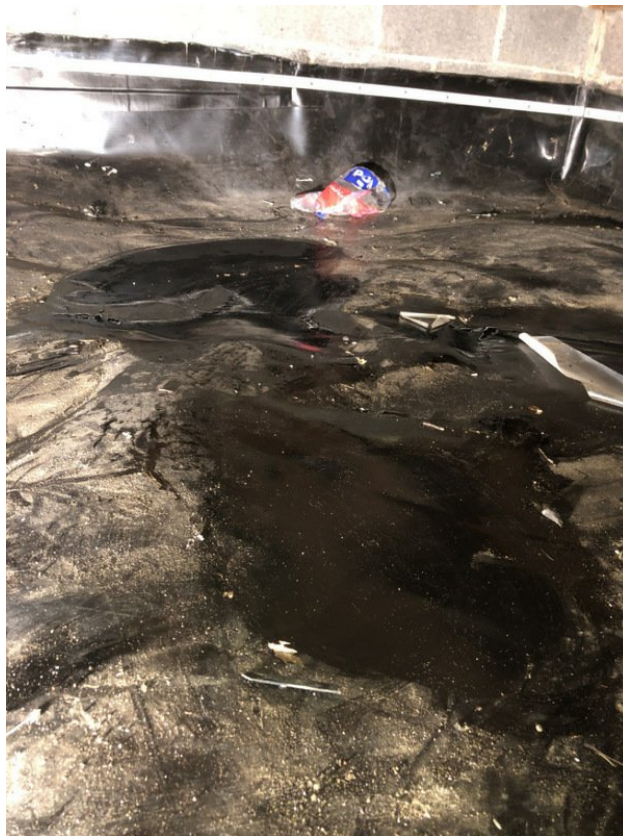
Is water observed on the barrier?	Yes
Location of Water on Barrier	Near north entrance of crawlspace
Can the source of water be identified?	No

Volume of Water on Barrier (gal)	7
Can water be felt under the barrier?	No
Do barrier seams need addition sealing or repair?	No

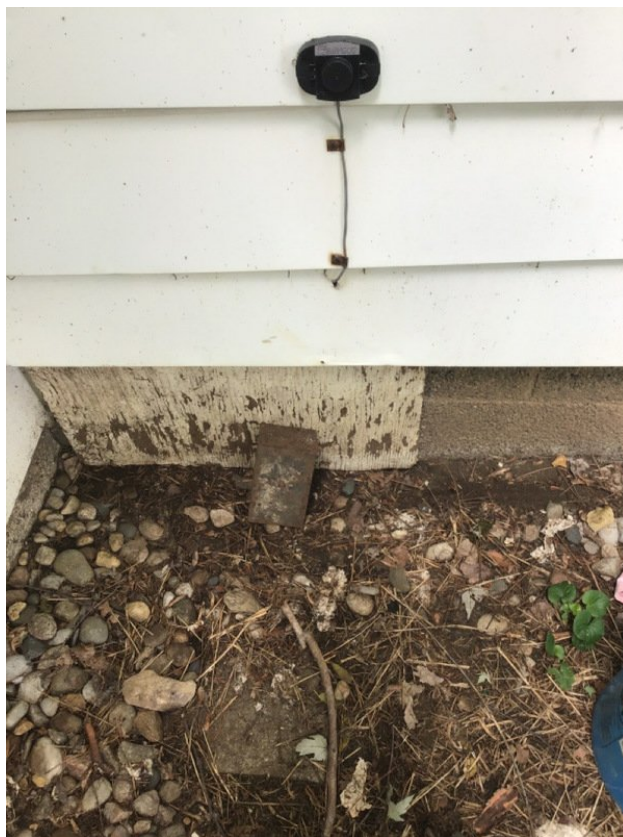
Notes	Crawl space closed with brick
-------	-------------------------------

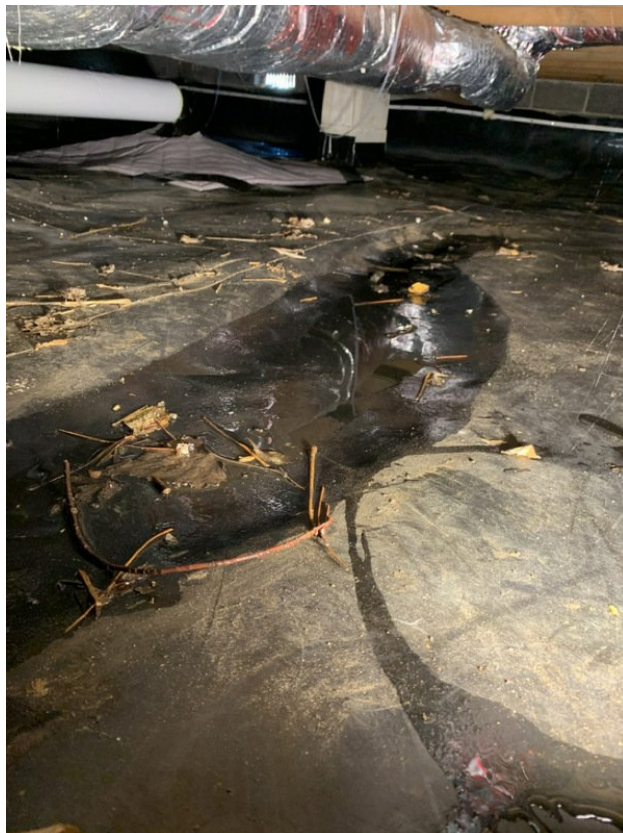
Is water observed on the barrier?	Yes
Location of Water on Barrier	Near entrance of crawl space
Can the source of water be identified?	No

Volume of Water on Barrier (gal)	1
Can water be felt under the barrier?	No
Do barrier seams need addition sealing or repair?	No

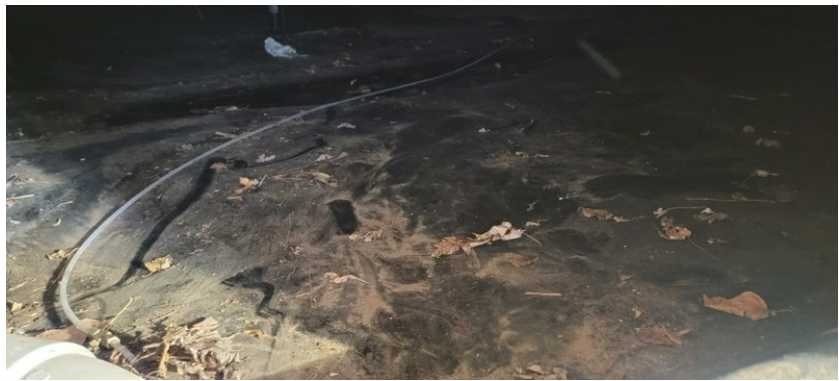
Is water observed on the barrier?	Yes
Location of Water on Barrier	To the right of the outside entrance
Can the source of water be identified?	No

Volume of Water on Barrier (gal)	2
Can water be felt under the barrier?	No
Do barrier seams need addition sealing or repair?	No
