# Transmittal Letter

**SUBJECT**  
Operation, Monitoring, and  
Maintenance Field Notes - 12091 Brewster

## 12091 Brewster, 2020-11-11, Full System Inspection

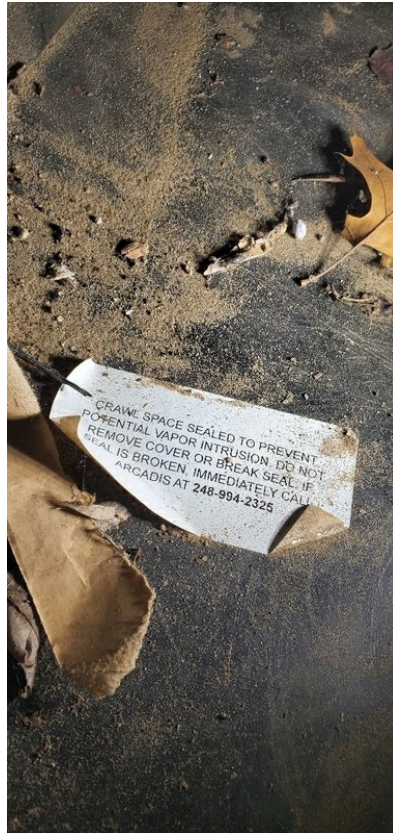
Barrier Label Photos

Are labels present at the crawlspace barrier? Yes

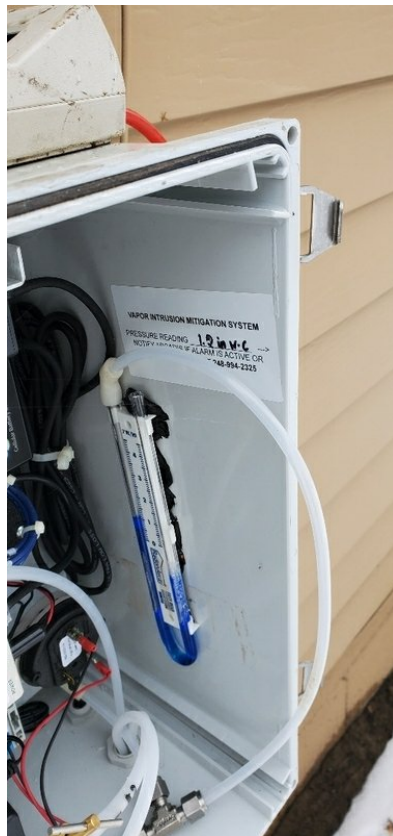
Common Label Photos

Are labels present at the pipe, control panel, u-tube, and breaker? Yes

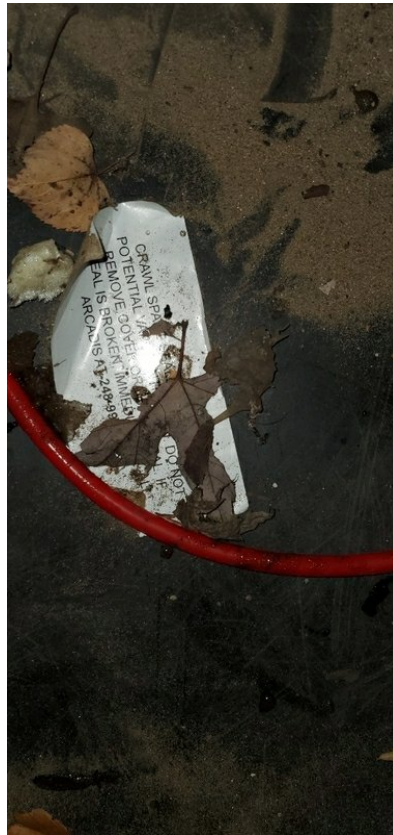
Barrier Label Photos

Are labels present at the crawlspace barrier? Yes

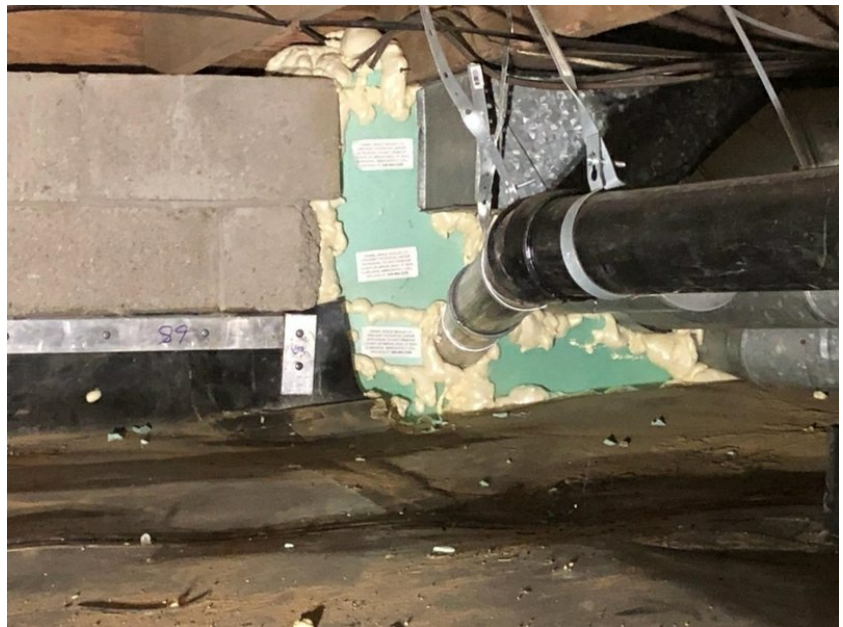
Inaccessible Crawlspace Label Photos

Are labels present at the inaccessible crawlspace? Yes

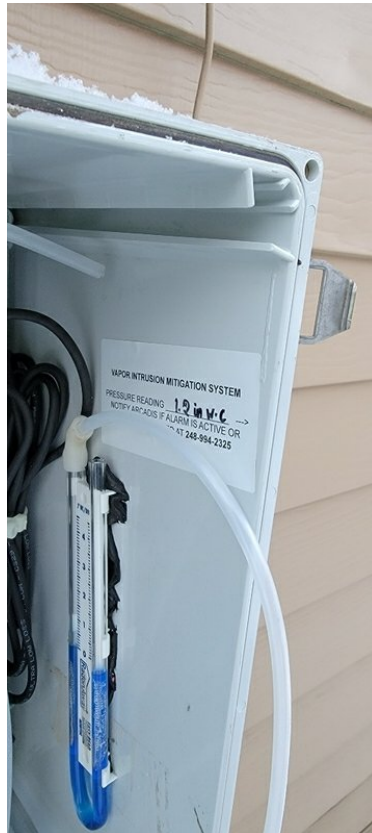
Common Label Photos

Are labels present at the pipe, control panel, u-tube, and breaker? Yes

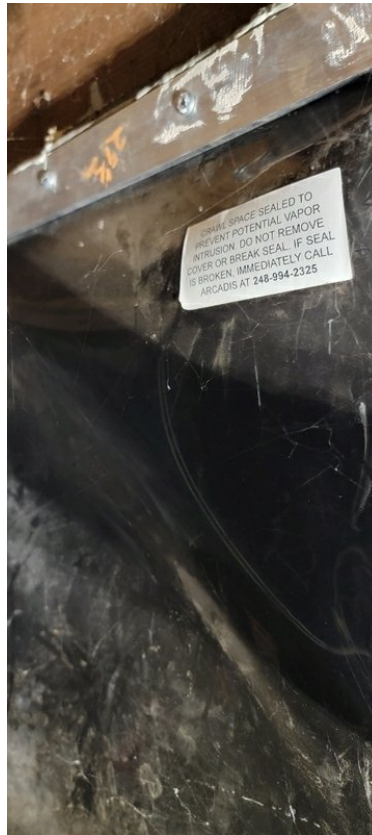
Barrier Label Photos

Are labels present at the crawlspace barrier? Yes

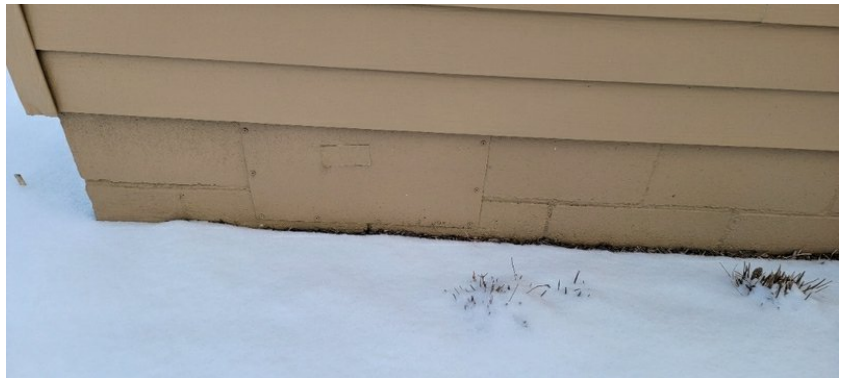
Notes Inaccessible crawlspace cover intact
