MEMO

May 10, 2019

Livonia Transmission Plant
Memo Regarding Email received on 5/2/2019 – 34450 Beacon Avenue and
other residences
36200 Plymouth Road, Livonia, Wayne County, Michigan
EGLE Site ID No. 82002970

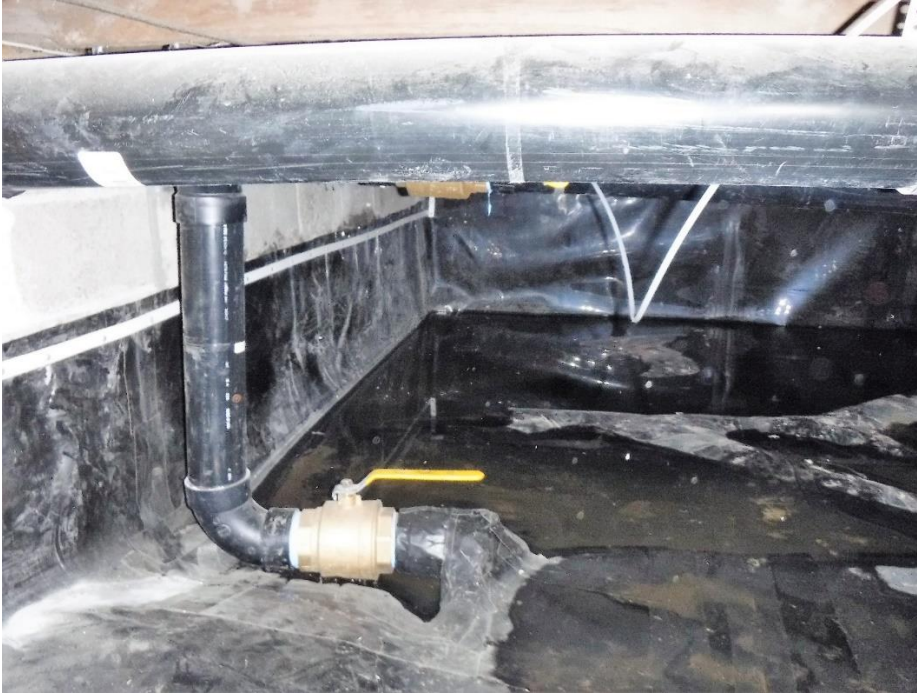
On April 26, 2019, Arcadis received an email from the current property owner located at 34450 Beacon that indicated that standing water was identified within the crawl space. Arcadis immediately brought an air purifier to the homeowner and began assessing the crawl space. Arcadis confirmed that water related to flooding conditions was present on the liner. Arcadis immediately started pumping water from the crawl space, but after 50 gallons of water had been removed, there was no evidence that the water was receding. It appeared that water was infiltrating through the green drains that are placed in the liner. Green drains are used to allow water to drain in the event there is a potable water leak, but do not allow

vapor to enter. The three green drains were capped with a 3-inch expansion cap. Arcadis returned on April 27, 2019 to assess the crawl space. Approximately 170 gallons of water was removed, which resulted in no significant decrease in the water level. Arcadis visually confirmed that some of the liner seams had become compromised, which was allowing water to pass through. It is believed some of the seams are failing due to the hydrostatic pressure from the flooding conditions. Arcadis sealed the liner seams per industry standards for the installation of a submembrane depressurization system.

Photo 1 – Standing water on the liner in the crawl space at 34450 Beacon

Until the water level subsides and is removed from the crawl space, the liner cannot be assessed for potential damage and/or be repaired. The property owner currently has an air purifier in the home and is in use. The interim preemptive mitigation system is currently running but continues to have signs of water present in the geo-venting. Once the water does subside, Arcadis will immediately assess and repair any damage to the interim preemptive mitigation system and evaluate performance metrics. Photo

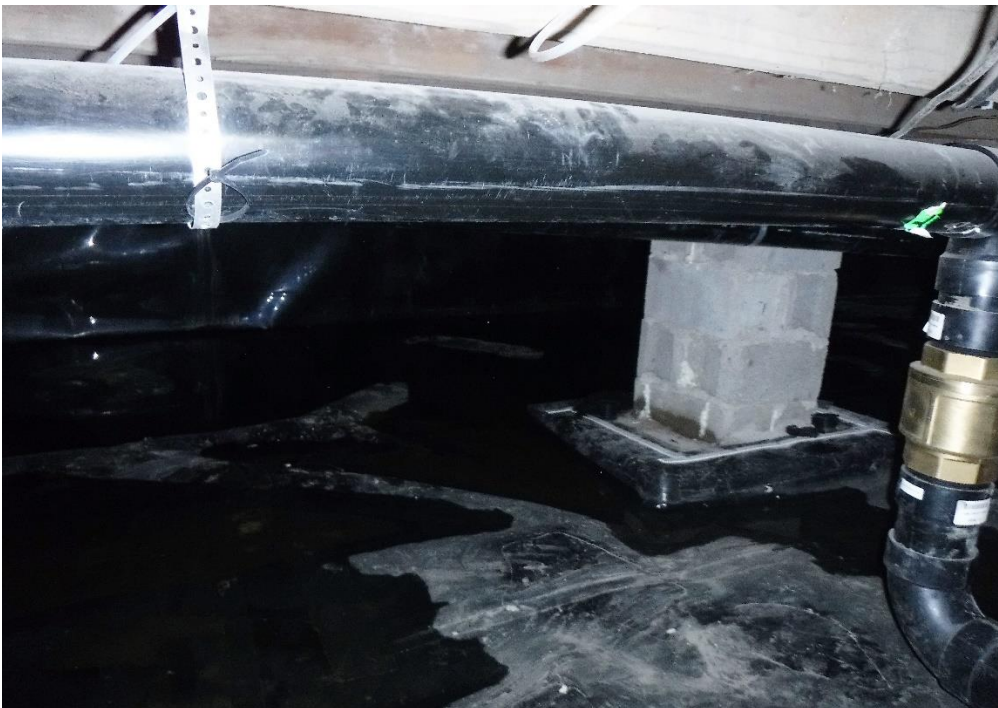
Photo 2 - Standing water on the liner in the crawl space at 34450 Beacon

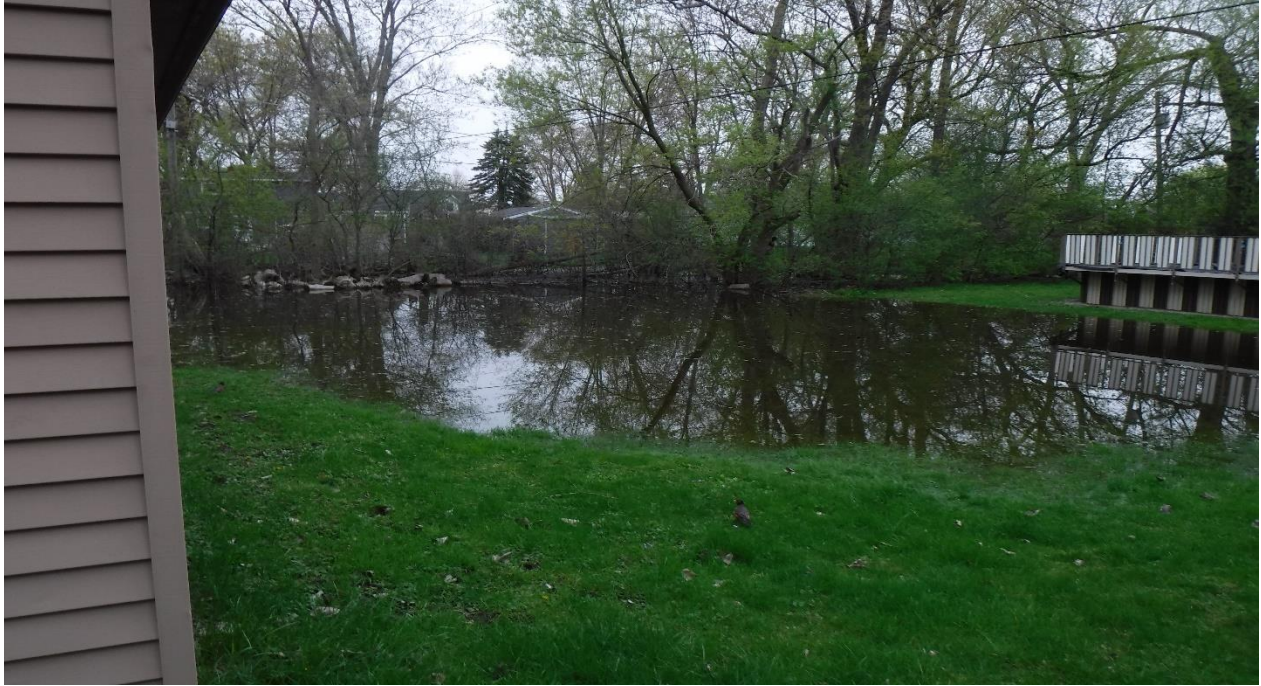
During the week of April 22, 2019, the Livonia area received approximately 1.22 inches of rain, which likely saturated the ground. During the week of April 29, 2019, the Livonia area received an additional 3.9 inches of rain, with 3.28 inches in a 24-hr period on April 30th and May 1st, which resulted in area wide flooding and road closures (AccuWeather, 2019). Governor Whitmer declared a state of emergency in nearby Wayne County, where 3,000 homes were flooded and the Southfield Freeway was closed (Associated Press, 2019).

Photo 3 - Flooding Conditions Near 34450 Beacon

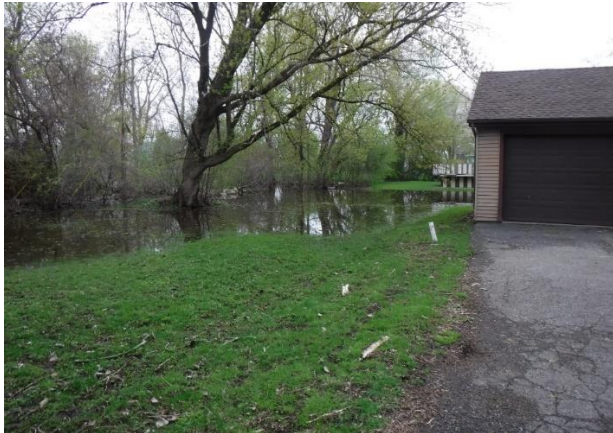
Photo 4 - Flooding Conditions Near 34450 Beacon

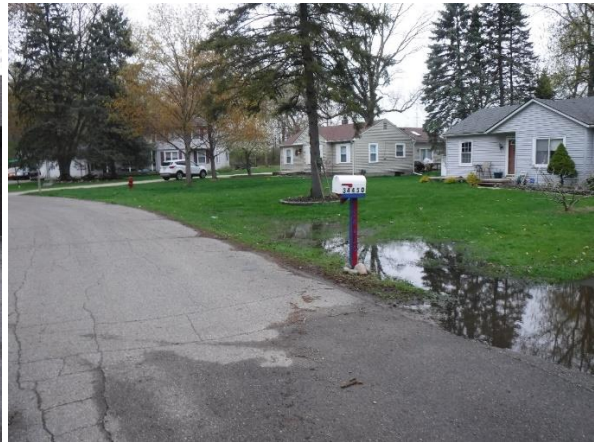
Photo 5 – Flooding Conditions Near 34450 Capital
