MEMO

Arcadis Project No.:
30042006

Subject:
Response to EGLE - Monthly Updates on Offsite Mitigation Systems related to the Ford Livonia Transmission Plant, 36200 Plymouth Road, Wayne County, Michigan EGLE Site ID No.: 82002970

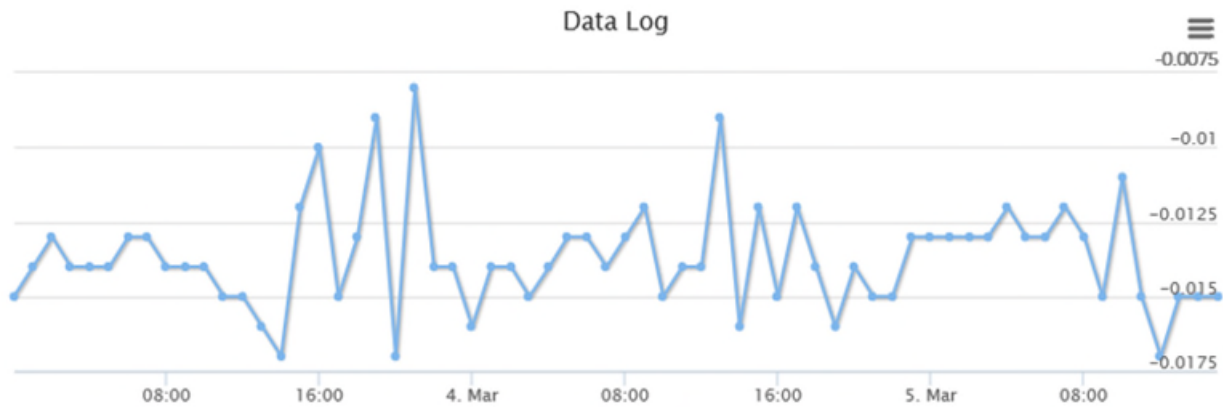
- *February 14, 2020 – 34480 Capitol – The installed data-logger collected data that Arcadis has described as erratic, beginning with the January 7, 2020, Operation, Monitoring and Maintenance (OM&M) event. The erratic pressure appears to occasionally cause a loss of negative pressure, rendering the system temporarily ineffective. Ford needs to investigate and determine the causes and implement a solution before the next update memo and ensure that a minimum negative pressure is maintained. Maintaining a negative pressure at a minimum of -0.005 inches wc allows for minor system fluctuations and allows for an adequate response time is necessary to ensure the mitigation system remains reliable an effective. The vacuum should be increased to allow for this.*

Additional work was completed at this property during February as described in the February 28, 2020 monthly update and on March 2, 2020. The improved vacuum coverage is demonstrated in the graph below where all differential pressure levels recorded are -0.008 in wc or more negative since completion of the work on March 2, 2020.

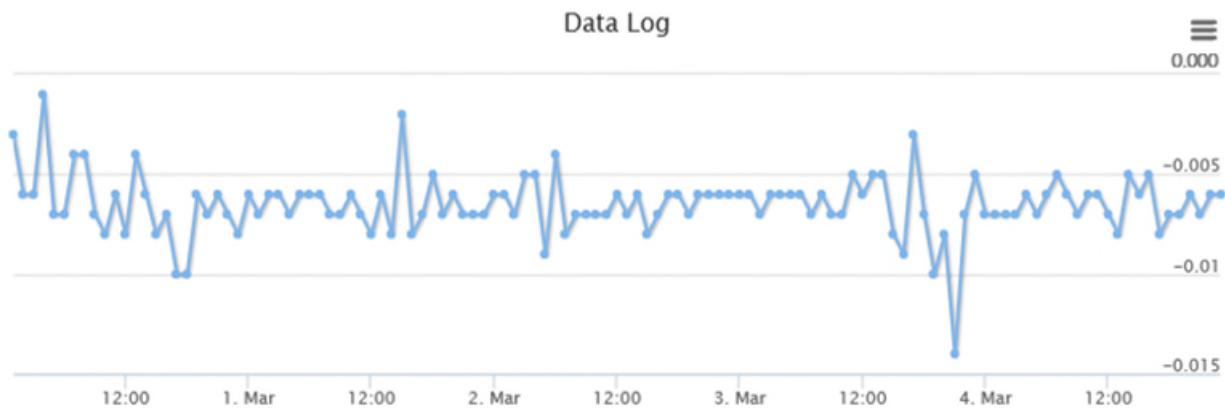
- February 14, 2020 – 12036 Brewster – The residence has a data log that shows that the vacuum is typically higher than -0.005 inches wc which does not allow for minor system fluctuations or allow for adequate response times to ensure the mitigation system is reliable and effective. The vacuum should be increased to allow for this. Additionally, there were times when a positive pressure was recorded, the mitigation system should be evaluated and adjusted to correct this from occurring.

An update was provided in the February 28, 2020 monthly update showing the results of the system adjustments that were made. The majority of the logged differential pressures are now -0.005 in wc or more higher.

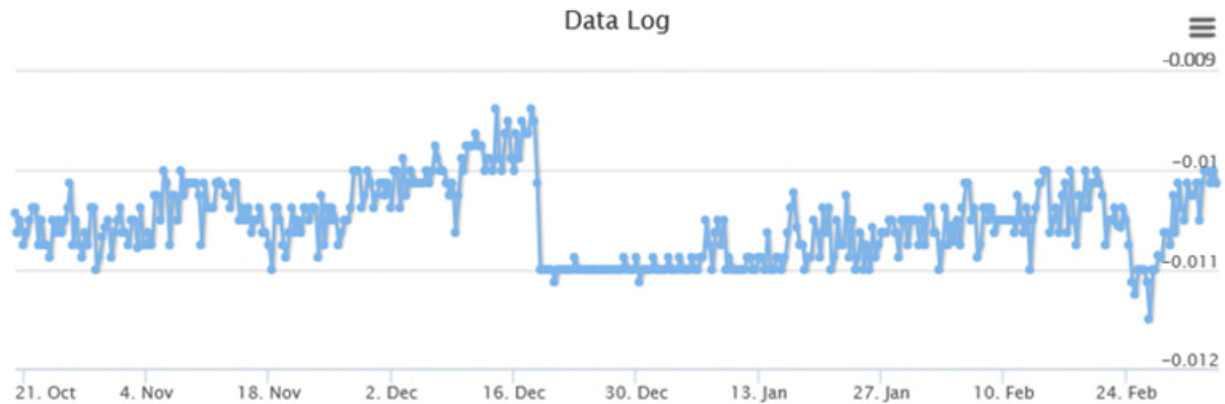
- February 14, 2020 – 34682 Beacon– This residence has a data log that shows that the vacuum is typically higher than -0.005 inches wc which does not allow for minor system fluctuations or allow for adequate response times to ensure the mitigation system is reliable and effective. The vacuum should be increased to allow for this.

34682 Beacon - On September 7, 2019, a vacuum transmitter was installed at sub-membrane monitoring point MP-5, since the property owner would not allow the transmitter to be installed at SSMP-4, located within the finished slab on grade portion of the home. Access to the inside of the home was granted on September 18, 2019 to perform system adjustments resulting in the following monitoring point readings, SSMP-1: -0.107 in wc, SSMP-2: -0.053 in wc, SSMP-3: -0.073 in wc, SSMP-4: -0.007 in wc, SSMP-5: -0.022 in wc, MP-4: -0.013 in wc, and MP-5: -0.009 in wc. The data logged by the vacuum transmitter is provided below. Logging data demonstrates that a differential pressure of -0.009 in wc or more negative is continuously being maintained and that the system continues to operate effectively in the crawlspace portion of the home. Per the February 28, 2020 monthly update, additional work will be completed at this property to address a reduction in vacuum coverage in the slab area of the home.

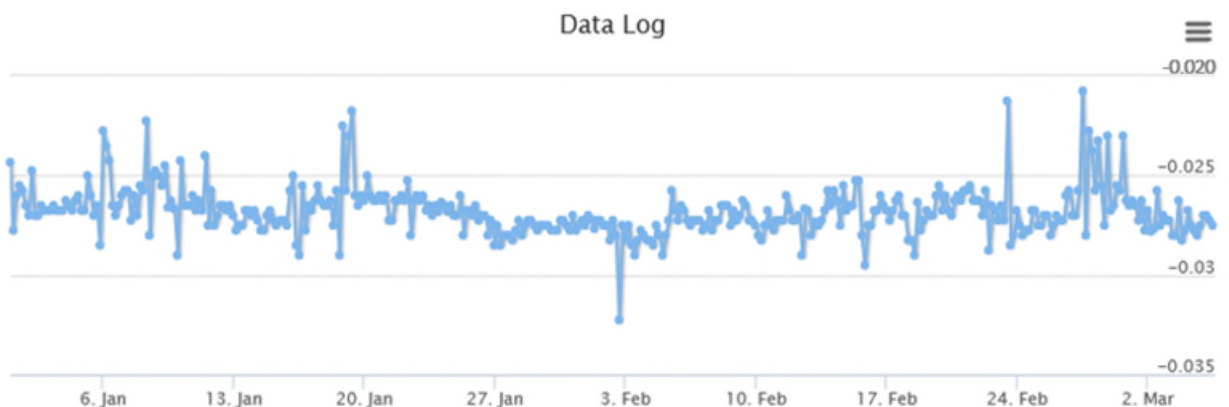
12100 Boston Post – A vacuum transmitter was installed on the Sub-Slab Monitoring Point SSMP-4 located in the attached garage addition on May 4, 2019 to continuously monitor vacuum levels and to confirm that vacuum is being maintained, since the vacuum level was less than the performance metric established by EGLE of -0.02 in wc. Data logged by the vacuum transmitter is provided below. Differential pressure levels are being maintained that are more negative than -0.020 in wc at SSMP-4, demonstrating continued effective operation in the crawlspace and attached garage portions of the home.

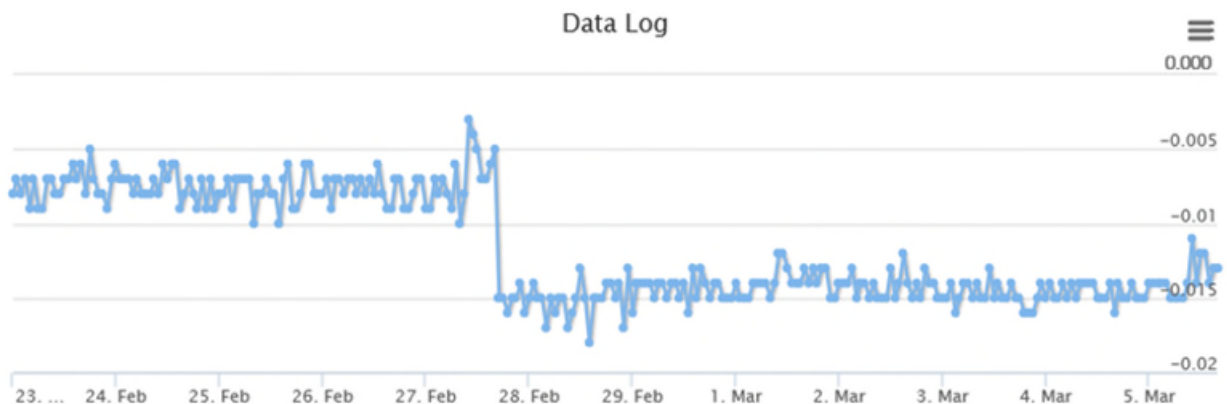
34591 Beacon - A vacuum transmitter was installed on September 16, 2019 at sub-slab monitoring point SSMP-1 to continuously monitor vacuum levels and to confirm that vacuum is being maintained since the vacuum level was less than the performance metric established by EGLE of -0.02 in wc. System modifications were completed on February 28, 2020. The data logged by the vacuum transmitter presented below demonstrates the resulting improvement in performance. The differential pressure of -0.010 in wc or more negative is now continuously being maintained at SSMP-1 and the system is operating effectively.

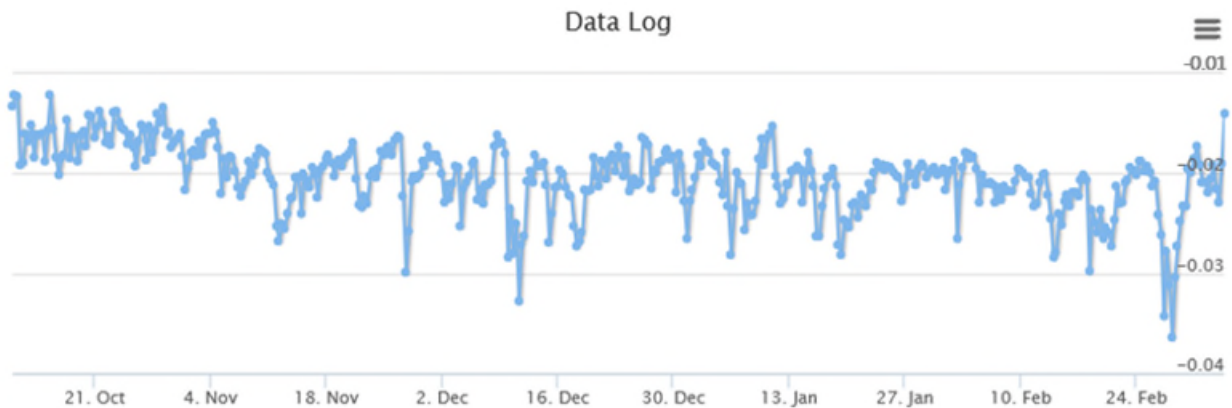
- January 23, 2020 -The sub-slab depressurization system at 12067 Boston Post had one point, MP-1, that did not meet the minimum depressurization standard. Can adjustments to the system be made to meet the minimum depressurization standard?
- February 14, 2020 – 12067 Boston Post – This residence has a data log that shows that the vacuum is typically higher than -0.005 inches wc which does not allow for minor system fluctuations or allow for adequate response times to ensure the mitigation system is reliable and effective. The vacuum should be increased to allow for this.

A vacuum transmitter was installed at sub-membrane monitoring point MP-1 on August 28, 2019 to continuously monitor vacuum levels and to confirm that vacuum is being maintained since the vacuum level was less than the performance metric established by EGLE of -0.02 in wc. Note that system adjustments were performed prior to the installation of the transmitter at MP-1, however -0.020 in wc was not able to be continuously maintained. The other three sub-membrane monitoring points installed at this property all meet the performance metric established by EGLE of -0.02 in wc. Data logged by the vacuum transmitter is provided below. Logging data demonstrates that a differential pressure of -0.011 in wc or more negative is continuously being maintained at MP-1 and that the system continues to operate effectively.

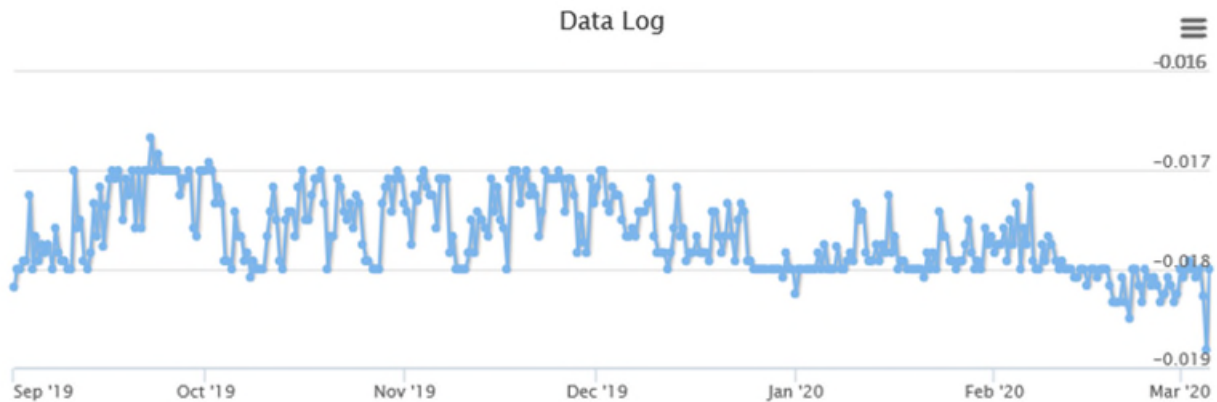
- November 18, 2019 - The home at 34990 Beacon had one point or more that did not meet the minimum depressurization standard in the August 30, 2019, and September 30, 2019, reports. Information regarding depressurization was not provided in the October 31, 2019 and should be included in future Memorandums. Please report on the actions taken to achieve adequate depressurization in this point.
- January 23, 2020 - The sub-slab depressurization system at 34990 Beacon had one point, MP-7, that did not meet the minimum depressurization standard. Can adjustments to the system be made to meet the minimum depressurization standard?

performance metric established by EGLE of -0.02 in wc. Note that system adjustments were incorporated on August 22, 2019, and the vacuum level at MP-7 has been optimized to the extent possible. The other six sub-membrane monitoring points installed at this property all meet the performance metric established by EGLE of -0.02 in wc. The data logged to date by the vacuum transmitter is provided below. All logging data demonstrates that differential pressure of -0.016 in wc or more negative is continuously being maintained at MP-7 and that the system continues to operate effectively.

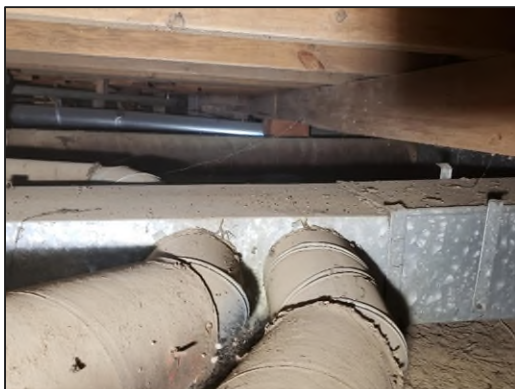
Heating duct without support beam is lying on dirt floor.

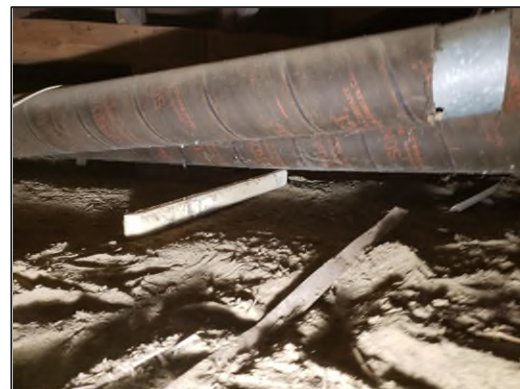
Numerous heating ducts lying on the floor or hanging with less than 10” of clearance below.

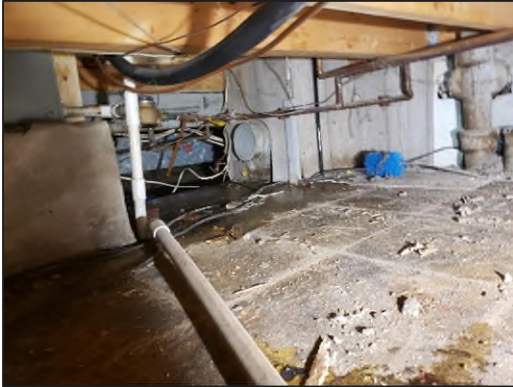
Water meter with multiple leaks

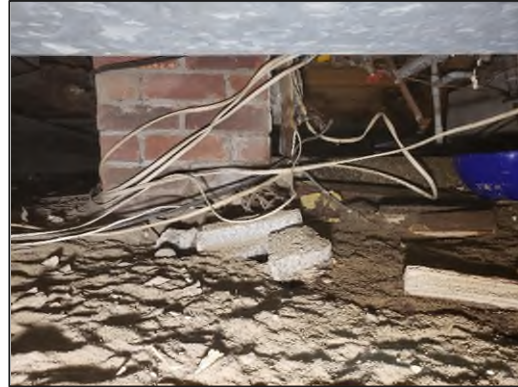
Numerous loose Romex 120V wrapped around a brick pillar.
