Livonia Transmission Plant  
36200 Plymouth Road, Livonia,  
Wayne County, Michigan  
EGLE Site ID No. 82002970  
Offsite Interim Preemptive Mitigation  
Installation Quarterly Update

October 31, 2022

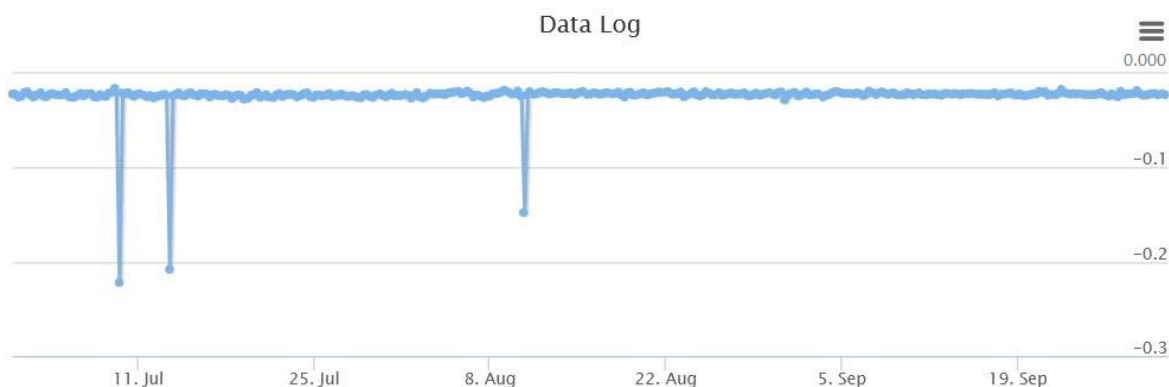
- **34550 Beacon** – The system is currently in operation and maintenance.
- **34591 Beacon** – The system is currently in operation and maintenance. An update of the data logged by the vacuum transmitter connected to SSMP-1 is presented below demonstrating that the system continues to operate effectively.

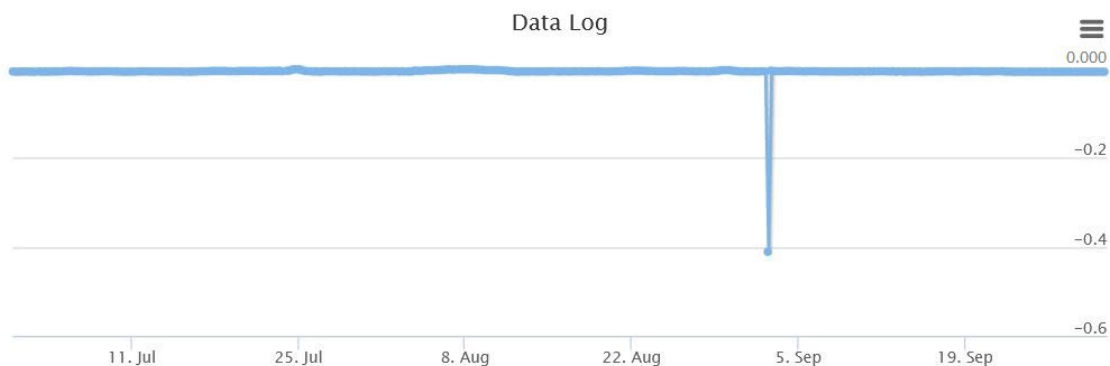
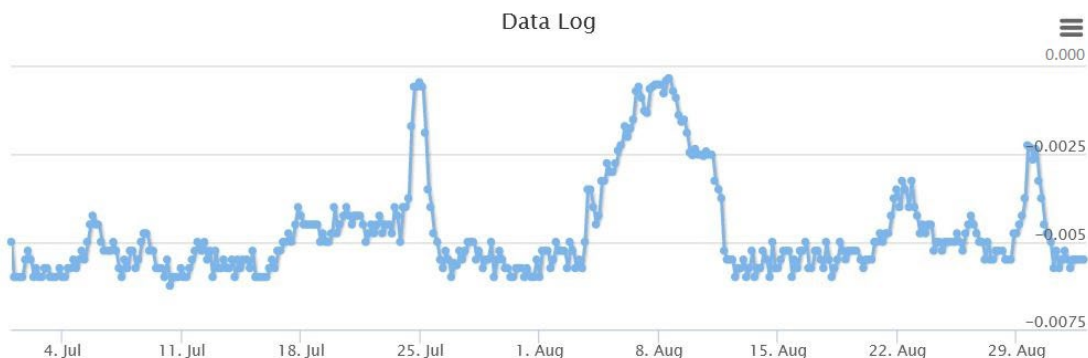
- **34600 Beacon** – The system is currently in operation and maintenance.
- **34644 Beacon** – The system is currently in operation and maintenance.
- **34682 Beacon** – The system is currently in operation and maintenance. An update of the data logged by the continuously monitored vacuum transmitter connected to sub-membrane monitoring point MP-5 is presented below indicating that the system continues to operate effectively. The transmitter data provided within previous monthly updates has also shown that vacuum in the area being monitored by the transmitter has been maintained.

Below is a zoomed in portion of the data log showing the IPM system continuing to maintain vacuum level at the monitoring point.

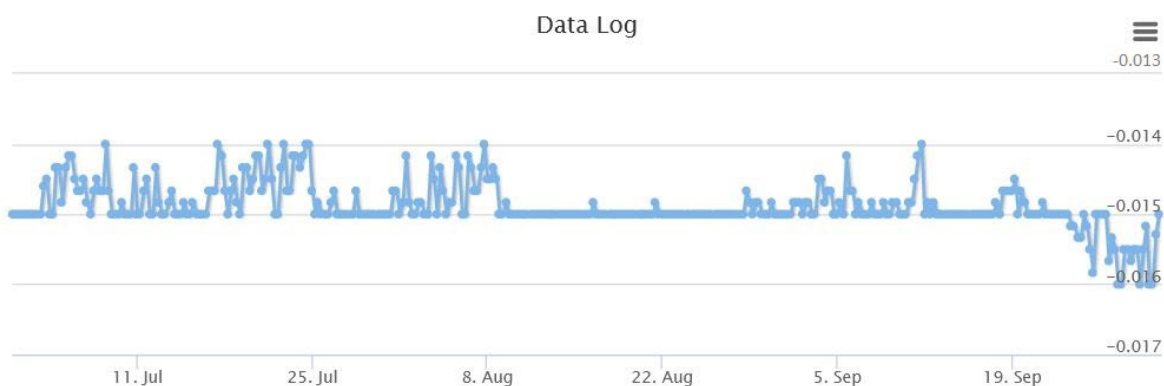
- **34950 Beacon** – The system is currently in operation and maintenance.
- **34990 Beacon** – The system is currently in operation and maintenance. An update of the data logged by the vacuum transmitter connected to MP-7 is presented below demonstrating that the system continues to operate effectively.

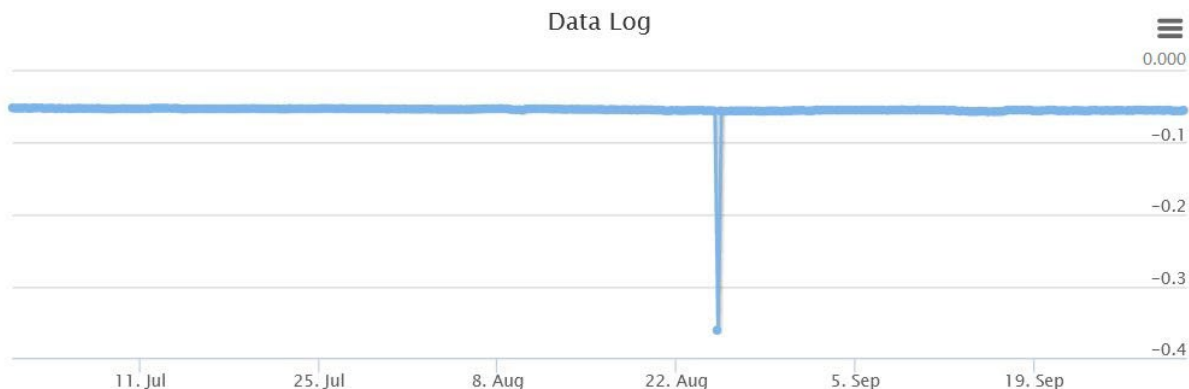
- **12067 Boston Post** – The system is currently in operation and maintenance. An update of the data logged by the vacuum transmitter connected to MP-1 is presented below demonstrating that the system continues to operate effectively.

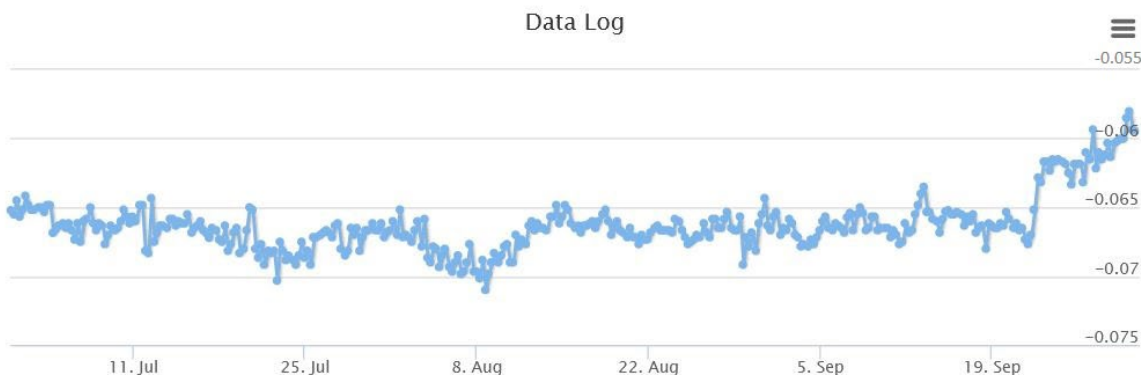
- **12070 Boston Post** – The system is currently in operation and maintenance.
- **12089 Boston Post** – The system is currently in operation and maintenance.
- **12100 Boston Post** – The system is currently in operation and maintenance. An update of the data logged by the vacuum transmitter connected to sub-slab monitoring point SSMP-4 is presented below demonstrating the system continues to operate effectively.

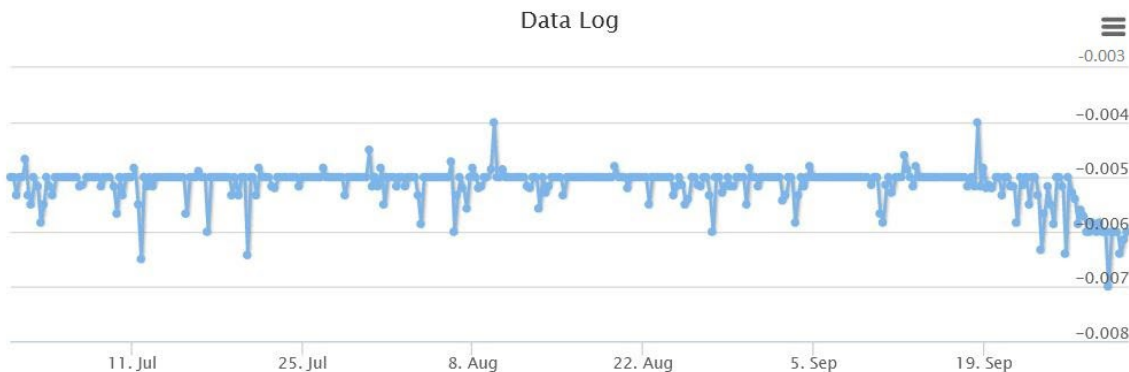
- **12131 Boston Post** –The system is currently in operation and maintenance. An update of the data logged by the vacuum transmitter connected to MP-4 is presented below demonstrating that the system continues to operate effectively. The area being monitored by the transmitter is located beneath a small breezeway between the attached garage and the home. The transmitter data provided within previous quarterly updates has also shown that vacuum in the area being monitored by the transmitter has been maintained.

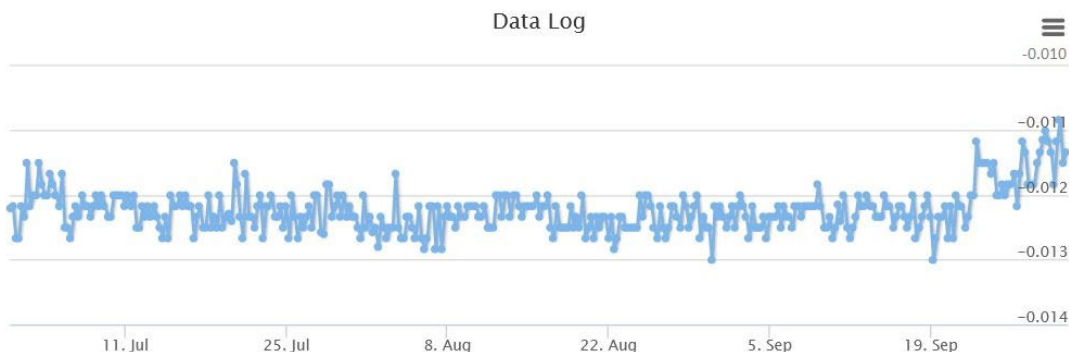
- **12141 Boston Post** – The system is currently in operation and maintenance. An update of the data logged by the vacuum transmitter connected to MP-4 is presented below demonstrating that the system continues to operate effectively. The transmitter data provided within previous quarterly updates has also shown that vacuum in the area being monitored by the transmitter has been maintained.

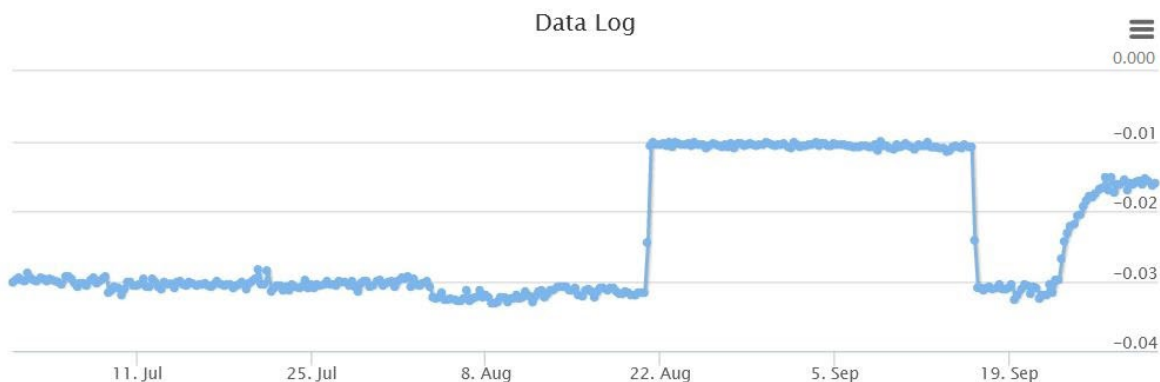
- **12017 Brewster** – The system is currently in operation and maintenance.
- **12036 Brewster** – The system is currently in operation and maintenance. An update of the data logged by the vacuum transmitter connected to SSMP-2 is presented below demonstrating that the system continues to operate effectively.

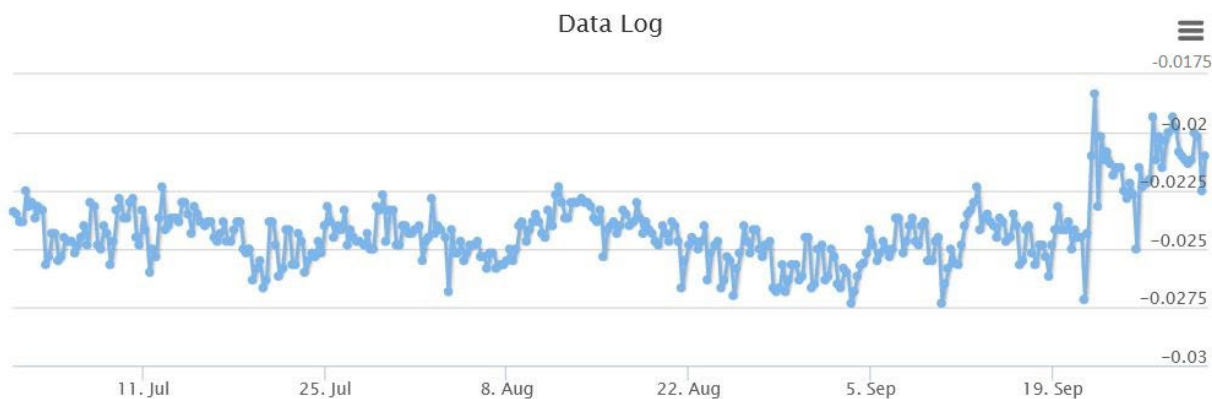
An update of the data logged by the vacuum transmitter connected to SSMP-2 is presented below demonstrating that the system continues to operate effectively.
