Transmittal Letter

PROJECT NUMBER
30146655

SUBJECT
Operation, Monitoring, and
Maintenance Field Notes - 34367 Capitol

Attached are the interim preemptive mitigation (IPM) system Operation, Monitoring, and Maintenance (OM&M) field notes. These field notes were recorded during OM&M visits at the property between March 31, 2020 and March 31, 2022. Please let me know if you have any questions.

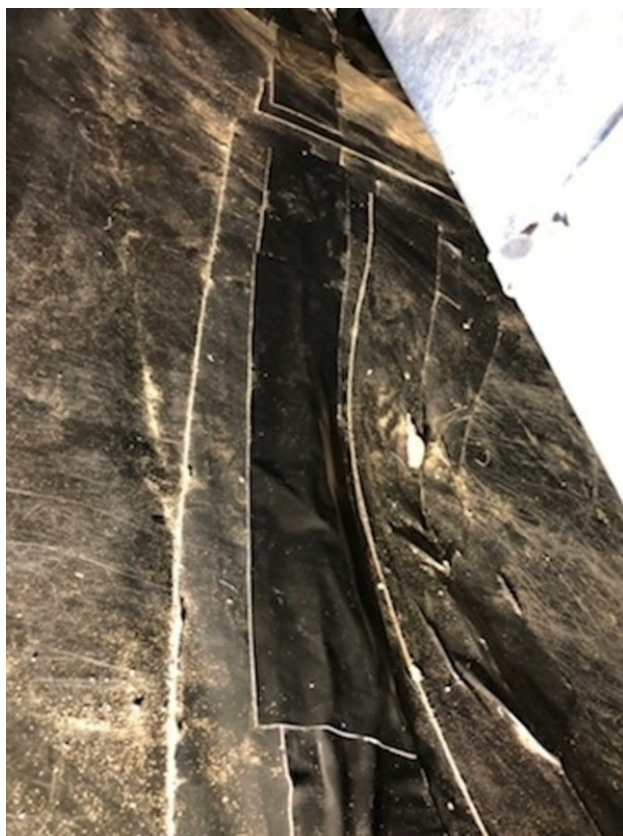
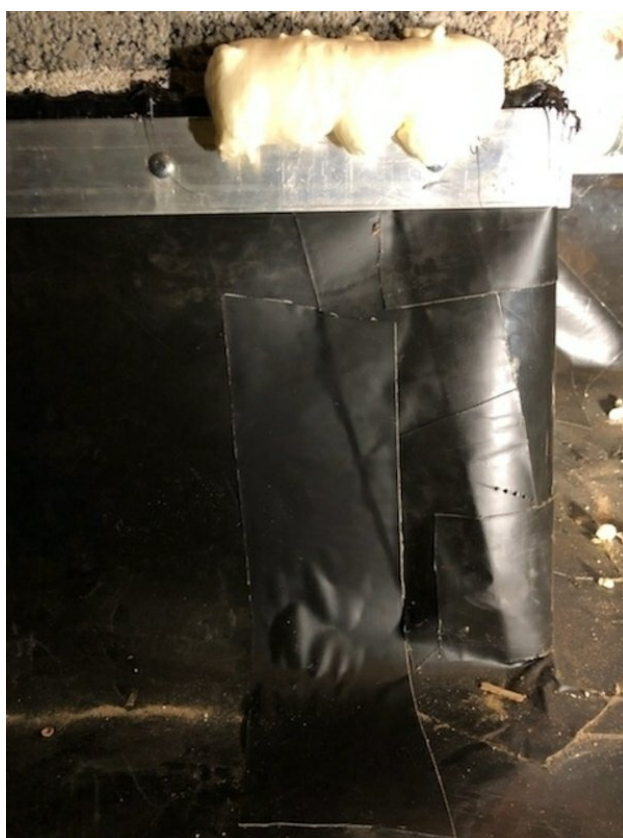
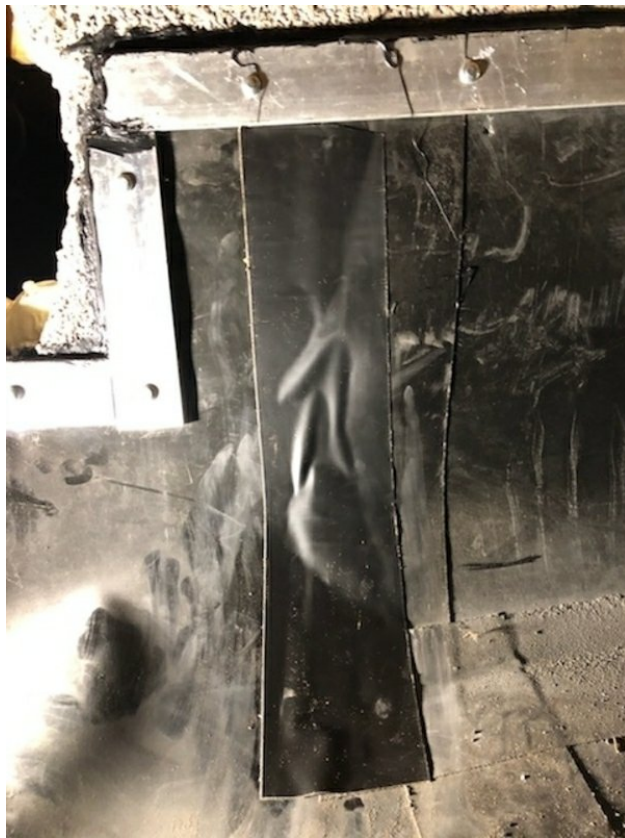
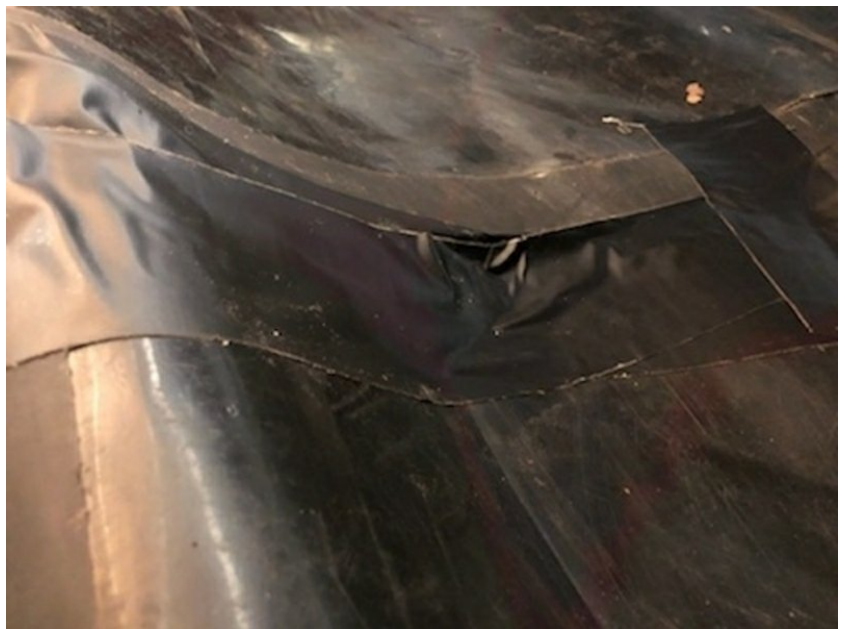
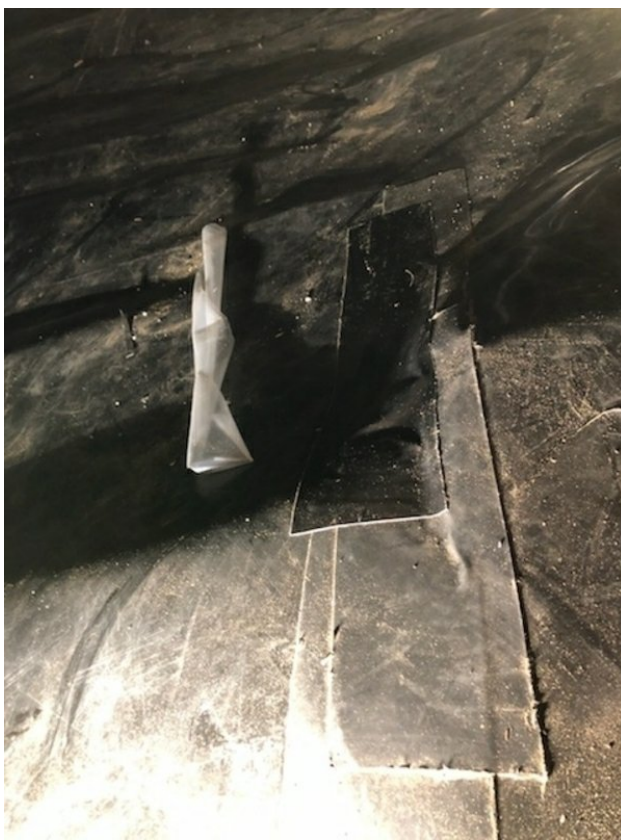
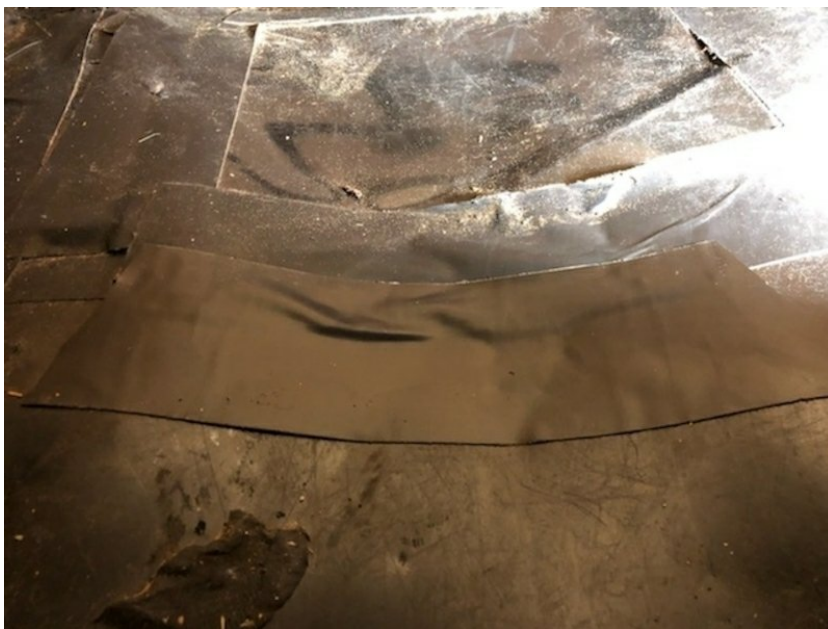
Were system repairs completed during this visit?	No
Additional sealing completed:	Sealed multiple lining gaps.
Sealing Completion Date	2021-02-16
Sealing Repair Photos

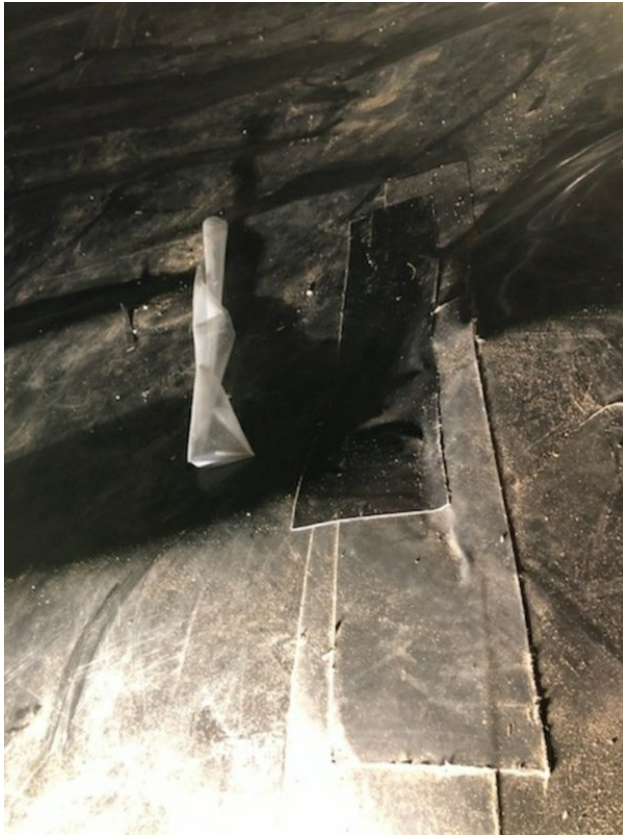
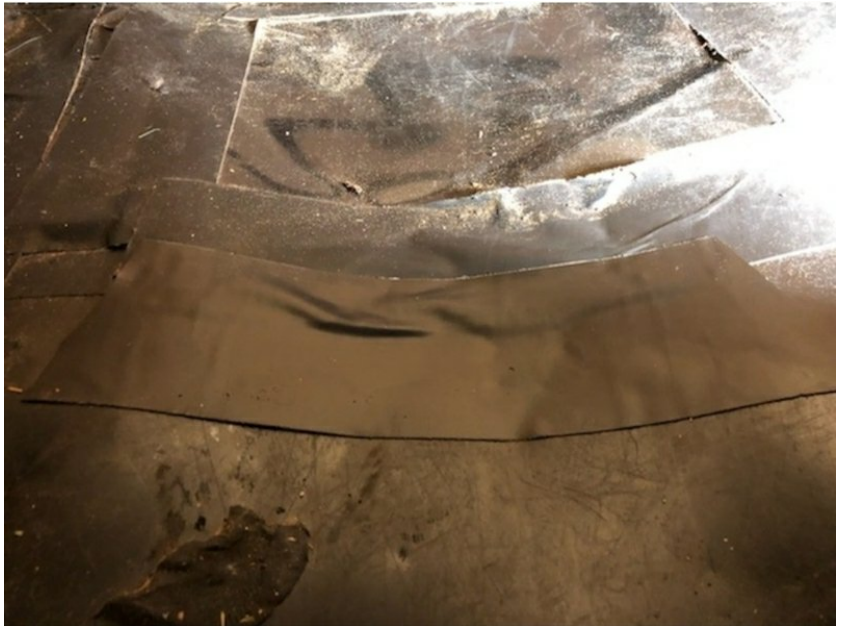
Sealing Repair Photos	
-----------------------	--

Which ones don't and why?	MP-4 was unable to reach metric, possibly due to needed seam repairs.
---------------------------	---

Additional sealing completed:	Sealing done in North side of crawlspace where tape was coming loose.
-------------------------------	---

Proposed modifications to address vacuum?	Seam repairs
---	--------------

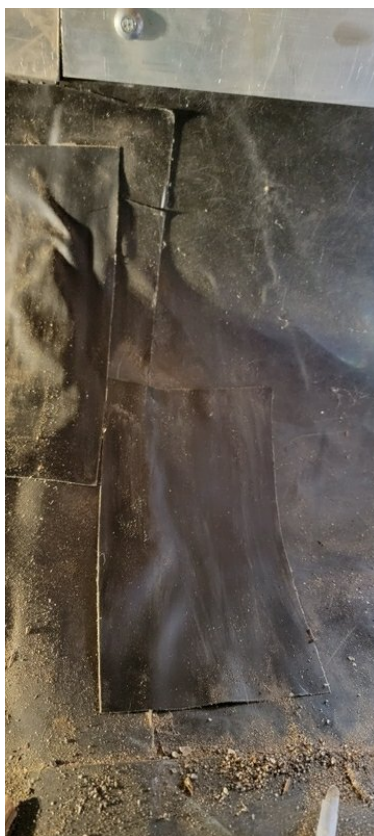
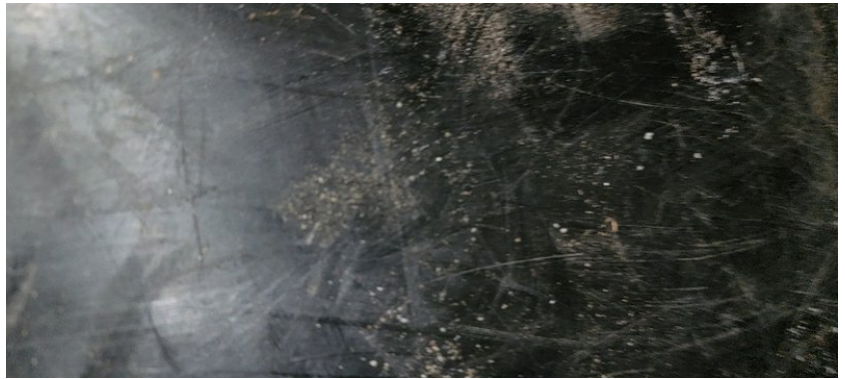
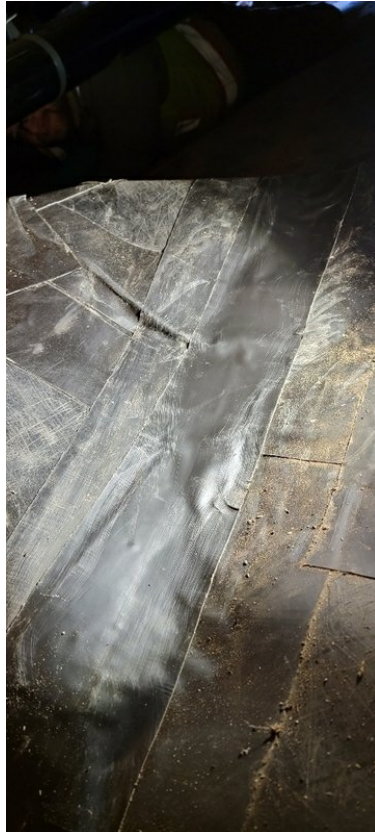
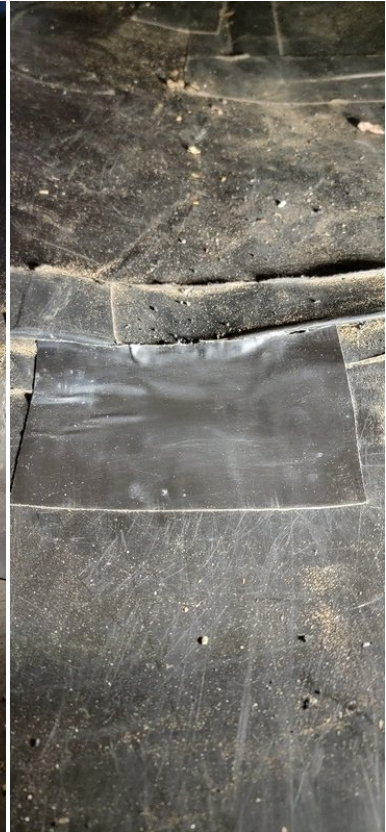
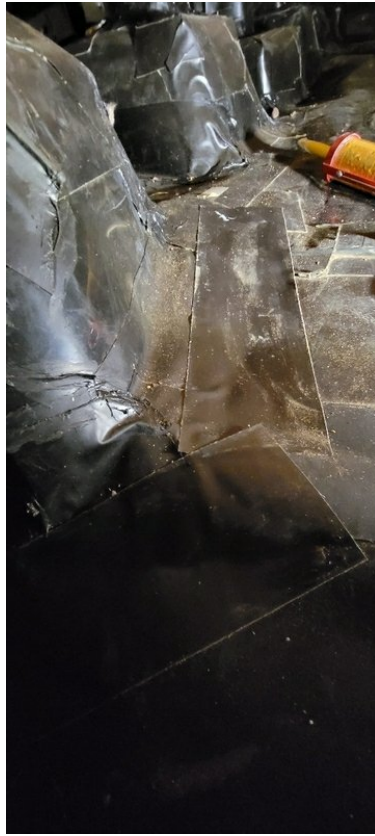
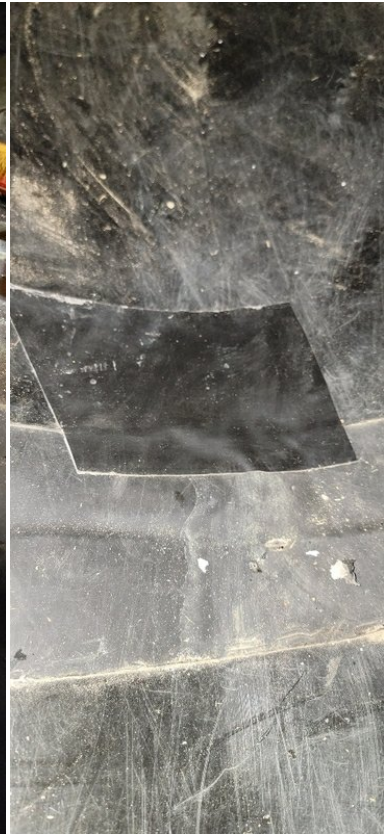
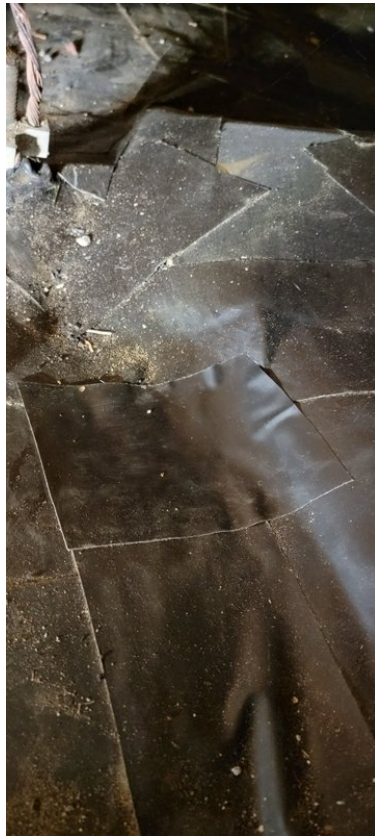
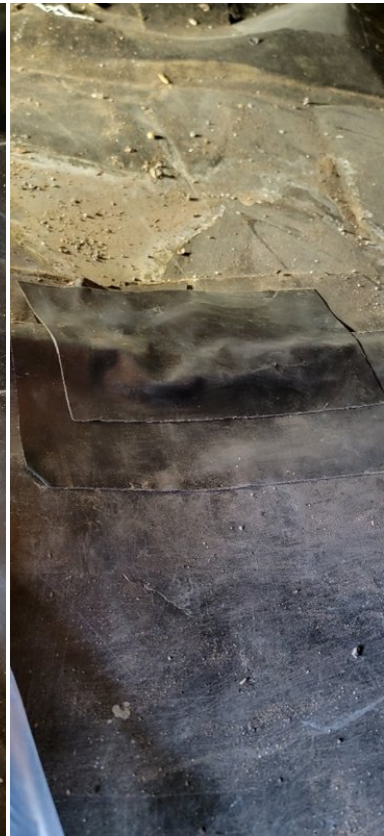
Sealing Repair Photos

Additional sealing completed:	Seam repairs done where tape was lifting.
-------------------------------	---
