Transmittal Letter

SUBJECT
Operation, Monitoring, and
Maintenance Field Notes - 34401 Capitol

Attached are the interim preemptive mitigation (IPM) system Operation, Monitoring, and Maintenance (OM&M) field notes. These field notes were recorded during OM&M visits at the property between June 30, 2020 and March 31, 2022. Please let me know if you have any questions.

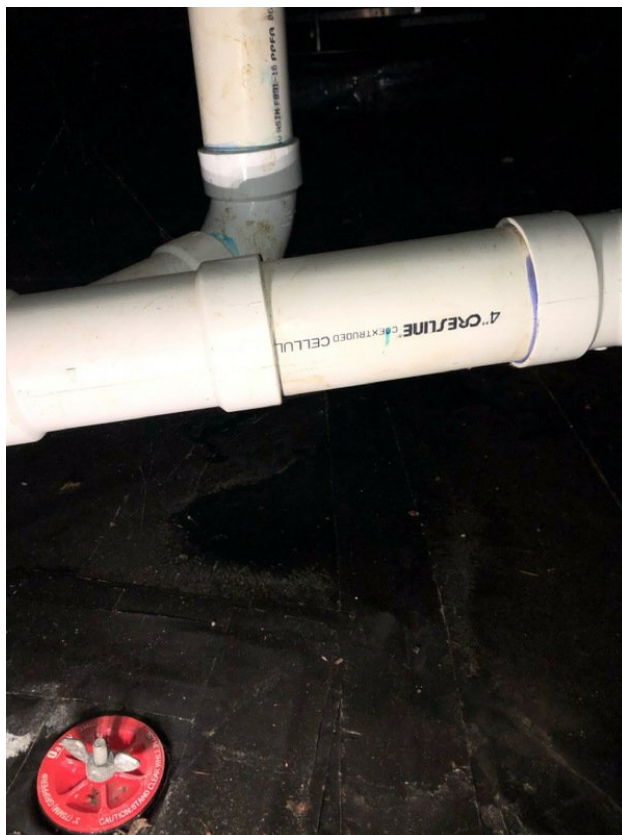
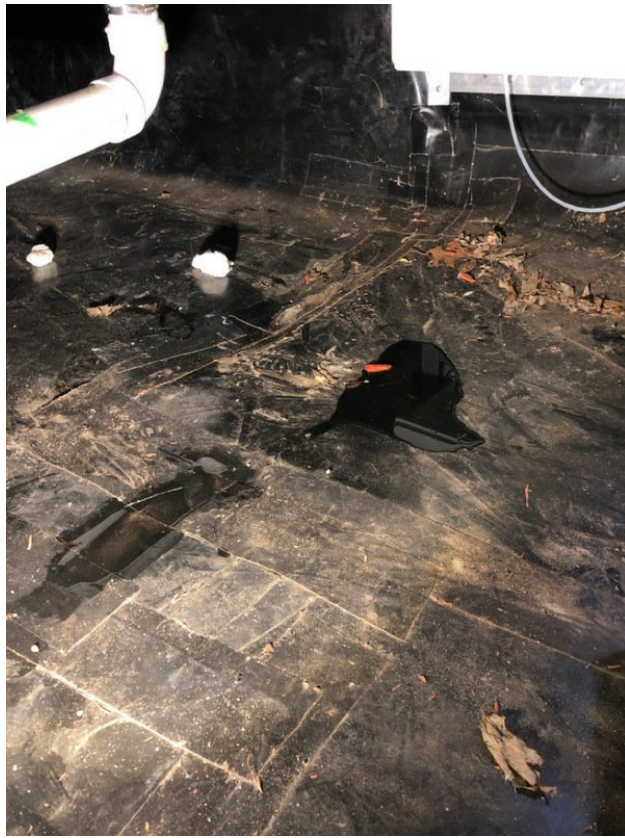
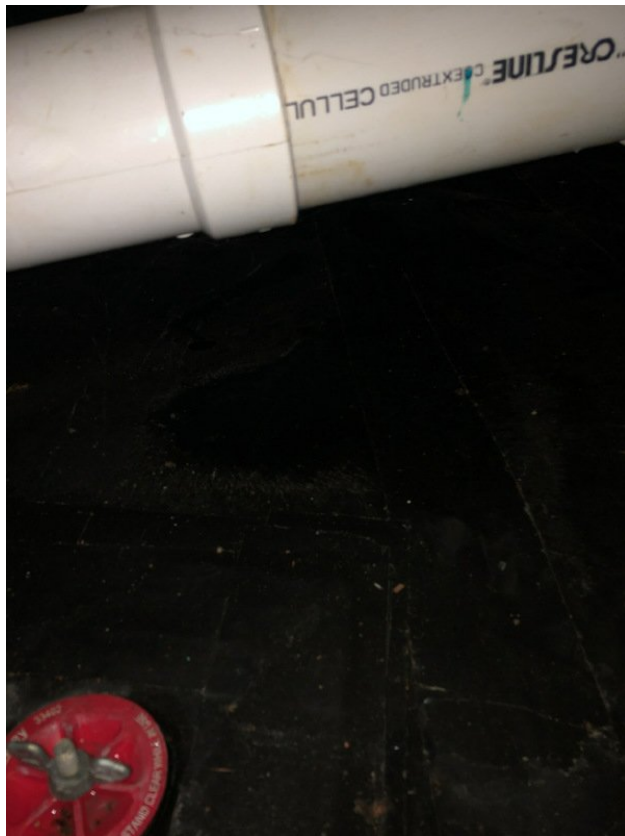
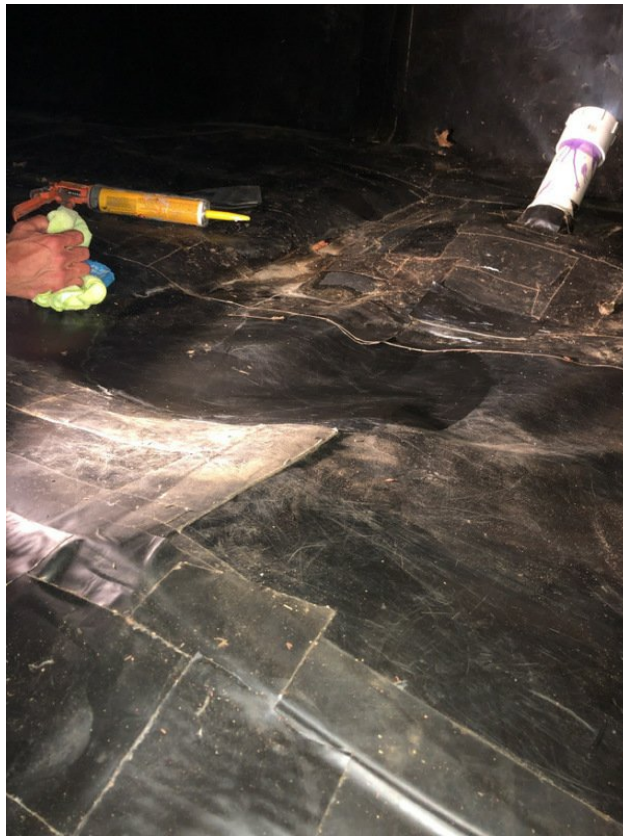
Location of Water on Barrier Near entrance of crawlspace under leaking plumbing.

Volume of Water on Barrier (gal)	0.4
Can water be felt under the barrier?	No
Describe Source Location	Coming from loose tape
Do barrier seams need addition sealing or repair?	Yes
Describe Repair Location and Mark	North side of crawlspace near white pvc
Barrier Repairs Needed

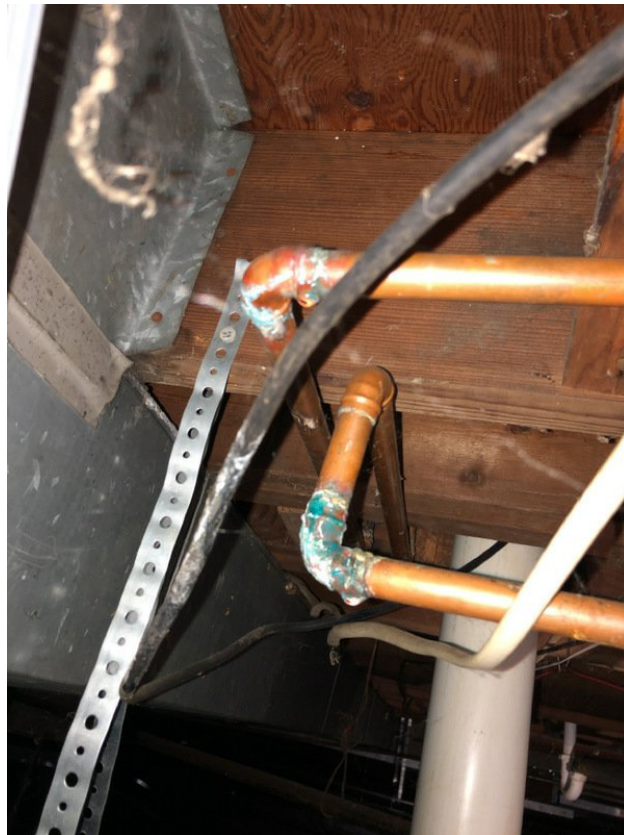
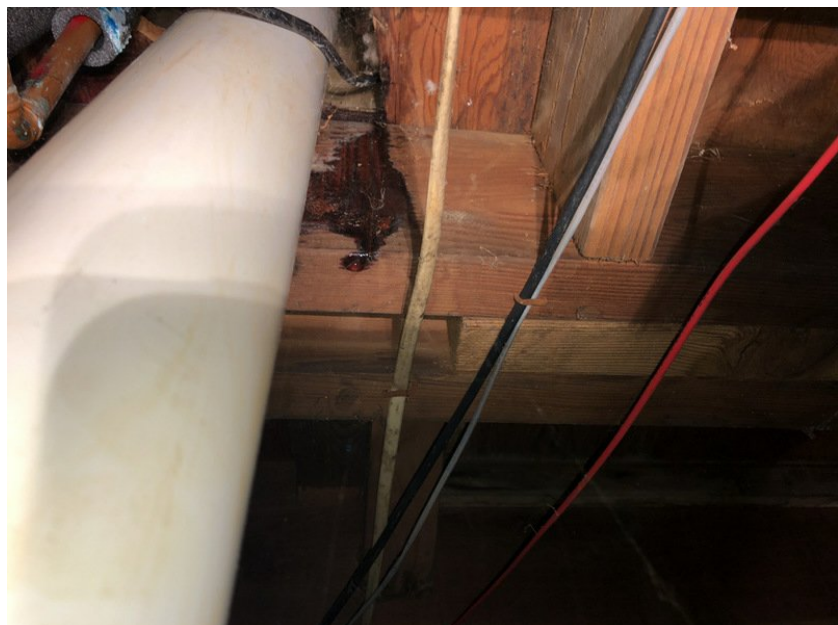
Plumbing Repair Photos

Are plumbing repairs needed?	Yes
Are plumbing repairs on a supply/waste line?	No
Plumbing Repair Location	6 ft NE of crawlspace entrance

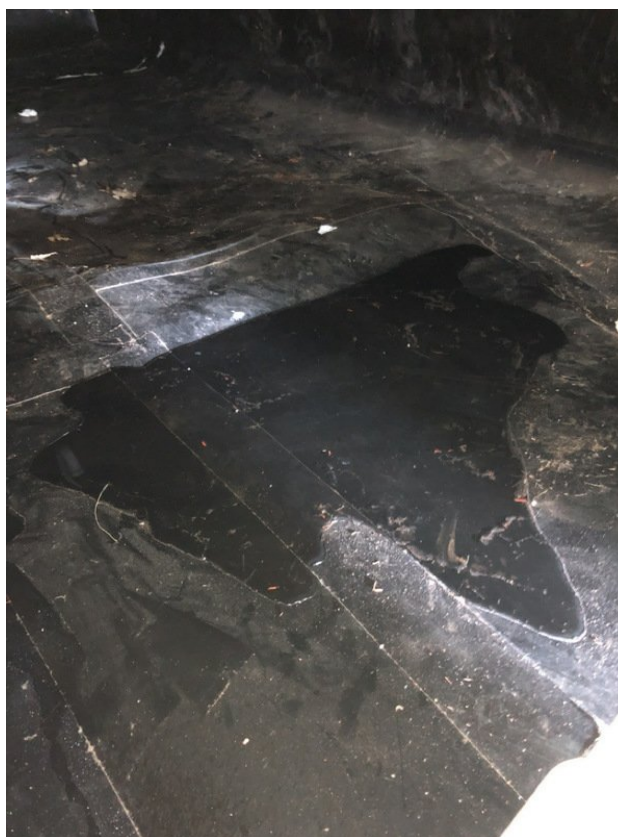
Is water observed on the barrier?	Yes
Location of Water on Barrier	Under plumbing that is actively leaking
Can the source of water be identified?	Yes

Volume of Water on Barrier (gal)	0.5
Can water be felt under the barrier?	No
Describe Source Location	From pipe above
Do barrier seams need addition sealing or repair?	No

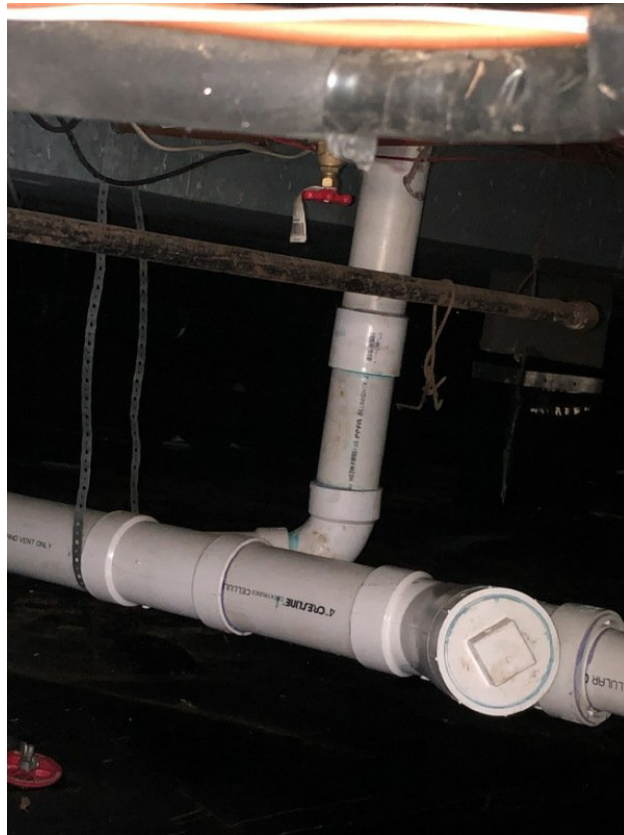
Plumbing Repair Photos

Are plumbing repairs needed?	Yes
Are plumbing repairs on a supply/waste line?	No
Plumbing Repair Location	6ft NE

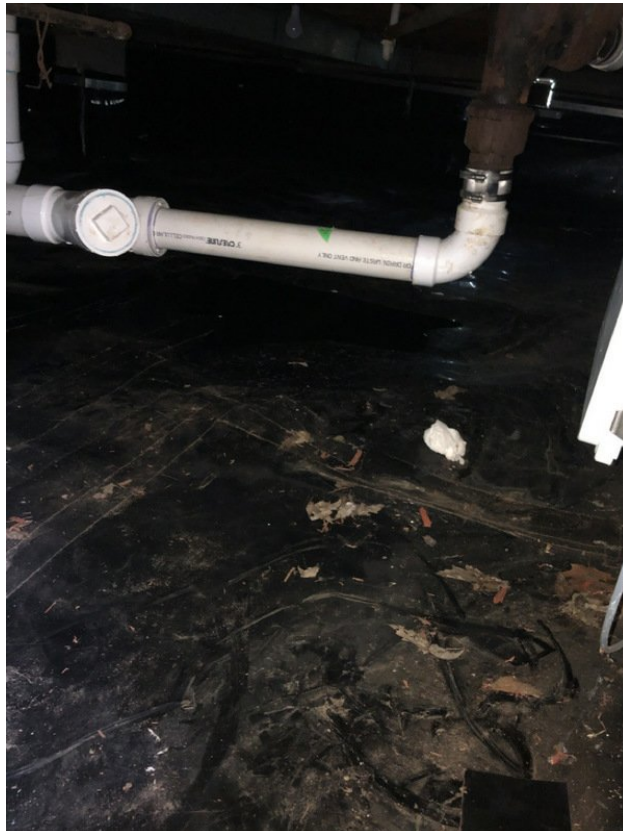
Is water observed on the barrier?	Yes
Location of Water on Barrier	Under plumbing leak that was observed from the last two rain events
Can the source of water be identified?	Yes

Volume of Water on Barrier (gal)	0.25
Can water be felt under the barrier?	No
Describe Source Location	Under leaking water pipe
Do barrier seams need addition sealing or repair?	No

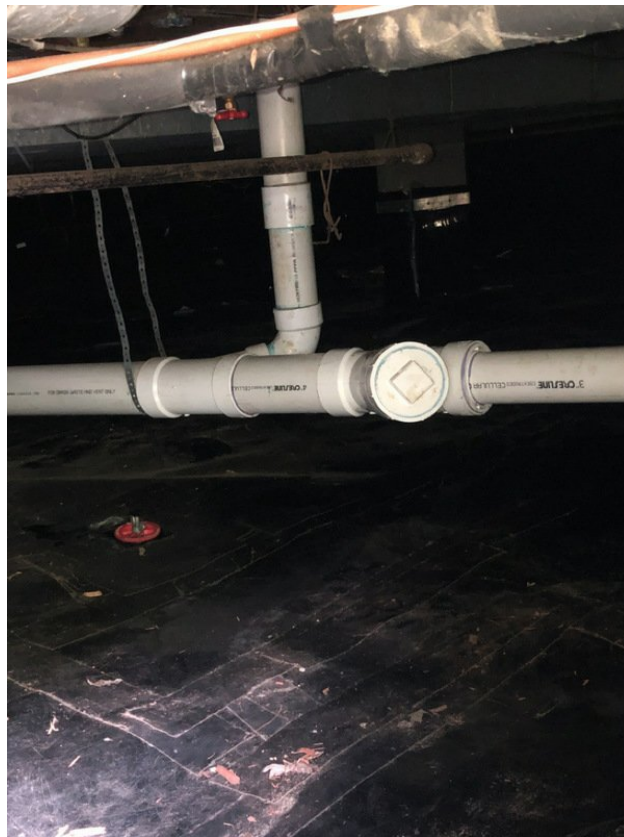
Plumbing Repair Photos

Are plumbing repairs needed?	Yes
Are plumbing repairs on a supply/waste line?	No
Plumbing Repair Location	6ft NE of crawlspace entrance

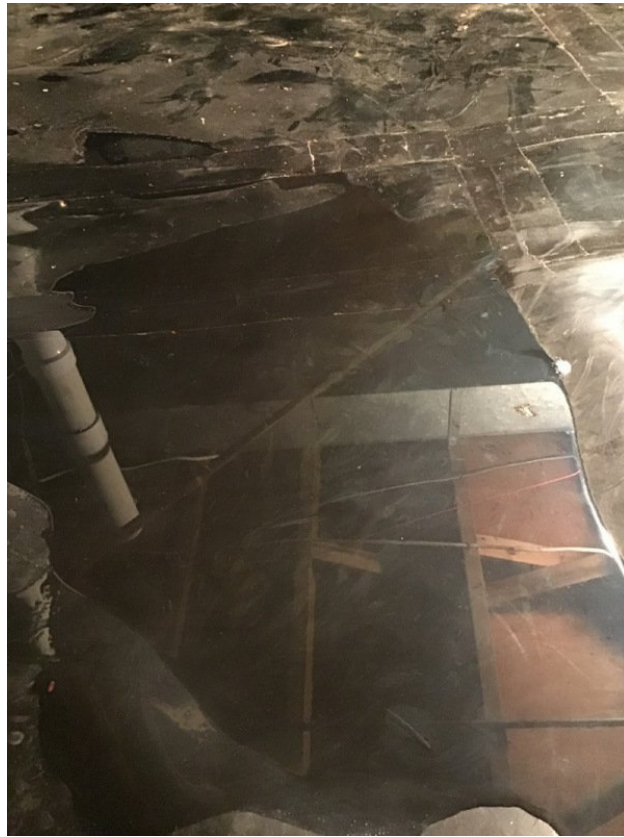
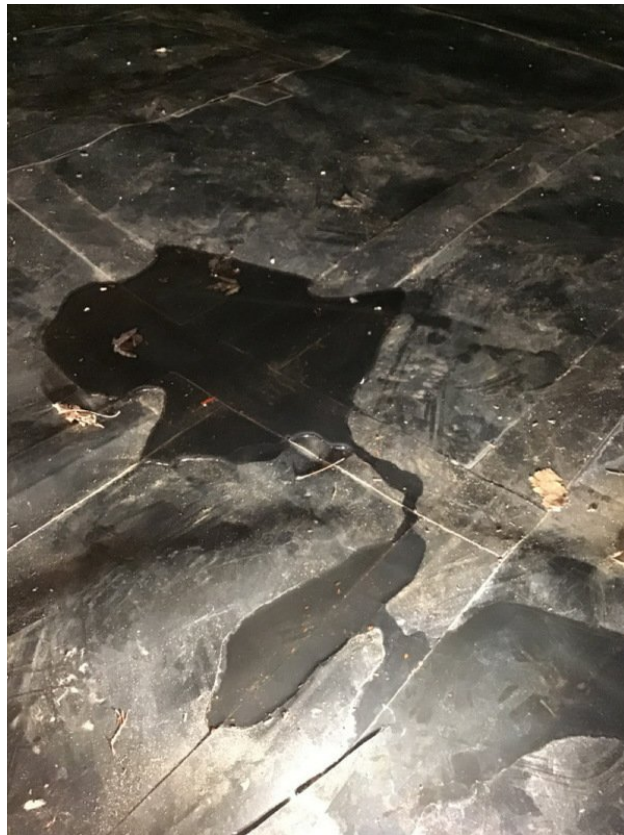
Is water observed on the barrier?	Yes
Location of Water on Barrier	Right of the crawl space entrance
Can the source of water be identified?	Yes

Volume of Water on Barrier (gal)	5
Can water be felt under the barrier?	Yes

Describe Source Location	Seam underwater
Do barrier seams need addition sealing or repair?	Yes
Describe Repair Location and Mark	Under water

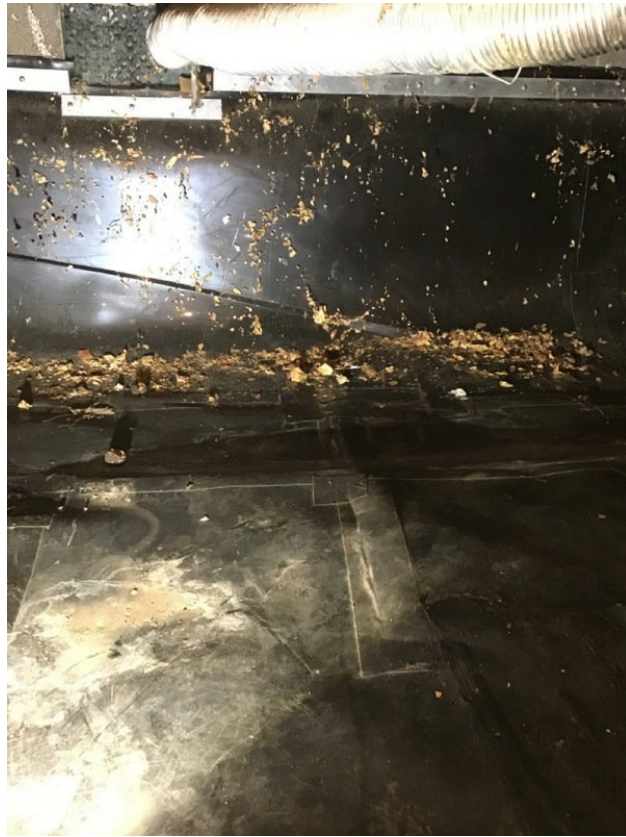
Notes	Evidence of rodents
-------	---------------------

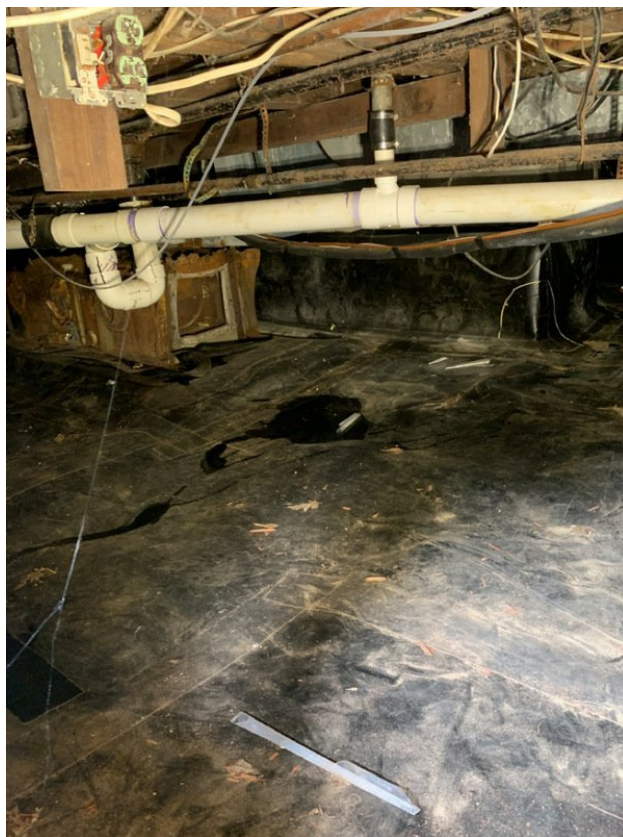
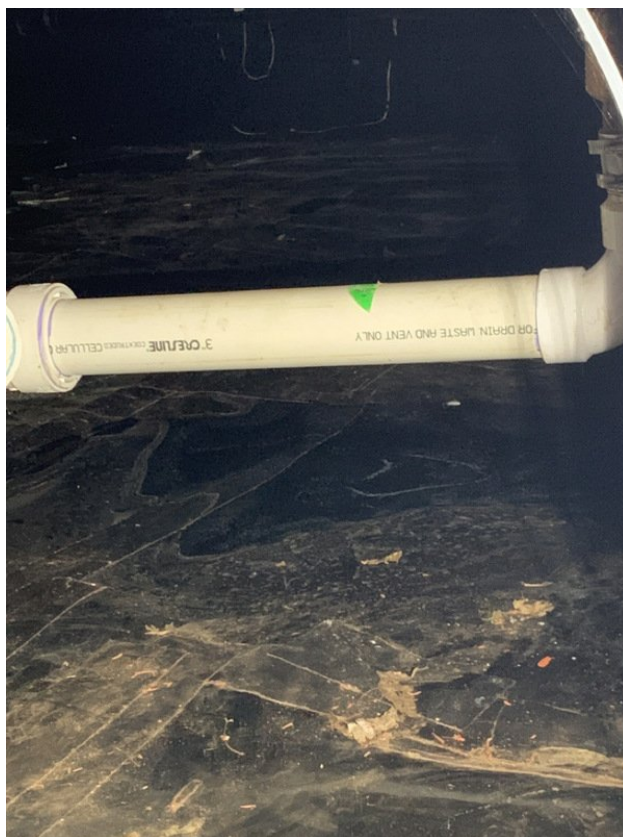
Is water observed on the barrier?	Yes
Location of Water on Barrier	SE and NE in crawl space
Can the source of water be identified?	No

Volume of Water on Barrier (gal)	1
Can water be felt under the barrier?	No

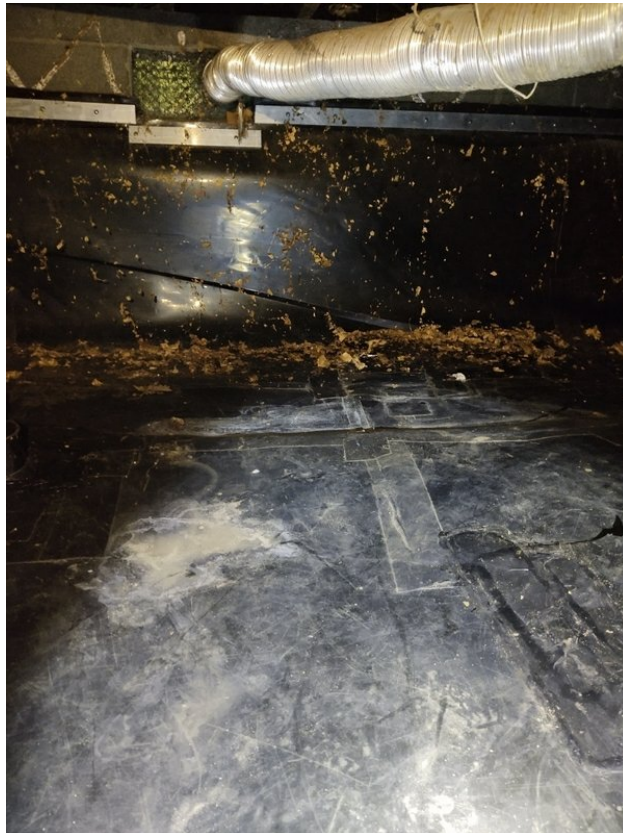
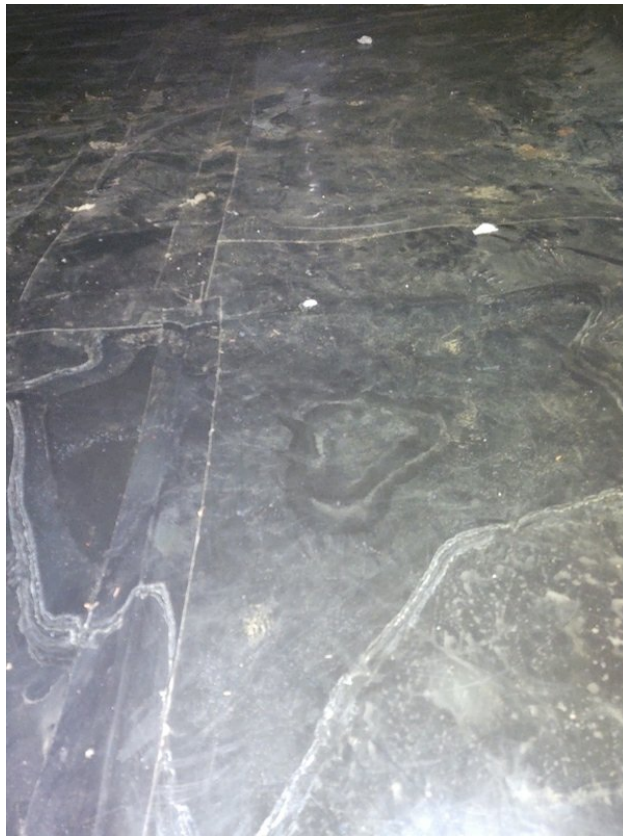
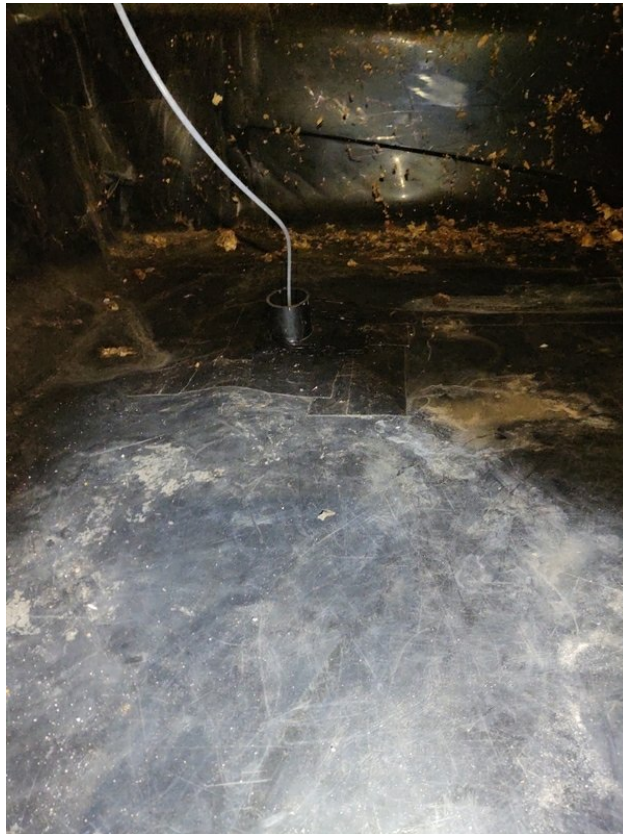
Is water observed on the barrier?	Yes
Location of Water on Barrier	Under sanitary line
Can the source of water be identified?	Yes

Volume of Water on Barrier (gal)	0.1
Can water be felt under the barrier?	No
Describe Source Location	Na
