SUBJECT
Operation, Monitoring, and
Maintenance Field Notes - 34591 Beacon

Attached are the interim preemptive mitigation (IPM) system Operation, Monitoring, and Maintenance (OM&M) field notes. These field notes were recorded during OM&M visits at the property between March 31, 2020 and March 31, 2022. Please let me know if you have any questions.

34591 Beacon, 2020-05-19, Water Inspection

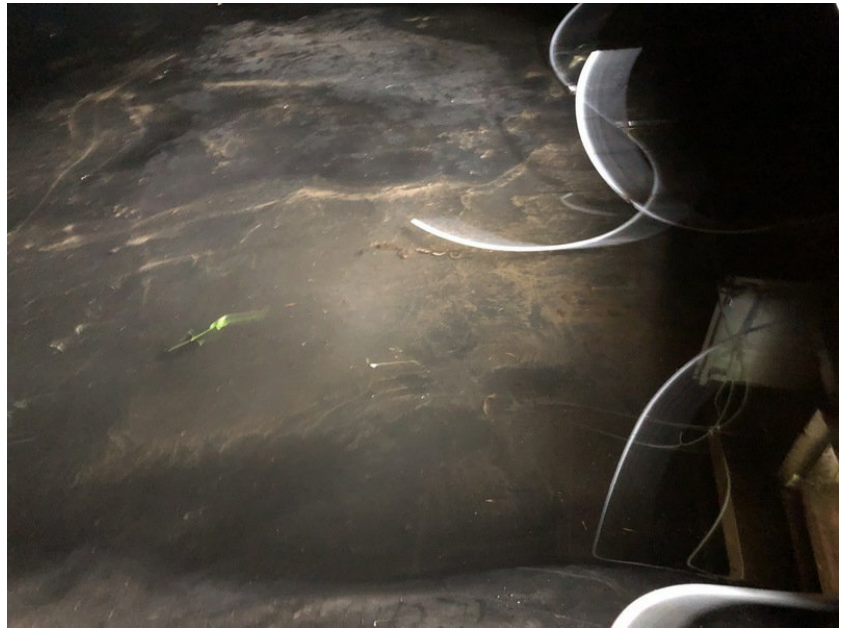
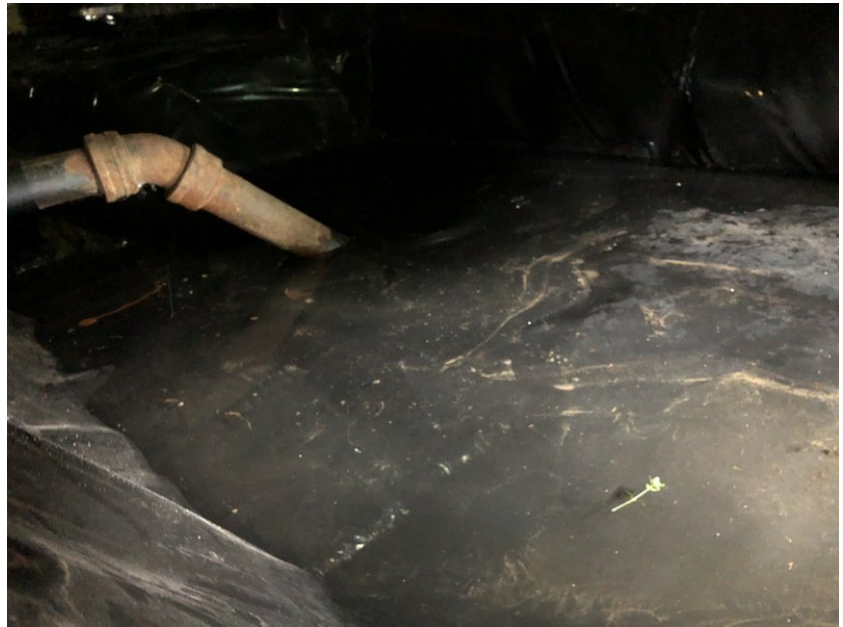
Is water observed on the barrier?	Yes
Location of Water on Barrier	In front of access door and SW low spot
Can the source of water be identified?	Yes

Volume of Water on Barrier (gal)	50
Can water be felt under the barrier?	Yes
Describe Source Location	Runoff through access door and window.
Do barrier seams need addition sealing or repair?	No

Notes Water will need to be removed on future date.

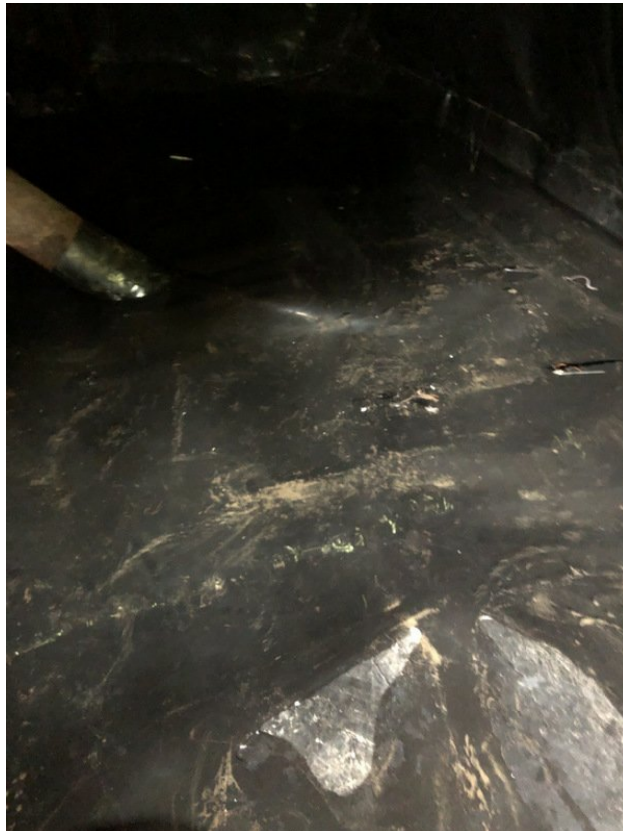
Is water observed on the barrier?	Yes
Location of Water on Barrier	In front of access door and SW corner
Can the source of water be identified?	Yes

Volume of Water on Barrier (gal)	100
Can water be felt under the barrier?	Yes
Describe Source Location	Peeled up tape underneath control panel box.
Do barrier seams need addition sealing or repair?	Yes
Describe Repair Location and Mark	Under control panel box

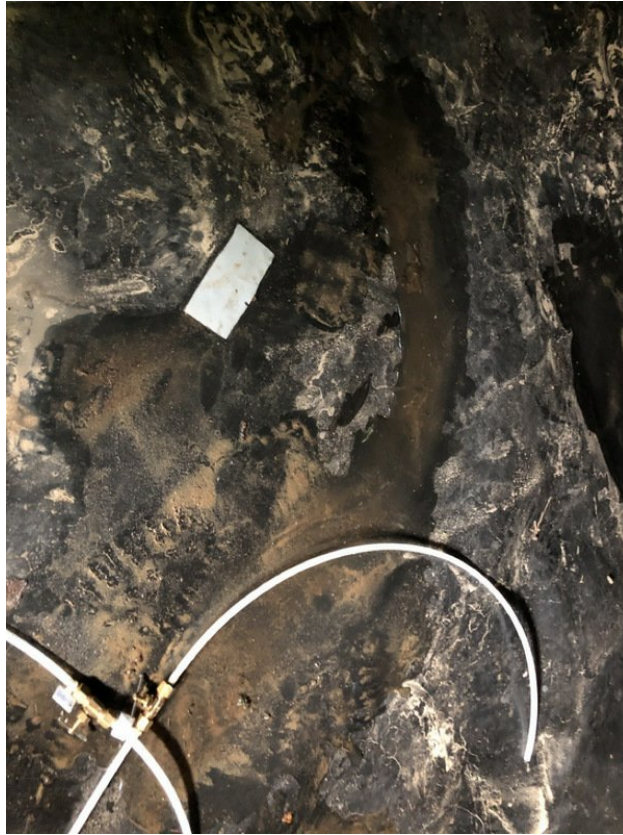
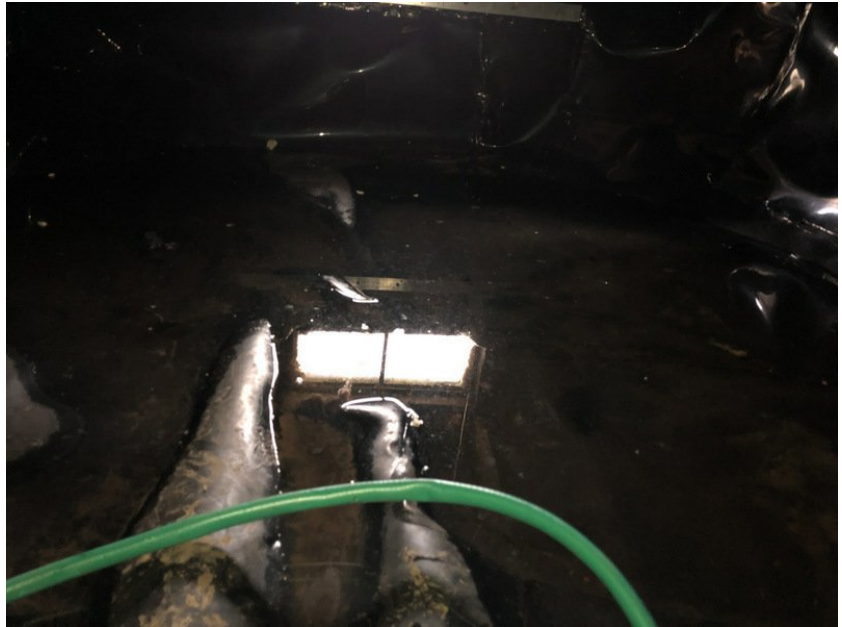
Is water observed on the barrier?	Yes
Location of Water on Barrier	In front of access door and SW low area
Can the source of water be identified?	Yes

Volume of Water on Barrier (gal)	26
Can water be felt under the barrier?	No
Describe Source Location	Window and door
Do barrier seams need addition sealing or repair?	No

Has water been removed today?	Yes
How much water was removed?	26 gallons

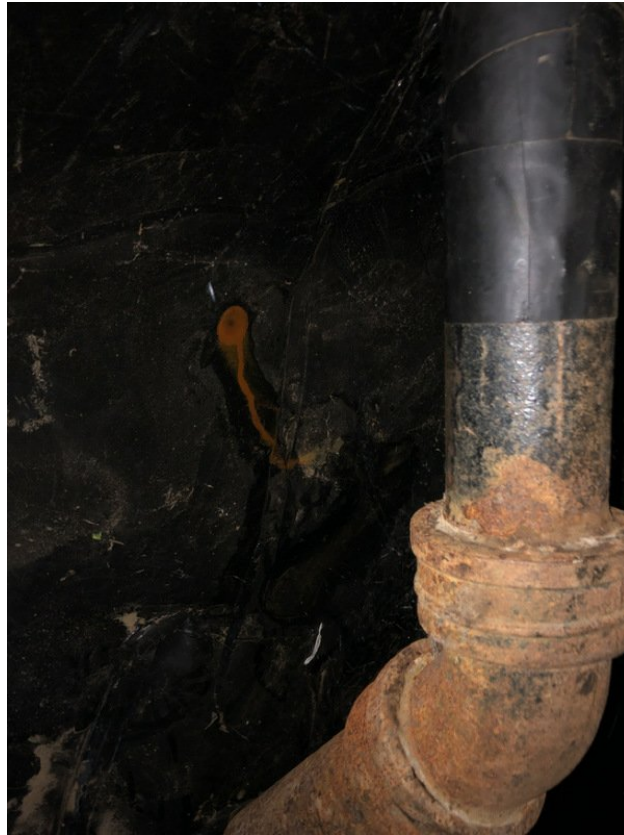
Plumbing Repair Photos

Are plumbing repairs needed?	Yes
Are plumbing repairs on a supply/waste line?	Yes
Plumbing Repair Location	In front of access door

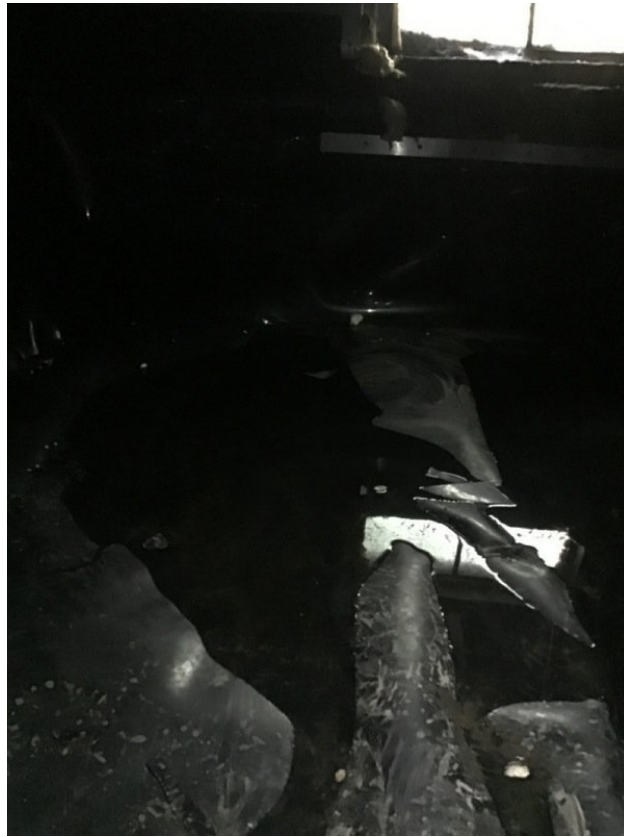
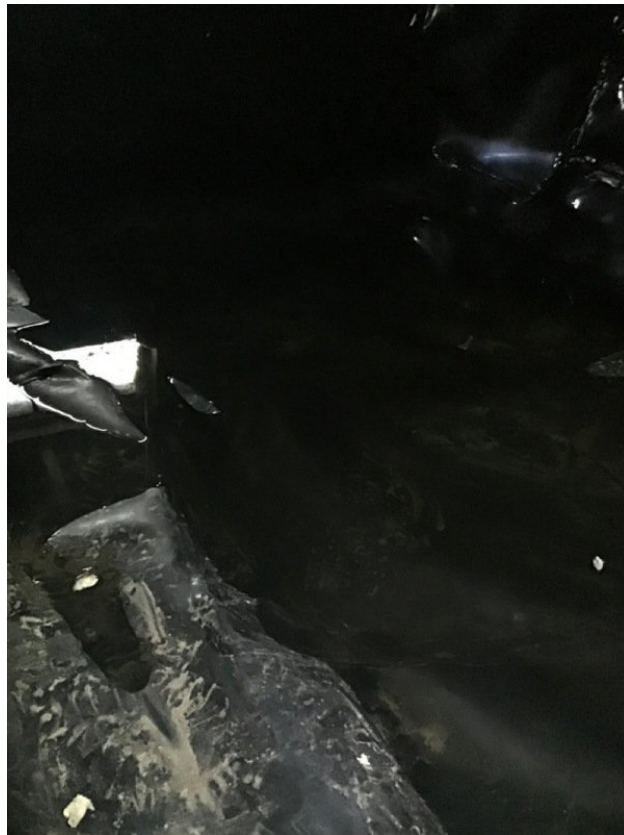
Is water observed on the barrier?	Yes
Location of Water on Barrier	Back bath tub
Can the source of water be identified?	No

Volume of Water on Barrier (gal)	20
Can water be felt under the barrier?	No

Repair Status	Possible window sealing, discuss with team
---------------	--

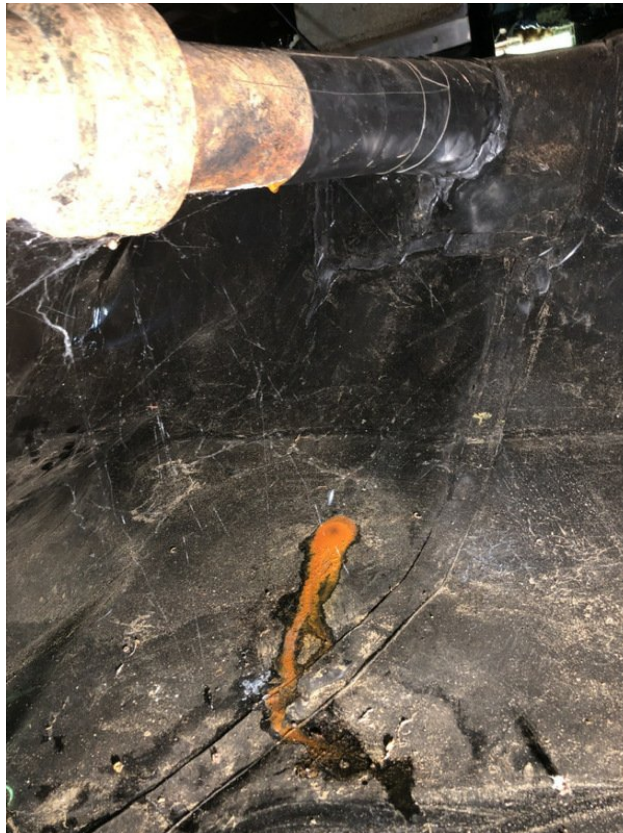
Is water observed on the barrier?	Yes
Location of Water on Barrier	Under the metal pipe near crawlspace entrance
Can the source of water be identified?	Yes

Volume of Water on Barrier (gal)	0.05
Can water be felt under the barrier?	No
Describe Source Location	Rusted metal sanitary pipe
Do barrier seams need addition sealing or repair?	Yes
Describe Repair Location and Mark	Metal pipe at tape

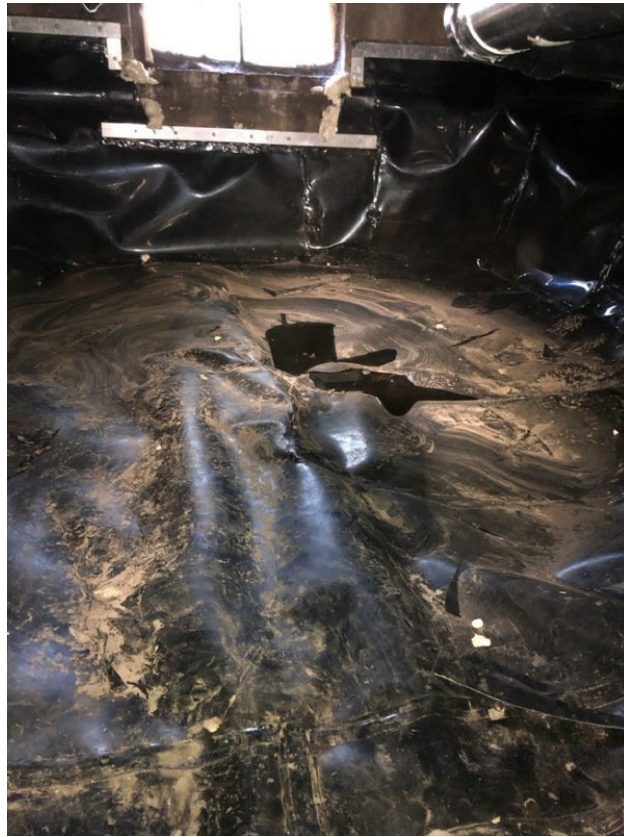
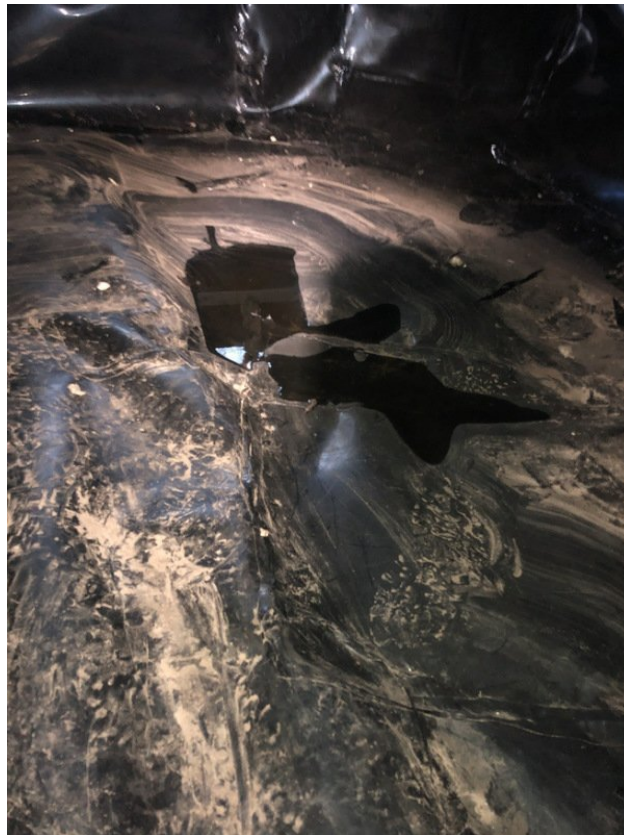
Is water observed on the barrier?	Yes
Location of Water on Barrier	West most area of crawlspace.
Can the source of water be identified?	Yes

Volume of Water on Barrier (gal)	0.1
Can water be felt under the barrier?	No

Describe Source Location	It's running from window that is partially below grade.
Do barrier seams need addition sealing or repair?	No

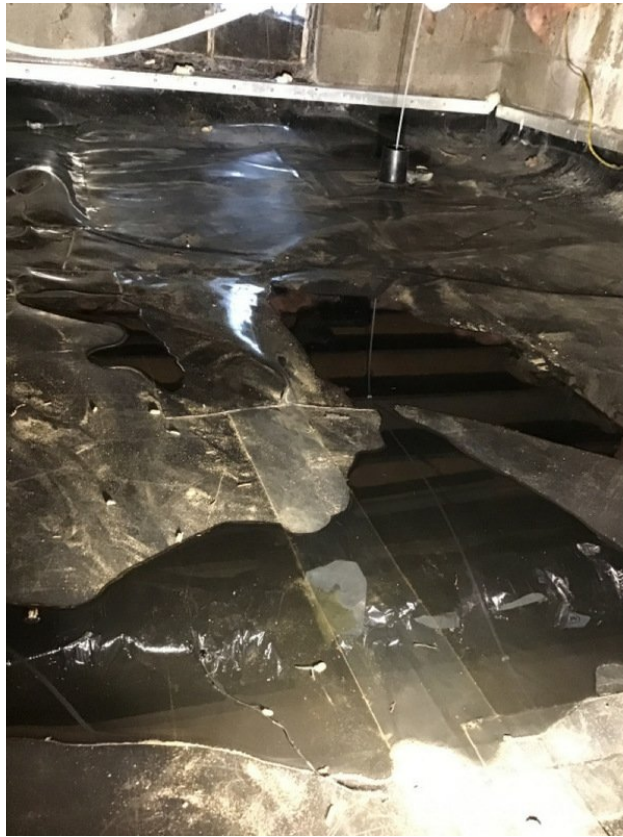
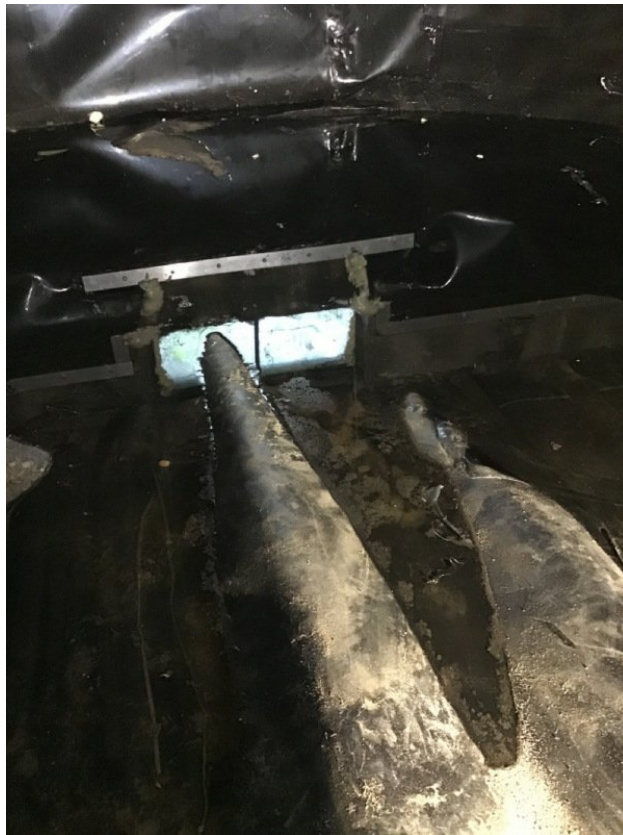
Is water observed on the barrier?	Yes
Location of Water on Barrier	Far bathtub & opposite of entrance
Can the source of water be identified?	Yes

Volume of Water on Barrier (gal)	30
Can water be felt under the barrier?	Yes

Describe Source Location	Window and small seam under water
Do barrier seams need addition sealing or repair?	Yes
Describe Repair Location and Mark	Small seam opposite entrance

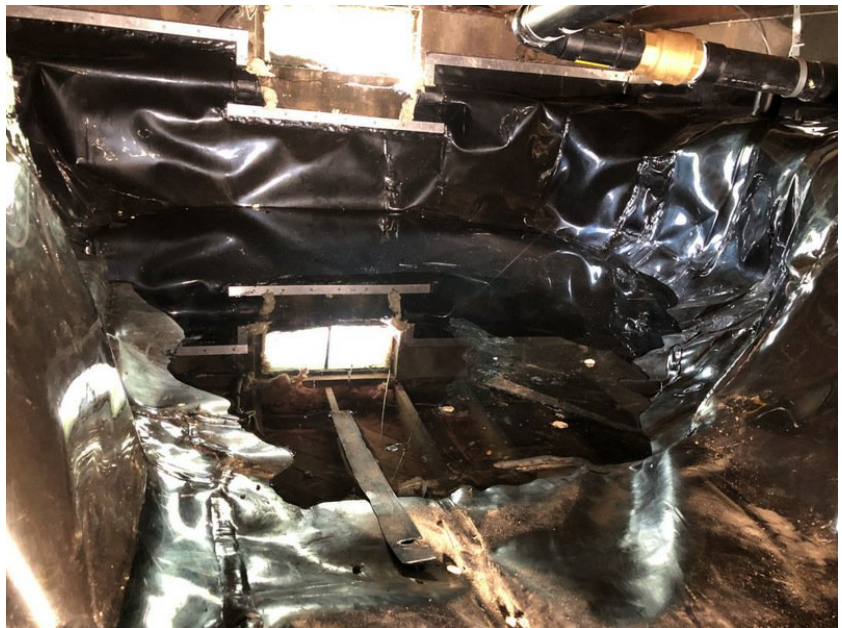
Is water observed on the barrier?	Yes
Location of Water on Barrier	Southwest corner (bathtub)
Can the source of water be identified?	Yes

Volume of Water on Barrier (gal)	100
Can water be felt under the barrier?	No
Describe Source Location	Window
Do barrier seams need addition sealing or repair?	No

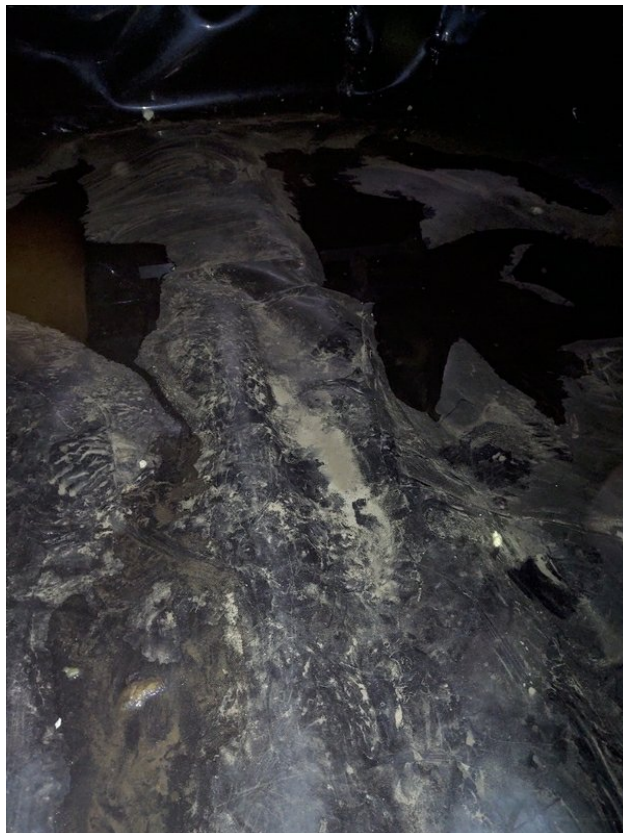
Is water observed on the barrier?	Yes
Location of Water on Barrier	Front right corner of house
Can the source of water be identified?	No

Volume of Water on Barrier (gal)	10
Can water be felt under the barrier?	No
Do barrier seams need addition sealing or repair?	No

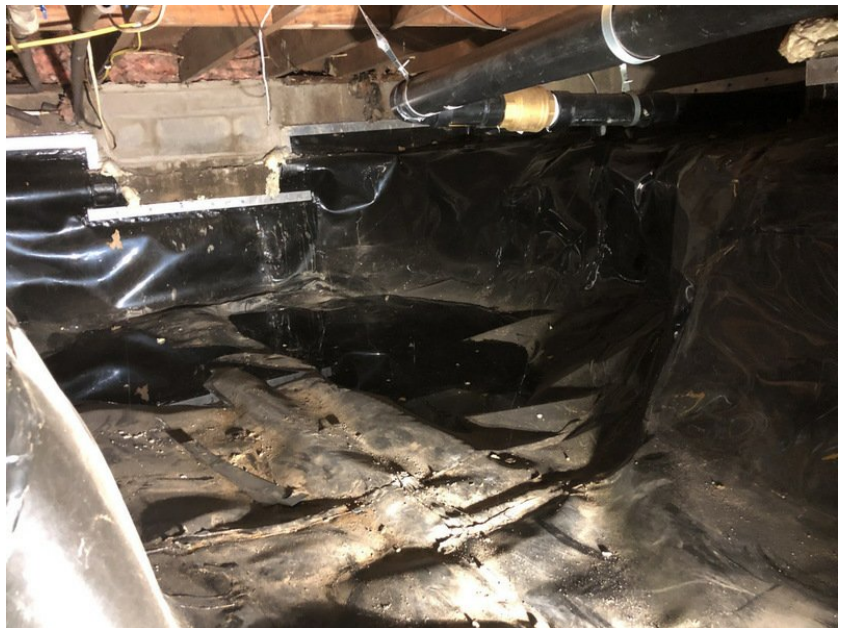
Is water observed on the barrier?	Yes
Location of Water on Barrier	Back "bath tub" area
Can the source of water be identified?	No

Volume of Water on Barrier (gal)	15
Can water be felt under the barrier?	No
Do barrier seams need addition sealing or repair?	No

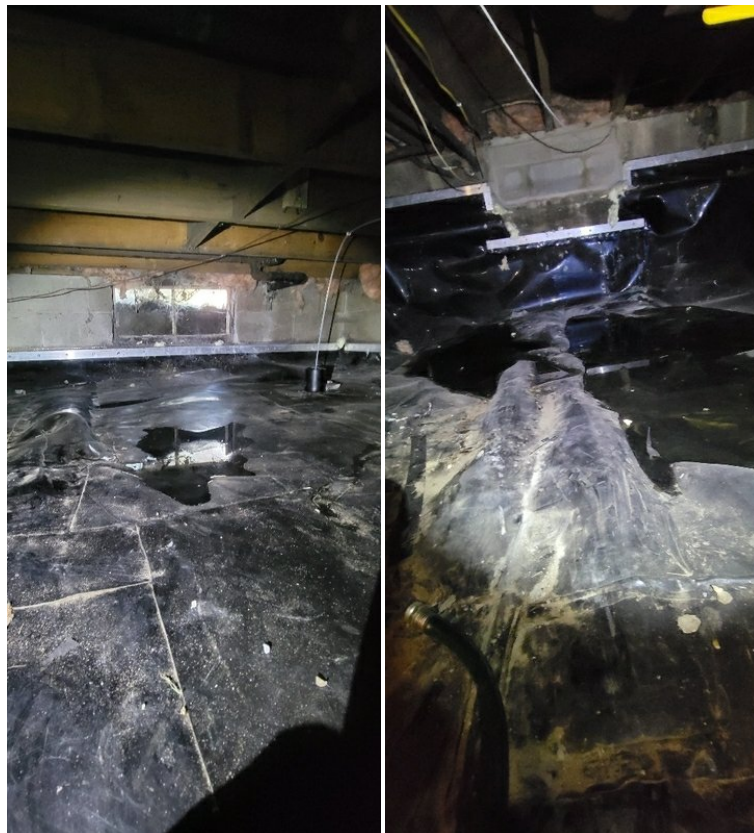
Is water observed on the barrier?	Yes
Location of Water on Barrier	Back of crawlspace
Can the source of water be identified?	Yes

Volume of Water on Barrier (gal)	8
Can water be felt under the barrier?	No
Describe Source Location	Crawlspace window
Do barrier seams need addition sealing or repair?	No

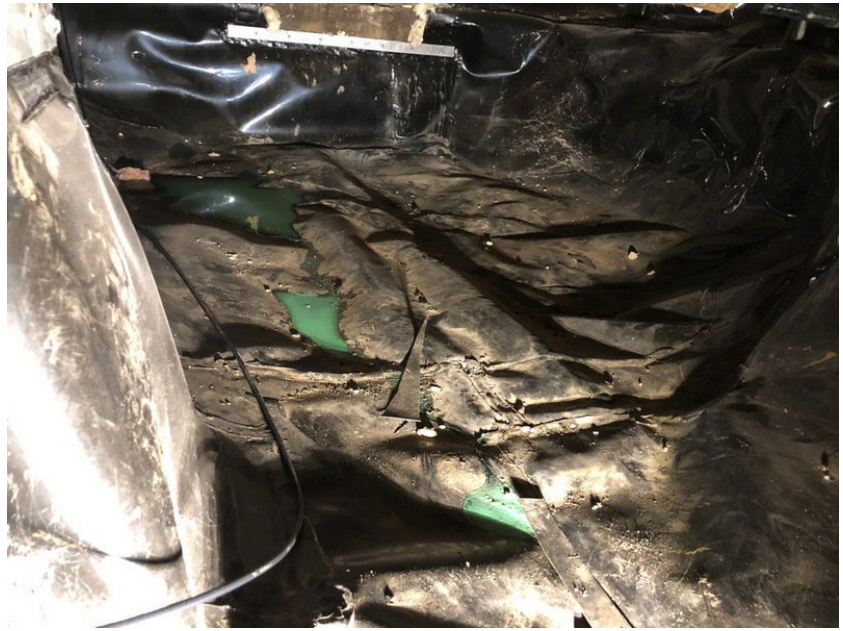
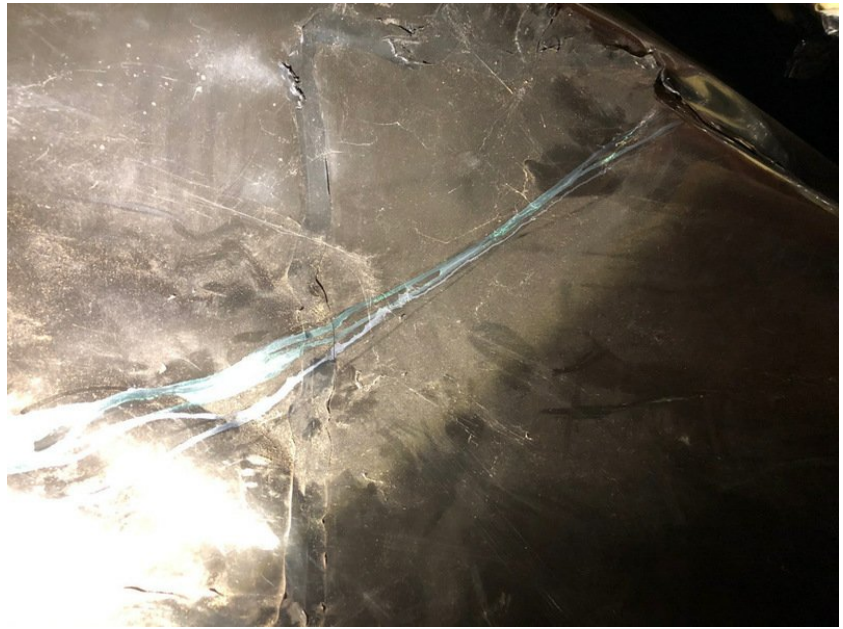
Is water observed on the barrier?	Yes
Location of Water on Barrier	SW corner "bathtub"
Can the source of water be identified?	No

Volume of Water on Barrier (gal)	2
Can water be felt under the barrier?	No
Do barrier seams need addition sealing or repair?	No
