Transmittal Letter

acon 48150 IC COPIES TO chlaufman (EGLE on (Ford)	FROM Kristoffer Hinskey 248-994-2240 kristoffer.hinskey@arcadis.com DATE October 4, 2022			
PROJECT N 30146655	UMBER	SUBJECT Operation, Monitoring, and Maintenance (OM&M) Field Notes – 34600 Beacon			
We are se	ending you:				
Copies	Delivery Date	Description			
1	10/6/2022	Operation, monitoring, and maintenance field notes.			
☐ AN Ap	oproved oproved as Noted s Requested	□ CR Correct and Resubmit □ Resubmit Copies □ F File □ Return Copies □ FA For Approval □ Review and Comment			
Mailing M	ethod				
 U.S. Postal Service 1st Class □ Courier/Hand Delivery □ FedEx Priority Overnight □ FedEx 2-Day Delivery □ Certified/Registered Mail □ United Parcel Service (UPS) □ FedEx Standard Overnight □ FedEx Economy □ Other: Email

Comment	s:				
field note	s. These field not	reemptive mitigation (IPM) system Operation, Monitoring, and Maintenance (OM&M) es were recorded during OM&M visits at the property between March 31, 2020 and t me know if you have any questions.

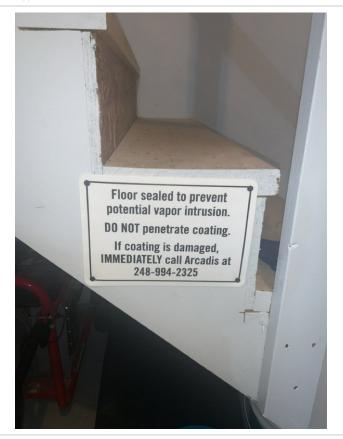
Garage Retrocoat Label Photos

Are labels present at the garage retrocoat?

Yes

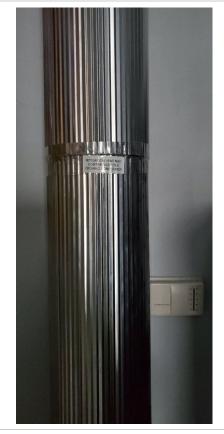
Common Label Photos

Are labels present at the pipe, control panel, utube, and breaker?

Yes

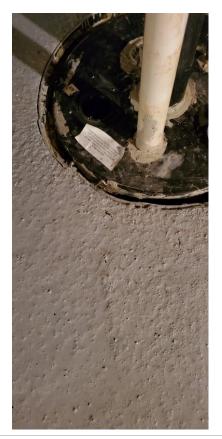
Sump Label Photos

Are labels present at the sump?

Yes

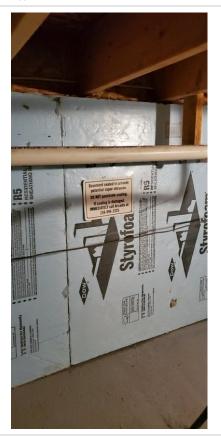
Basement Retrocoat Label Photos

Are labels present at the basement retrocoat?

Yes

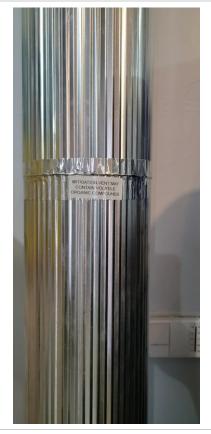
Common Label Photos

Are labels present at the pipe, control panel, utube, and breaker?

Yes

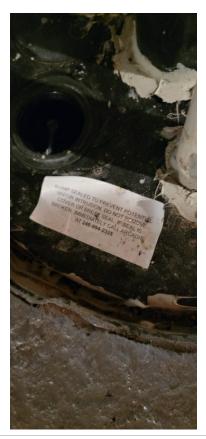
Sump Label Photos

Are labels present at the sump?

Yes

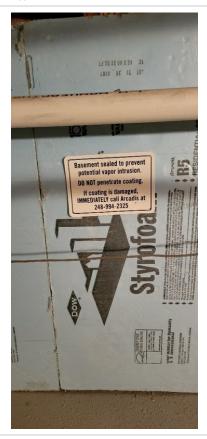
Basement Retrocoat Label Photos

Are labels present at the basement retrocoat?

Yes
