# **Transmittal Letter**

PROJECT NUMBER 30146655 FROM Kristoffer Hinskey 248-994-2240 <u>kristoffer.hinskey@arcadis.com</u>

**SUBJECT** Operation, Monitoring, and Maintenance Field Notes - 34644 Beacon

## 34644 Beacon, 2020-11-16, Full System Inspection

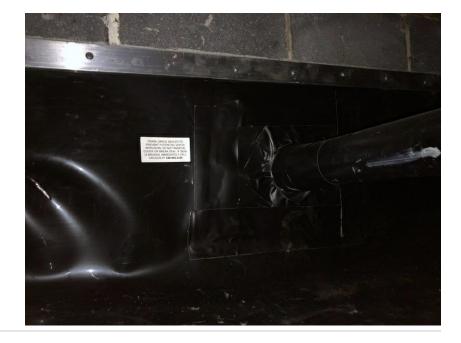
Inaccessible Crawlspace Label Photos

Are labels present at the inaccessible crawlspace? Yes

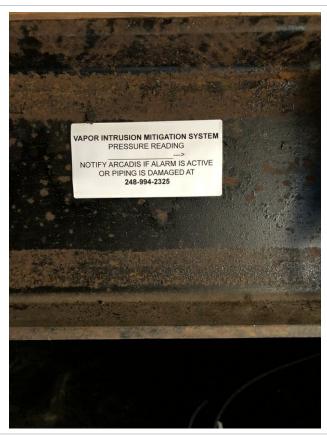
Common Label Photos

Are labels present at the pipe, control panel, u-Yes tube, and breaker?

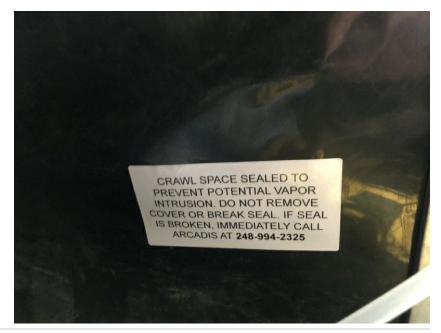
Garage Retrocoat Label Photos

Are labels present at the garage retrocoat?

No

No Retro-coat

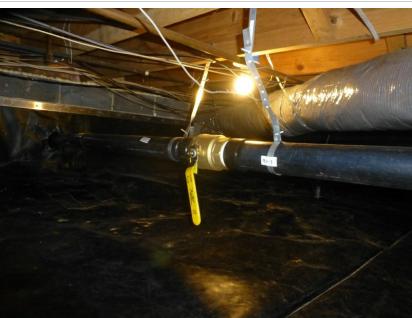
Inaccessible Crawlspace Label Photos

#### Are labels present at the inaccessible crawlspace?

No

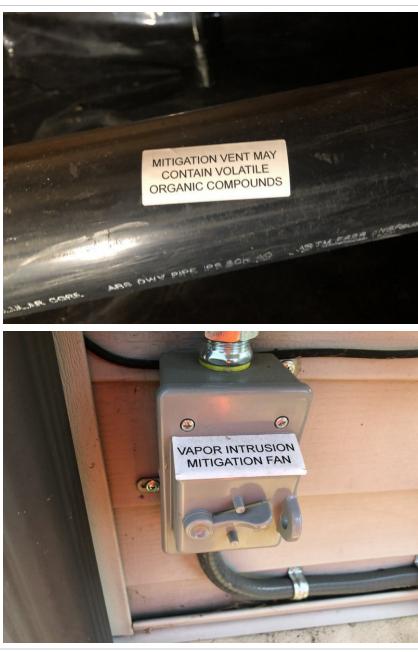
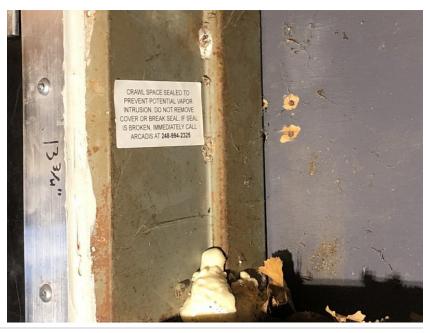
Common Label Photos

Are labels present at the pipe, control panel, u-Yes tube, and breaker?

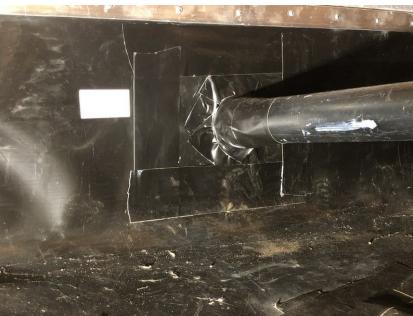
Inaccessible Crawlspace Label Photos

Are labels present at the inaccessible crawlspace?

Yes

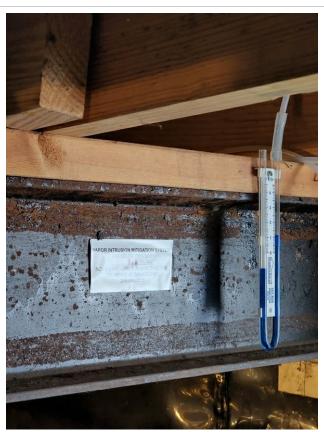
Common Label Photos

Are labels present at the pipe, control panel, u-Yes tube, and breaker?

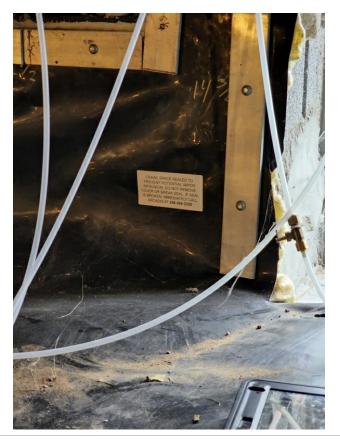
Are labels present at the crawlspace barrier?

Yes

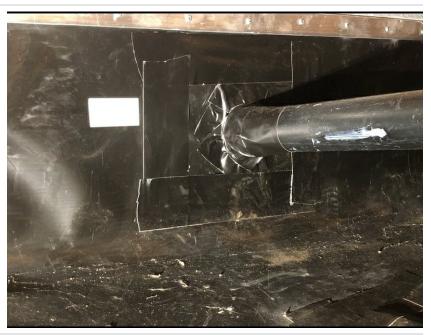
Inaccessible Crawlspace Label Photos

Are labels present at the inaccessible crawlspace? Yes
