# **Transmittal Letter**

**SUBJECT** Operation, Monitoring, and Maintenance Field Notes - 34920 Beacon

# 34920 Beacon, 2020-11-11, Full System Inspection

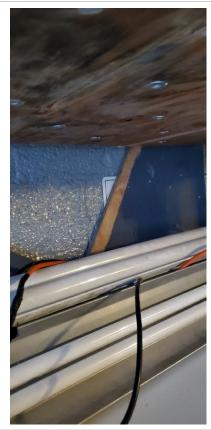
Garage Retrocoat Label Photos

Are labels present at the garage retrocoat?	Yes
Are labels present at the crawlspace barrier?	Yes

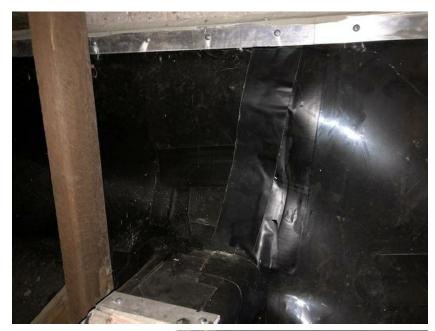
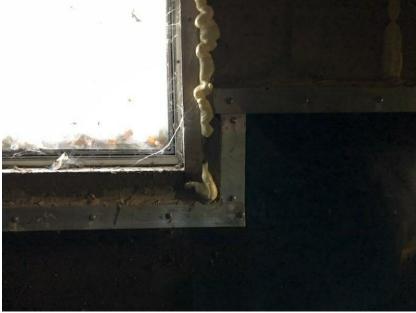
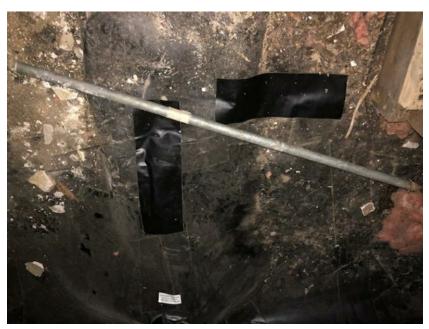
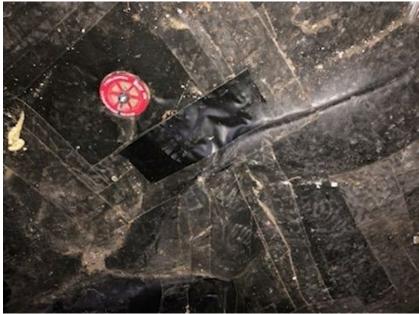
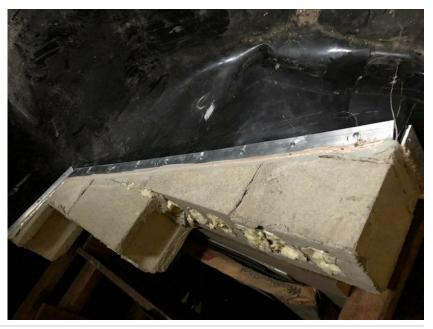
Sealing Repair Photos

0	
Sensaphone Link	N/A
Repairs	
Sample Delay	
Send Sample Delay Email	N/A
email body	
Repair Completion	
Were seam repairs completed during this visit?	Yes
Were system repairs completed during this visit?	No
Additional sealing completed:	Taped and sealed seams
Sealing Completion Date	2020-11-17
Caalina Danain Dhataa

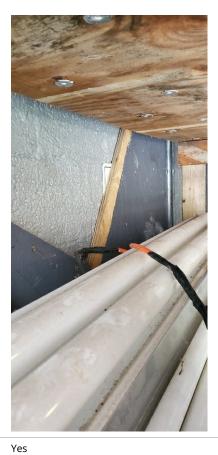
Garage Retrocoat Label Photos

#### Are labels present at the garage retrocoat?

Yes

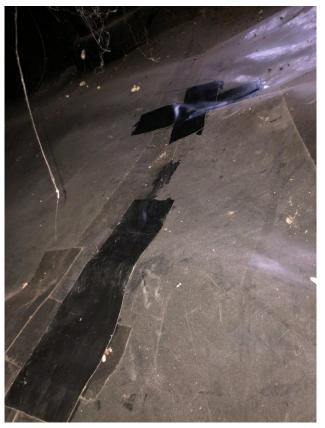
Sample Belay	
Send Sample Delay Email	N/A
email body	
Repair Completion	
Were seam repairs completed during this visit?	Yes
Were system repairs completed during this visit?	No
Additional sealing completed:	Taping of seams
Sealing Completion Date	2021-02-15

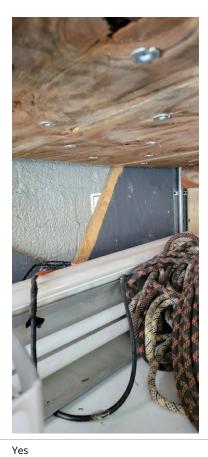
Garage Retrocoat Label Photos

Are labels present at the garage retrocoat?

Yes

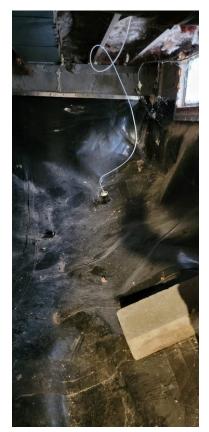
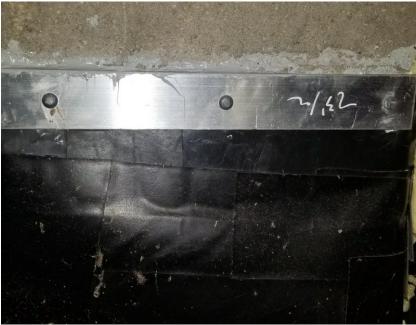
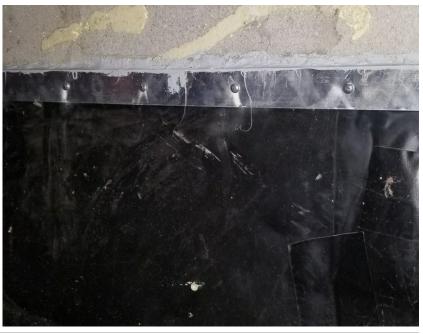
Sealing Repair Photos

• •	
Were seam repairs completed during this visit?	Yes
Were system repairs completed during this visit?	No
Additional sealing completed:	Tape repairs by MP-3. Sikaflex applied above batten bar on west side of crawlspace.
Sealing Completion Date	2022-01-25
