**SUBJECT**

Ford Livonia Transmission Plant -  
Quarterly Residential Mitigation Update Letter  
36200 Plymouth Road, Livonia,  
Wayne County, Michigan  
EGLE Site ID No. 82002970

October 31, 2023

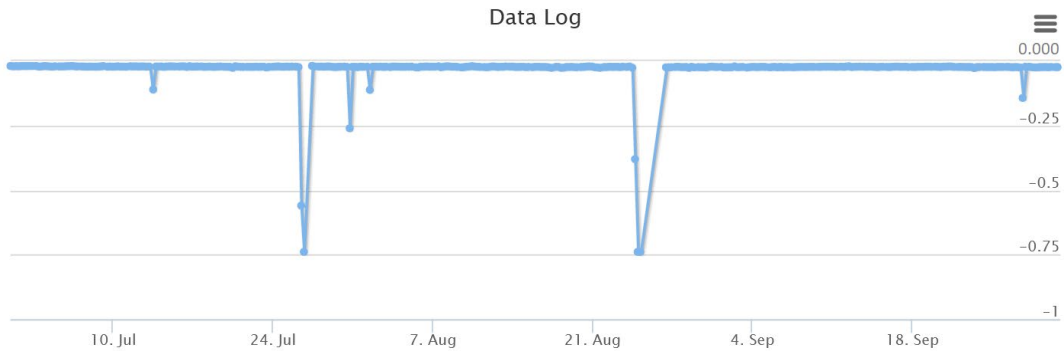
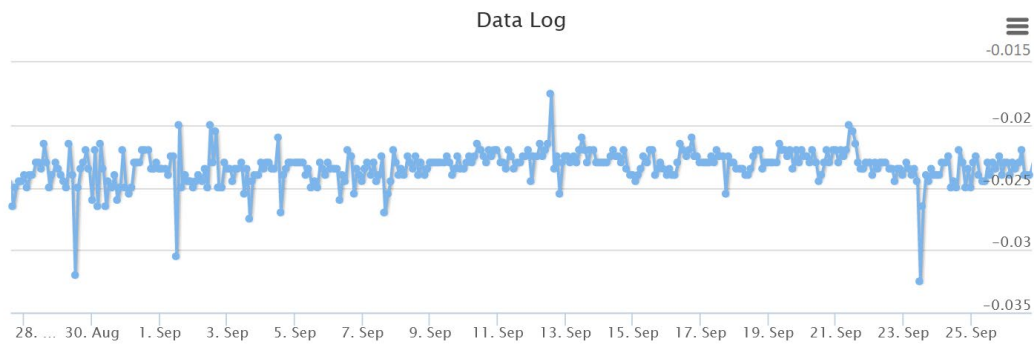
An update of the data logged by the vacuum transmitter connected to SSMP-1 is presented below.

A zoomed in portion of the data logged shows the system continued to operate effectively.

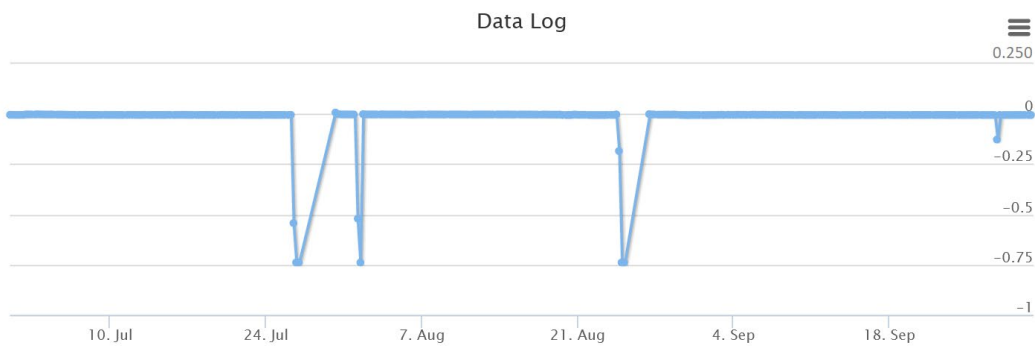
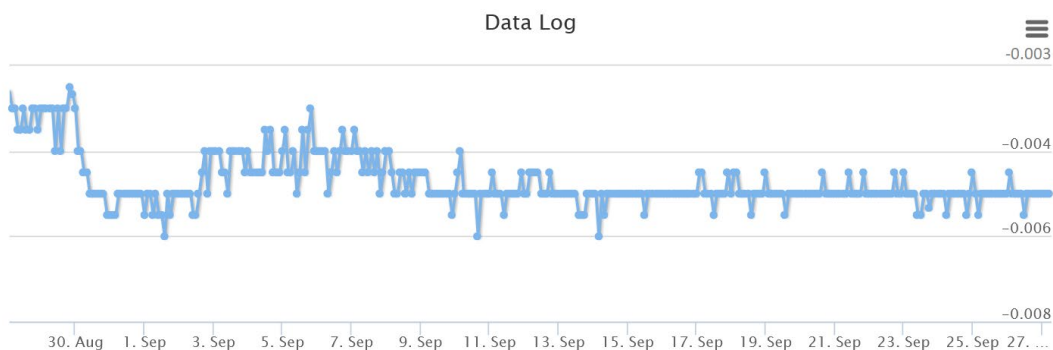
An update of the data logged by the continuously monitored vacuum transmitter connected to sub-membrane monitoring point MP-5 is presented below.

A zoomed in portion of the data logged shows the system continued to operate effectively.

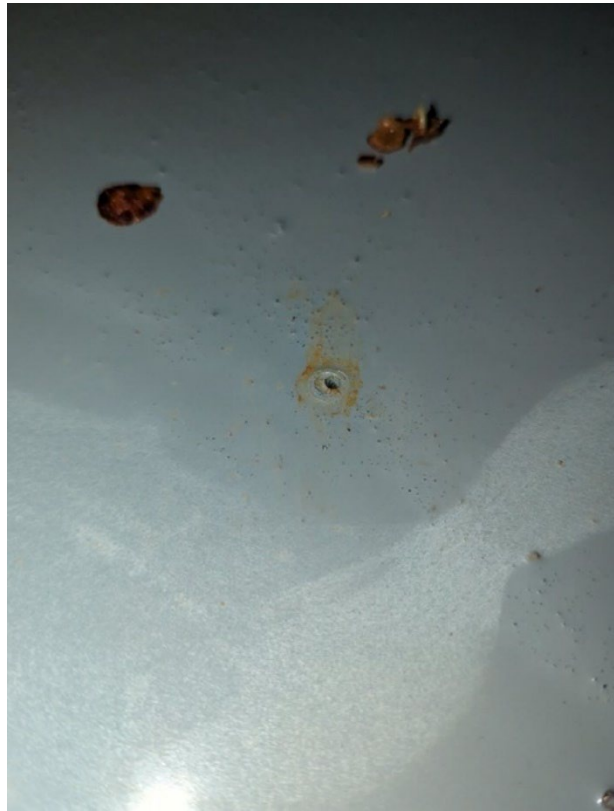
On September 21, 2023, the homeowner reached out to Arcadis providing photographs of the basement floor showing dried red-brown deposits forming on the Retro-coat®. Arcadis scheduled an inspection with the homeowner on September 25, 2023. Arcadis inspected the dried deposits on the Retro-coat® floor, gently scraped away the deposits, and noted there was a depression under the dried deposit. The eleven deposits and depressions are located in the north-west corner of the basement. Arcadis collected photographs and took measurements of the deposits and depressions in the Retro-coat®. The information was provided to the installation contractor. The installation contractor engaged Land Science and discussed the root cause and repair procedures.

**Picture 1** – Deposits and depressions on the Retro-coat®.

On October 24, 2023, the installation contractor contacted Arcadis with the remedy to repair the issues in the Retro-coat®. The areas where the deposits and depressions were observed are proposed to be grinded down to concrete, followed by Primer MV (high moisture primer) and Retro-coat® reapplication. Arcadis is scheduling this repair work with the homeowner and contractor.

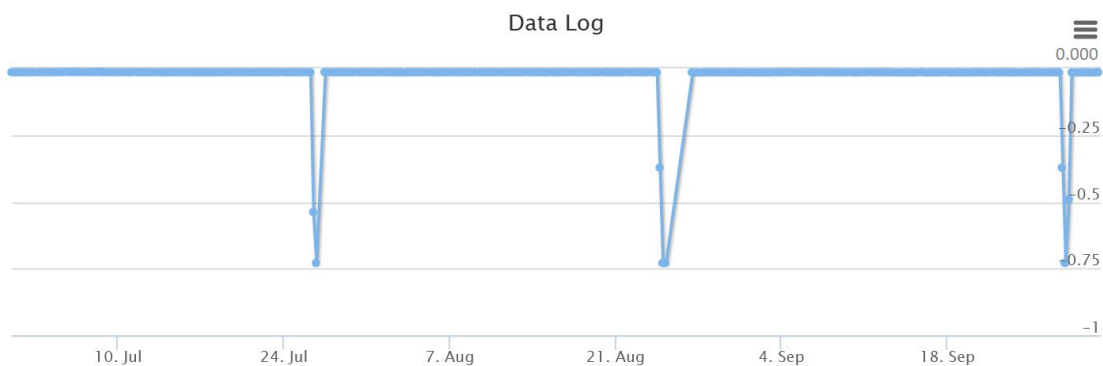
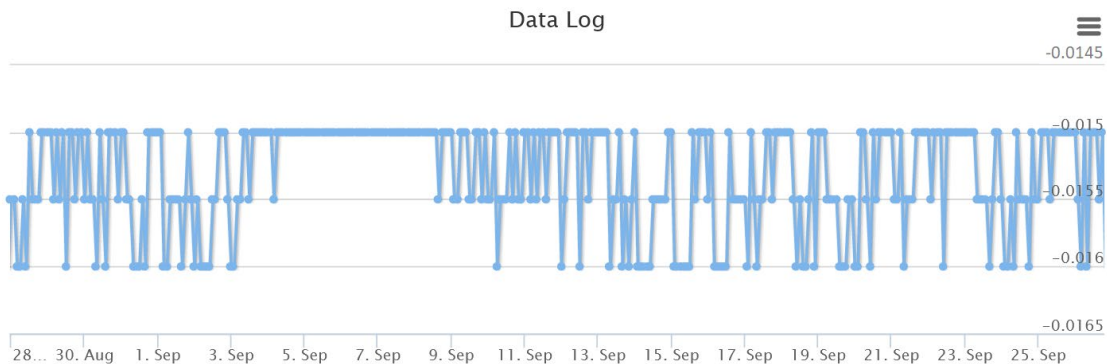
A zoomed in portion of the data logged shows the system continued to operate effectively.

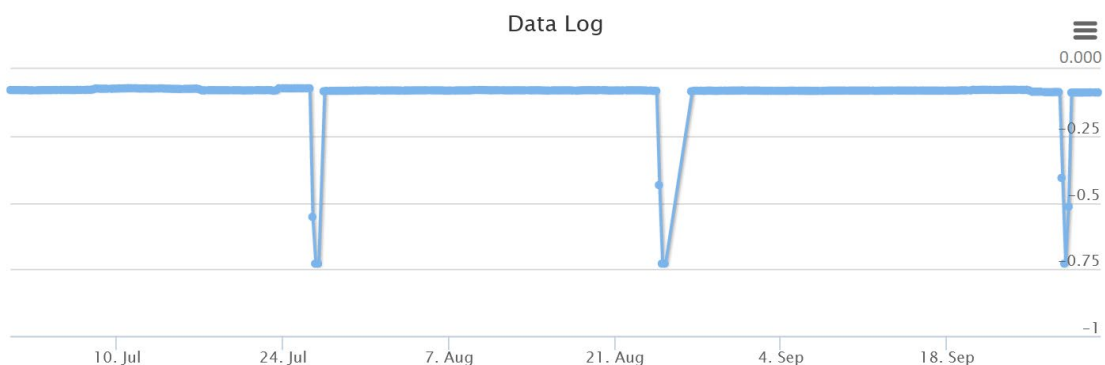
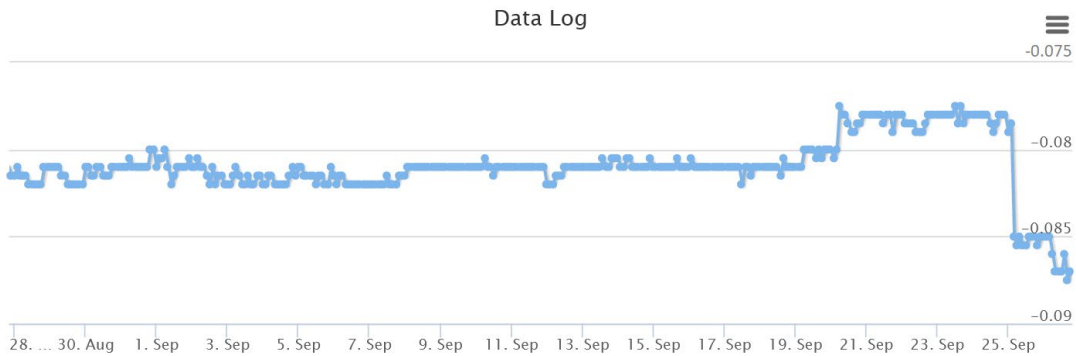
An update of the data logged by the vacuum transmitter connected to MP-1 is presented below.

A zoomed in portion of the data logged shows the system continued to operate effectively.

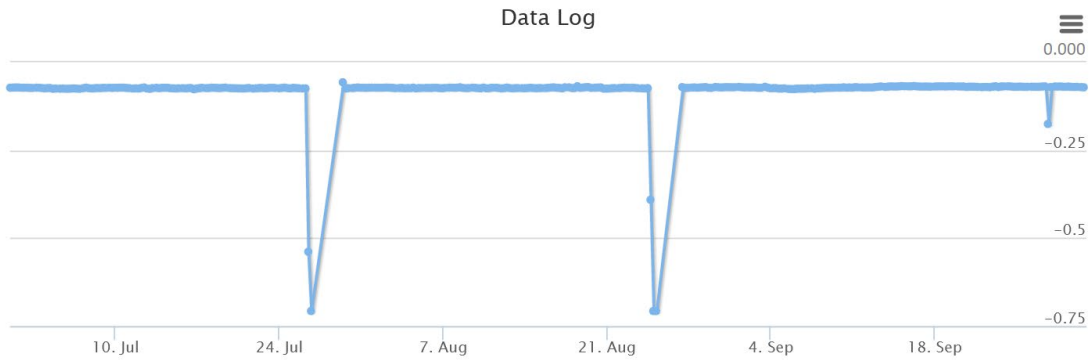
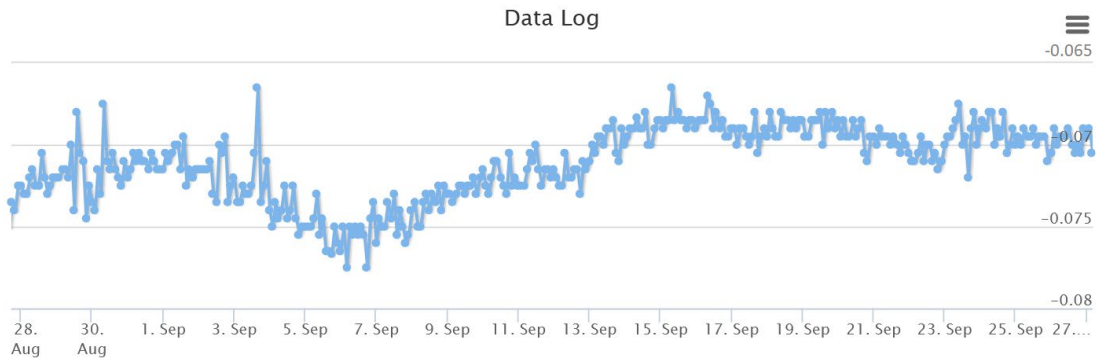
A zoomed in portion of the data logged shows the system continued to operate effectively.

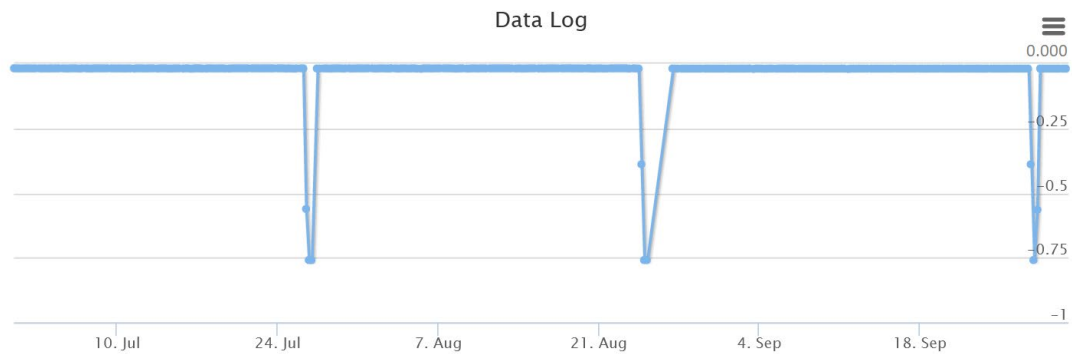
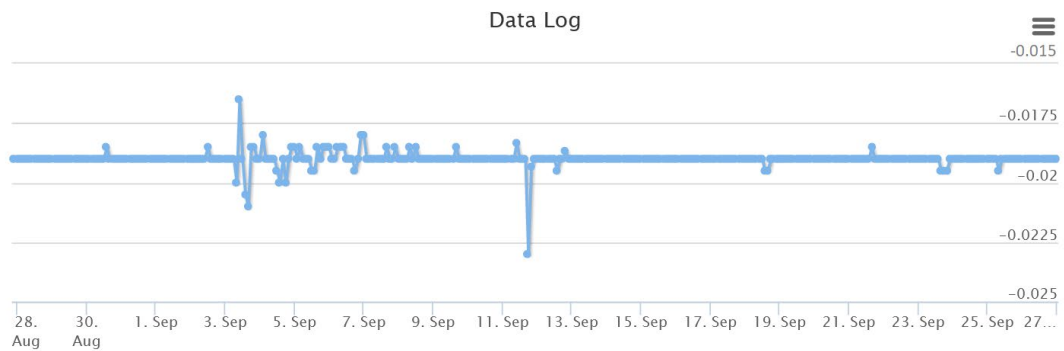
A zoomed in portion of the data logged shows the system continued to operate effectively.

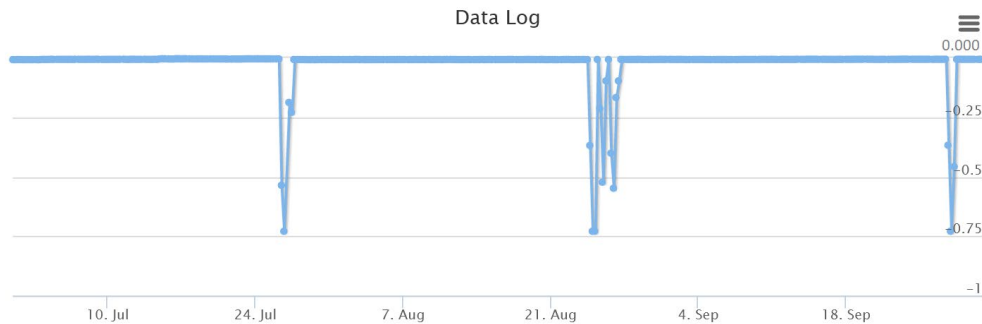
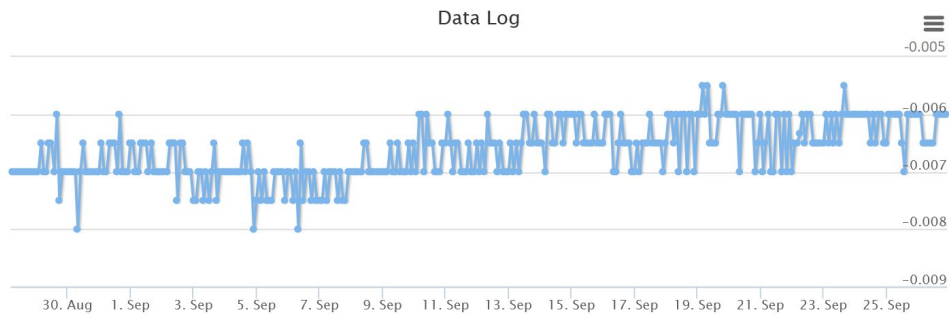
A zoomed in portion of the data logged shows the system continued to operate effectively.

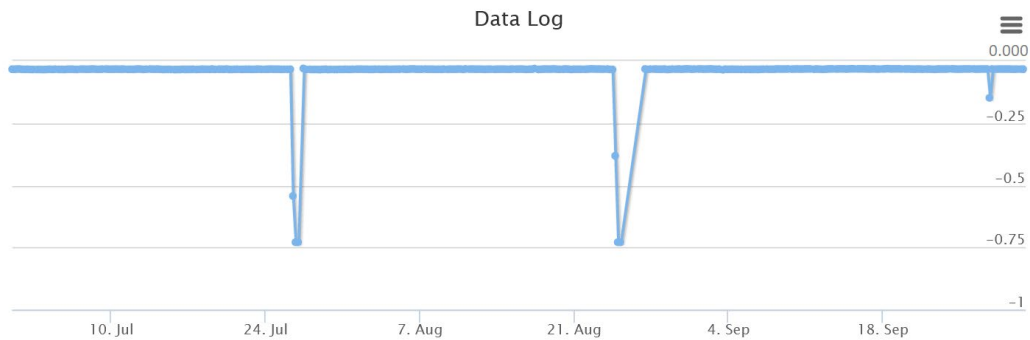
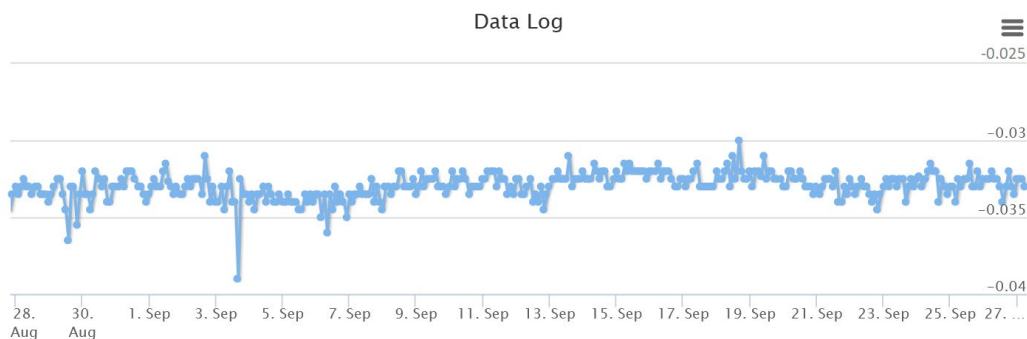
A zoomed in portion of the data logged shows the system continued to operate effectively.

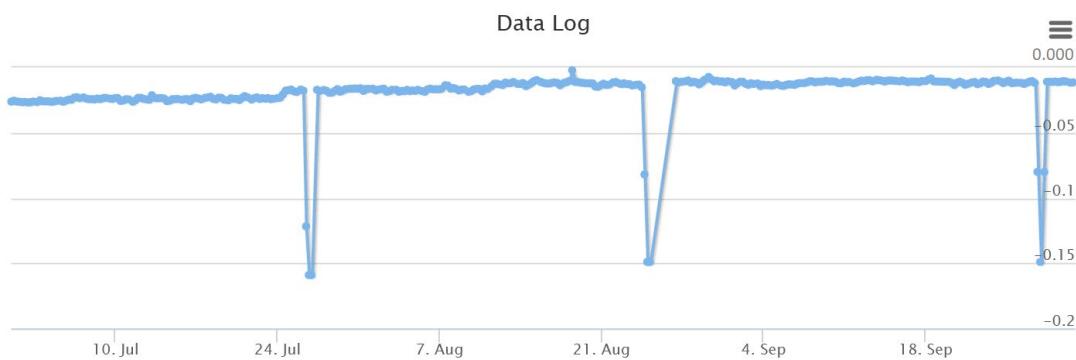
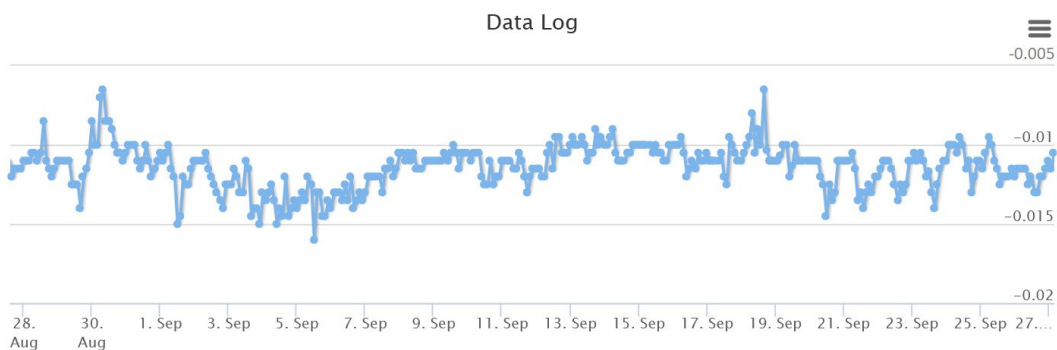
- **34480 Capitol Avenue** – The system is currently in operation and is being maintained and monitored. The third annual OM&M event was completed on August 11, 2023. All monitoring points achieved the performance metric established by EGLE of -0.02 in wc except SSMP-2 which is being continuously monitored by a vacuum transmitter. During the monitoring event, Arcadis recalibrated the vacuum transmitter. An update of the data logged by the vacuum transmitter connected to SSMP-2 is presented below.

A zoomed in portion of the data logged shows the system continued to operate effectively.
