UTILITY CORRIDOR RESPONSE ACTIVITY PLAN FOR INTERIM RESPONSE ACTIVITIES

Livonia Transmission Plant

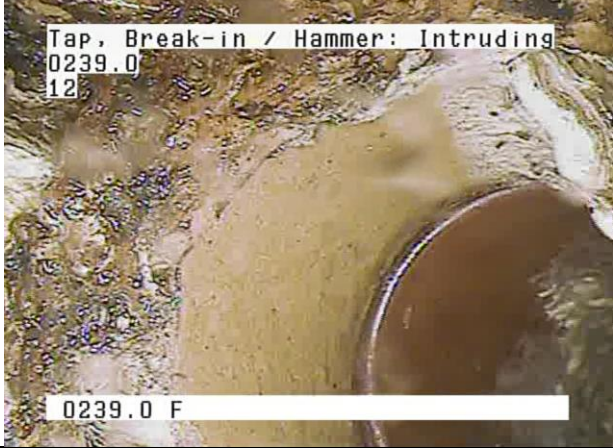
<p>Tap, Break-in / Hammer: Intruding 0239.0 12</p> <p>0239.0 F</p>	SAMH-1244 TO SAMH-1245	239.0' TOP (12oc)

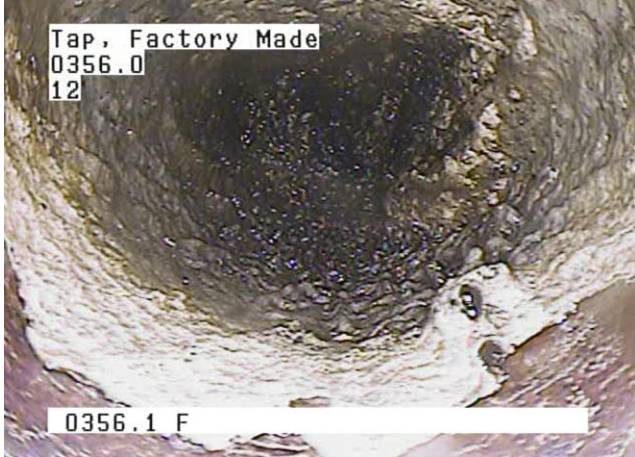
<p>Tap, Factory Made 0356.0 12 0356.1 F</p>	SAMH-1256 TO SAMH-1244	356.1' TOP (12oc)

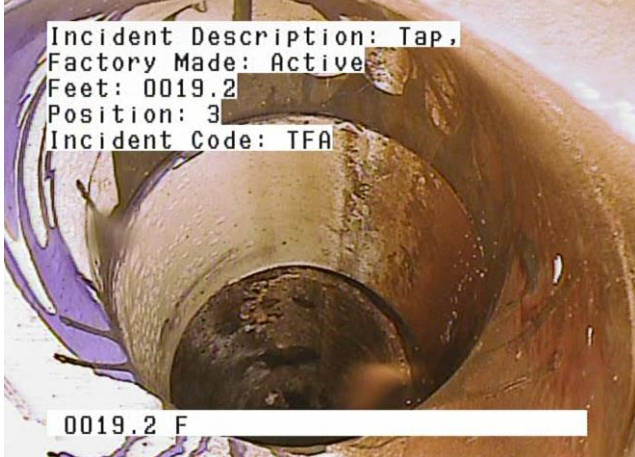
<p>Incident Description: Tap, Factory Made: Active Feet: 0019.2 Position: 3 Incident Code: TFA 0019.2 F</p>	SAMH-1258 TO SAMH-1257	19.1' RIGHT (3oc)

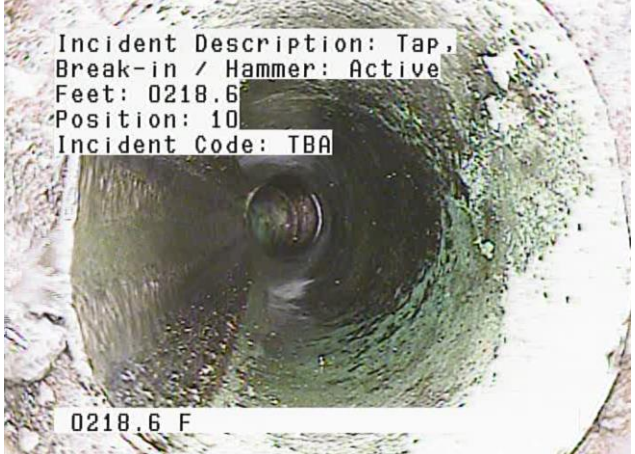
<p>Incident Description: Tap, Break-in / Hammer: Active Feet: 0218.6 Position: 10 Incident Code: TBA 0218.6 F</p>	SAMH-1233A TO SAMH-1233	218.6' LEFT (10oc)

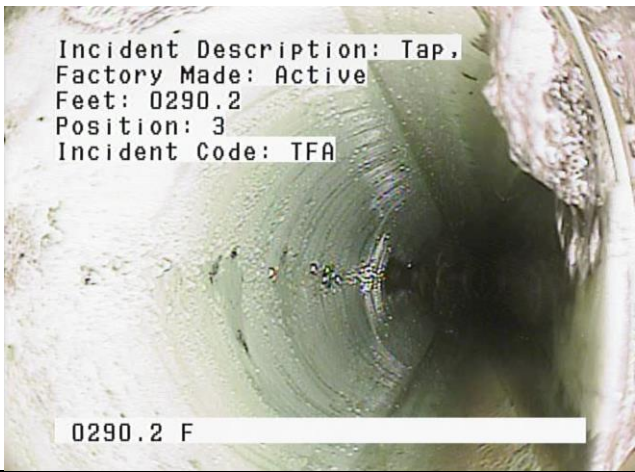
<p>Incident Description: Tap, Factory Made: Active Feet: 0290.2 Position: 3 Incident Code: TFA</p> <p>0290.2 F</p>	SAMH-1234 TO SAMH-1233A	290.2' RIGHT (3oc)

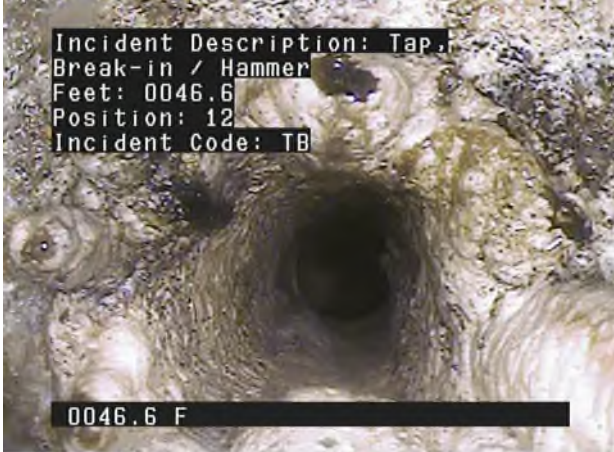
<p>Incident Description: Tap, Break-in / Hammer Feet: 0046.6 Position: 12 Incident Code: TB</p> <p>0046.6 F</p>	SL-16 TO SL-17	46.6' TOP

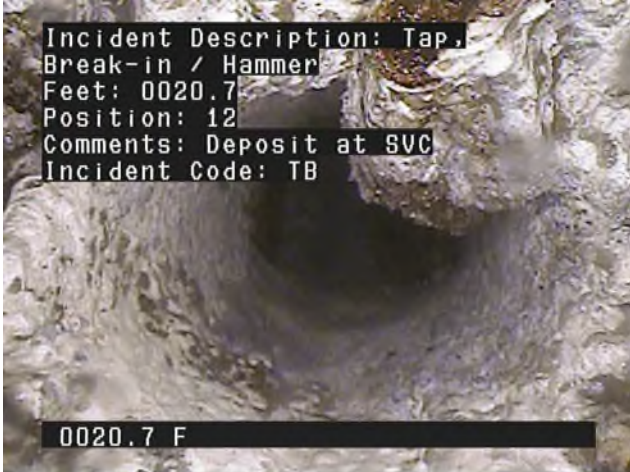
<p>Incident Description: Tap, Break-in / Hammer Feet: 0020.7 Position: 12 Comments: Deposit at SVC Incident Code: TB</p> <p>0020.7 F</p>	SL-17 TO SL-18	20.7' TOP

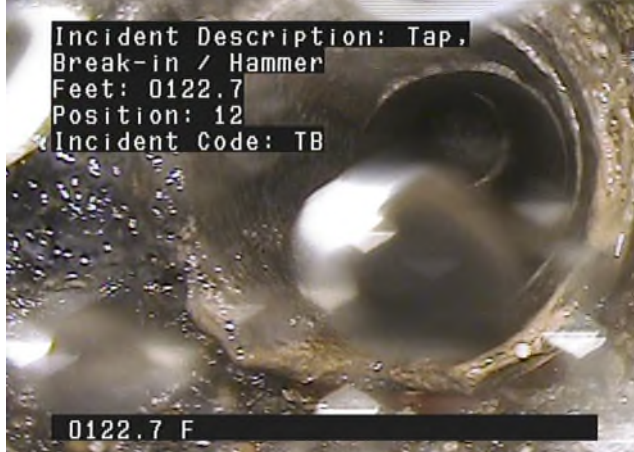
<p>Incident Description: Tap, Break-in / Hammer Feet: 0122.7 Position: 12 Incident Code: TB</p> <p>0122.7 F</p>	SL-17 TO SL-18	123.7' TOP

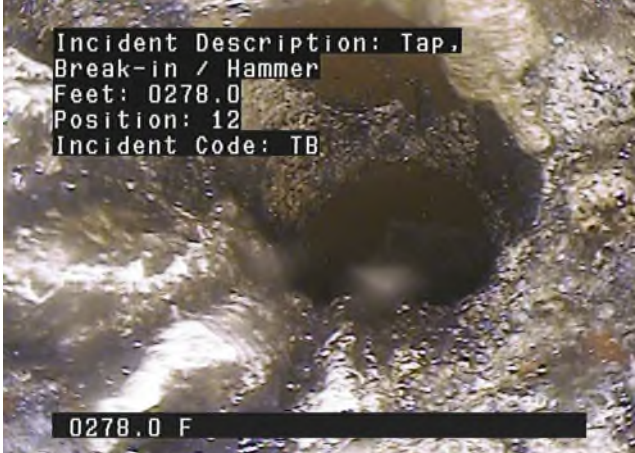
<p>Incident Description: Tap, Break-in / Hammer Feet: 0278.0 Position: 12 Incident Code: TB</p> <p>0278.0 F</p>	SL-17 TO SL-18	278.0' TOP

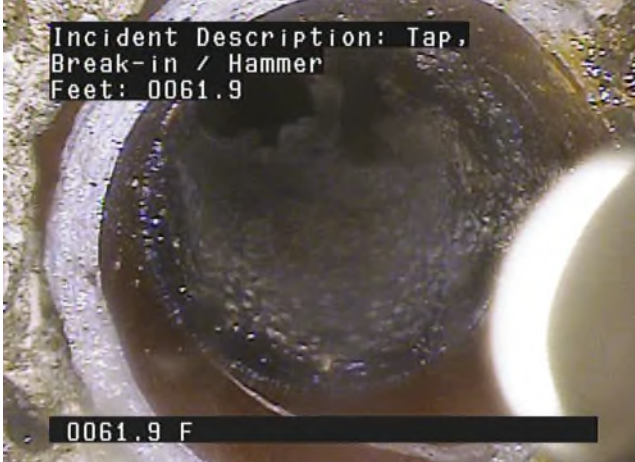
<p>Incident Description: Tap, Break-in / Hammer Feet: 0061.9</p> <p>0061.9 F</p>	SL-18 TO SL-3D	61.9' TOP

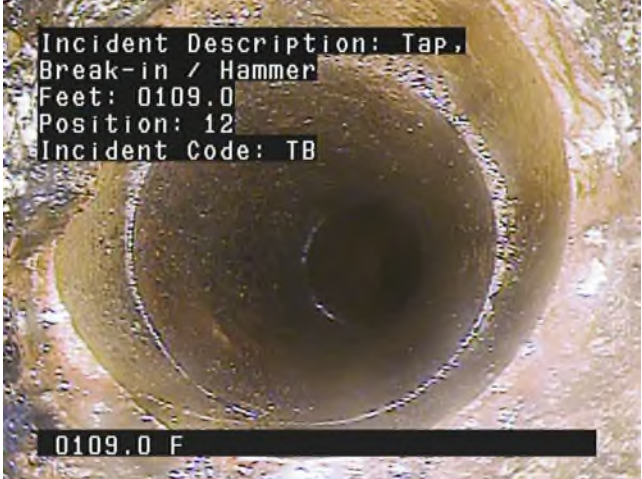
<p>Incident Description: Tap, Break-in / Hammer Feet: 0109.0 Position: 12 Incident Code: TB</p> <p>0109.0 F</p>	SL-18 TO SL-3D	109' TOP

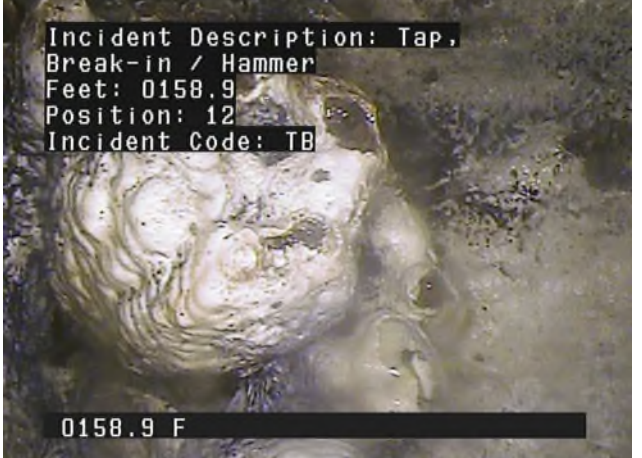
<p>Incident Description: Tap, Break-in / Hammer Feet: 0158.9 Position: 12 Incident Code: TB</p> <p>0158.9 F</p>	SL-18 to SL-3D	158.9' TOP

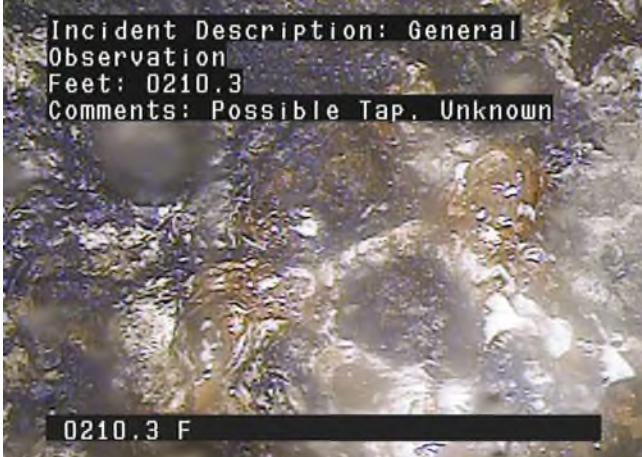
<p>Incident Description: General Observation Feet: 0210.3 Comments: Possible Tap, Unknown</p> <p>0210.3 F</p>	SL-18 to SL-3D	210.3' TOP

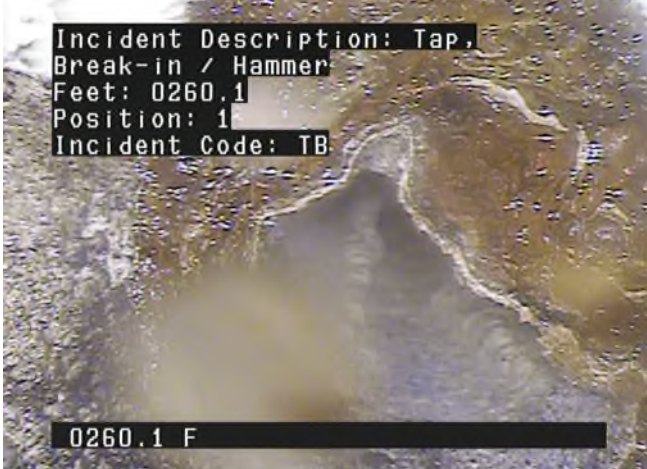
<p>Incident Description: Tap, Break-in / Hammer Feet: 0260.1 Position: 1 Incident Code: TB</p> <p>0260.1 F</p>	SL-18 TO SL-3D	260.1' TOP

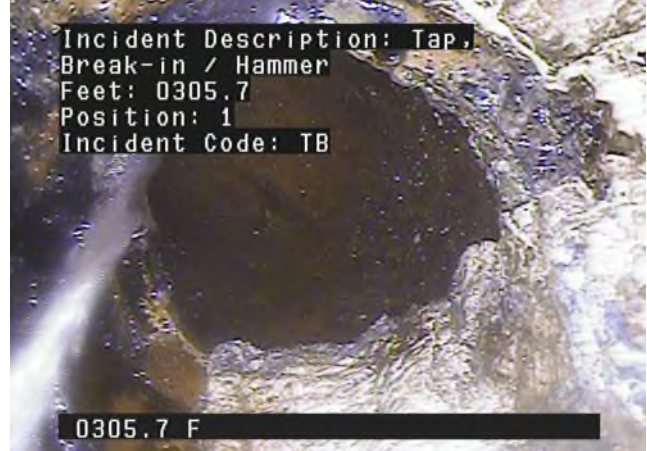
<p>Incident Description: Tap, Break-in / Hammer Feet: 0305.7 Position: 1 Incident Code: TB</p> <p>0305.7 F</p>	SL-18 TO SL-3D	305.7' TOP

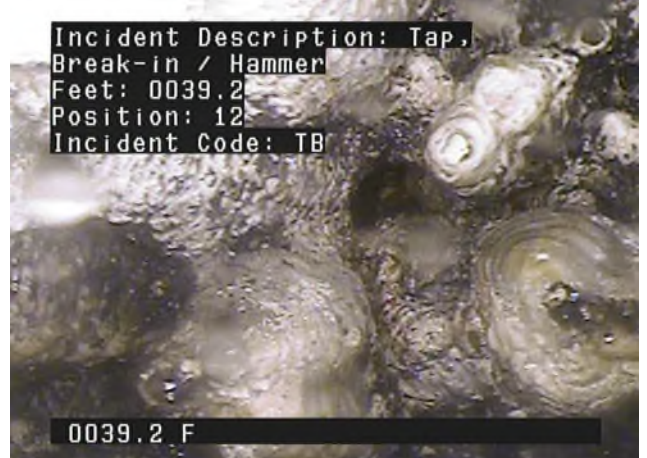
<p>Incident Description: Tap, Break-in / Hammer Feet: 0039.2 Position: 12 Incident Code: TB</p> <p>0039.2 F</p>	SL-3D TO SL-4	39.2' TOP

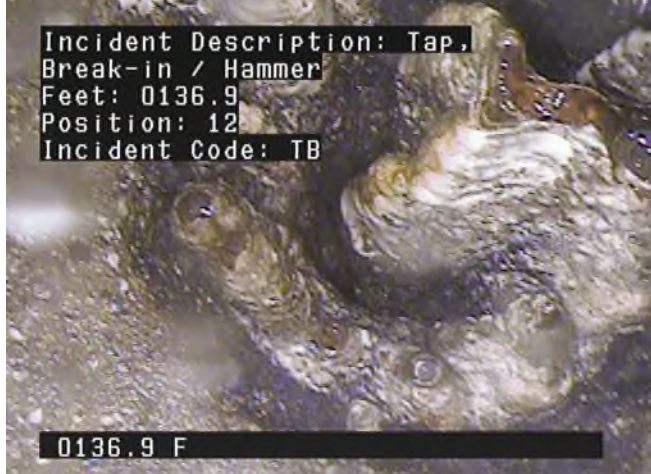
<p>Incident Description: Tap, Break-in / Hammer Feet: 0136.9 Position: 12 Incident Code: TB</p> <p>0136.9 F</p>	SL-3D TO SL-4	136.9' TOP

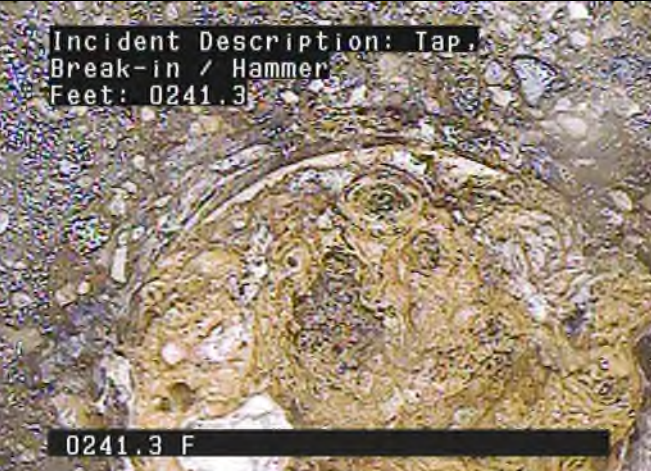
<p>Incident Description: Tap, Break-in / Hammer Feet: 0241.3</p> <p>0241.3 F</p>	SL-3D TO SL-4	241.3' TOP

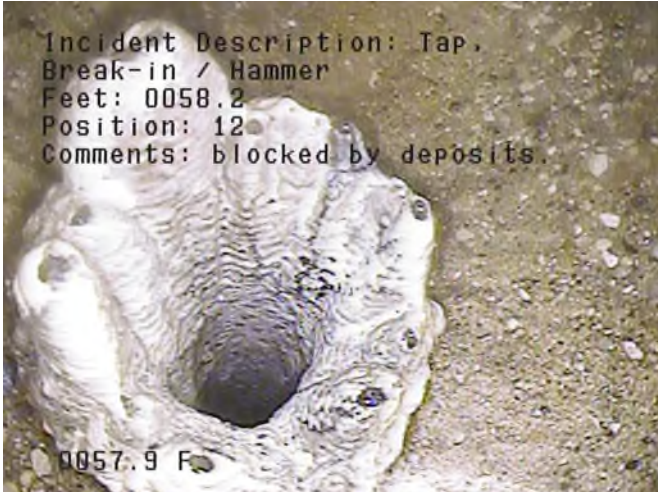
<p>Incident Description: Tap, Break-in / Hammer Feet: 0058.2 Position: 12 Comments: blocked by deposits. 0057.9 F</p>	SL-4 TO SL-5	57.9' TOP

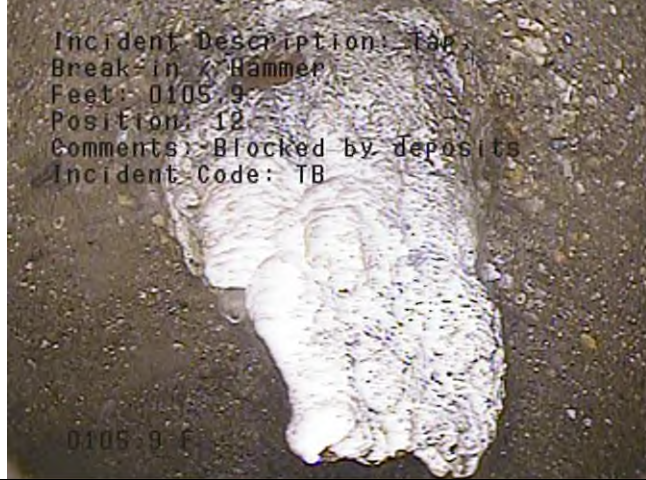
<p>Incident Description: Tap, Break-in / Hammer Feet: 0105.9 Position: 12 Comments: Blocked by deposits Incident Code: TB</p> <p>0105.9 F</p>	SL-4 TO SL-5	105.9' TOP

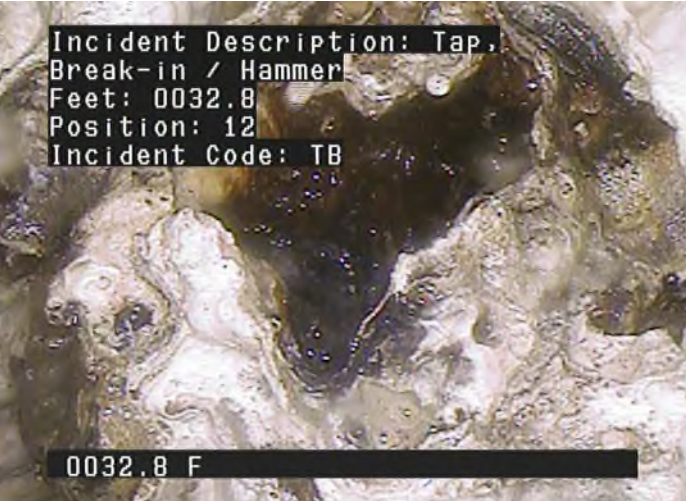
<p>Incident Description: Tap, Break-in / Hammer Feet: 0032.8 Position: 12 Incident Code: TB</p> <p>0032.8 F</p>	SAMH-1228A TO SL-3	32.8' TOP

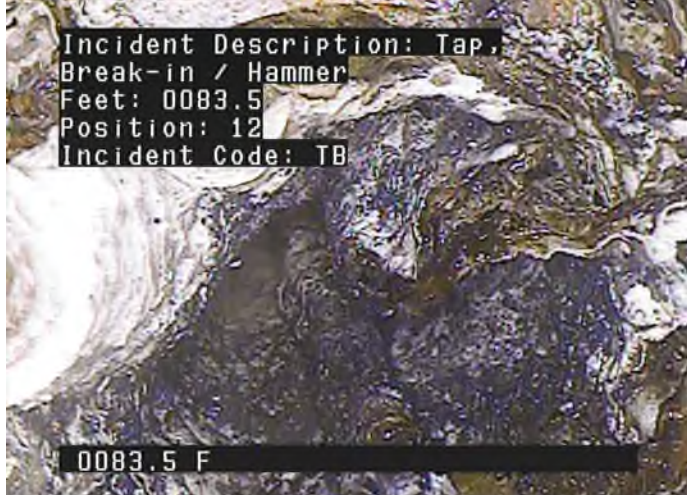
<p>Incident Description: Tap, Break-in / Hammer Feet: 0083.5 Position: 12 Incident Code: TB</p> <p>0083.5 F</p>	SAMH-1228A TO SL-3	83.5' TOP

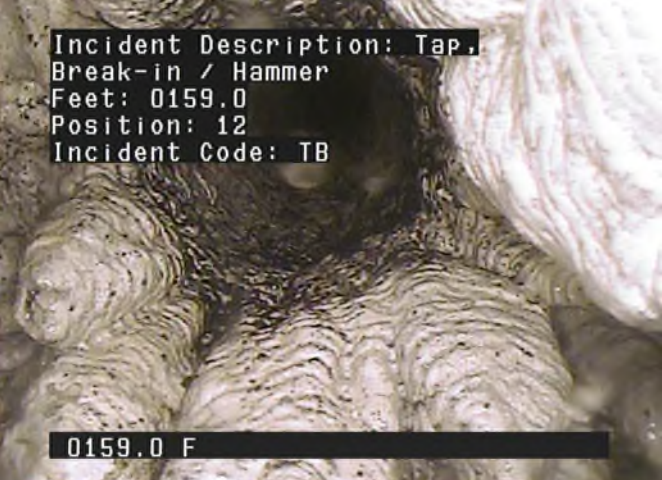
<p>Incident Description: Tap, Break-in / Hammer Feet: 0159.0 Position: 12 Incident Code: TB</p> <p>0159.0 F</p>	SAMH-1228A TO SL-3	159.9' TOP
