# MEMO

Arcadis Project No.:  
30050315

Subject:  
Utility Corridor Assessment – Response to EGLE Letter Dated February 11, 2022  
and Scope of Work for offsite Utility Corridor Assessment  
36200 Plymouth Road, Livonia, Wayne County  
Consent Decree No 2:1712372-GAD-RSW (CJ)  
Site ID No.: 82002970

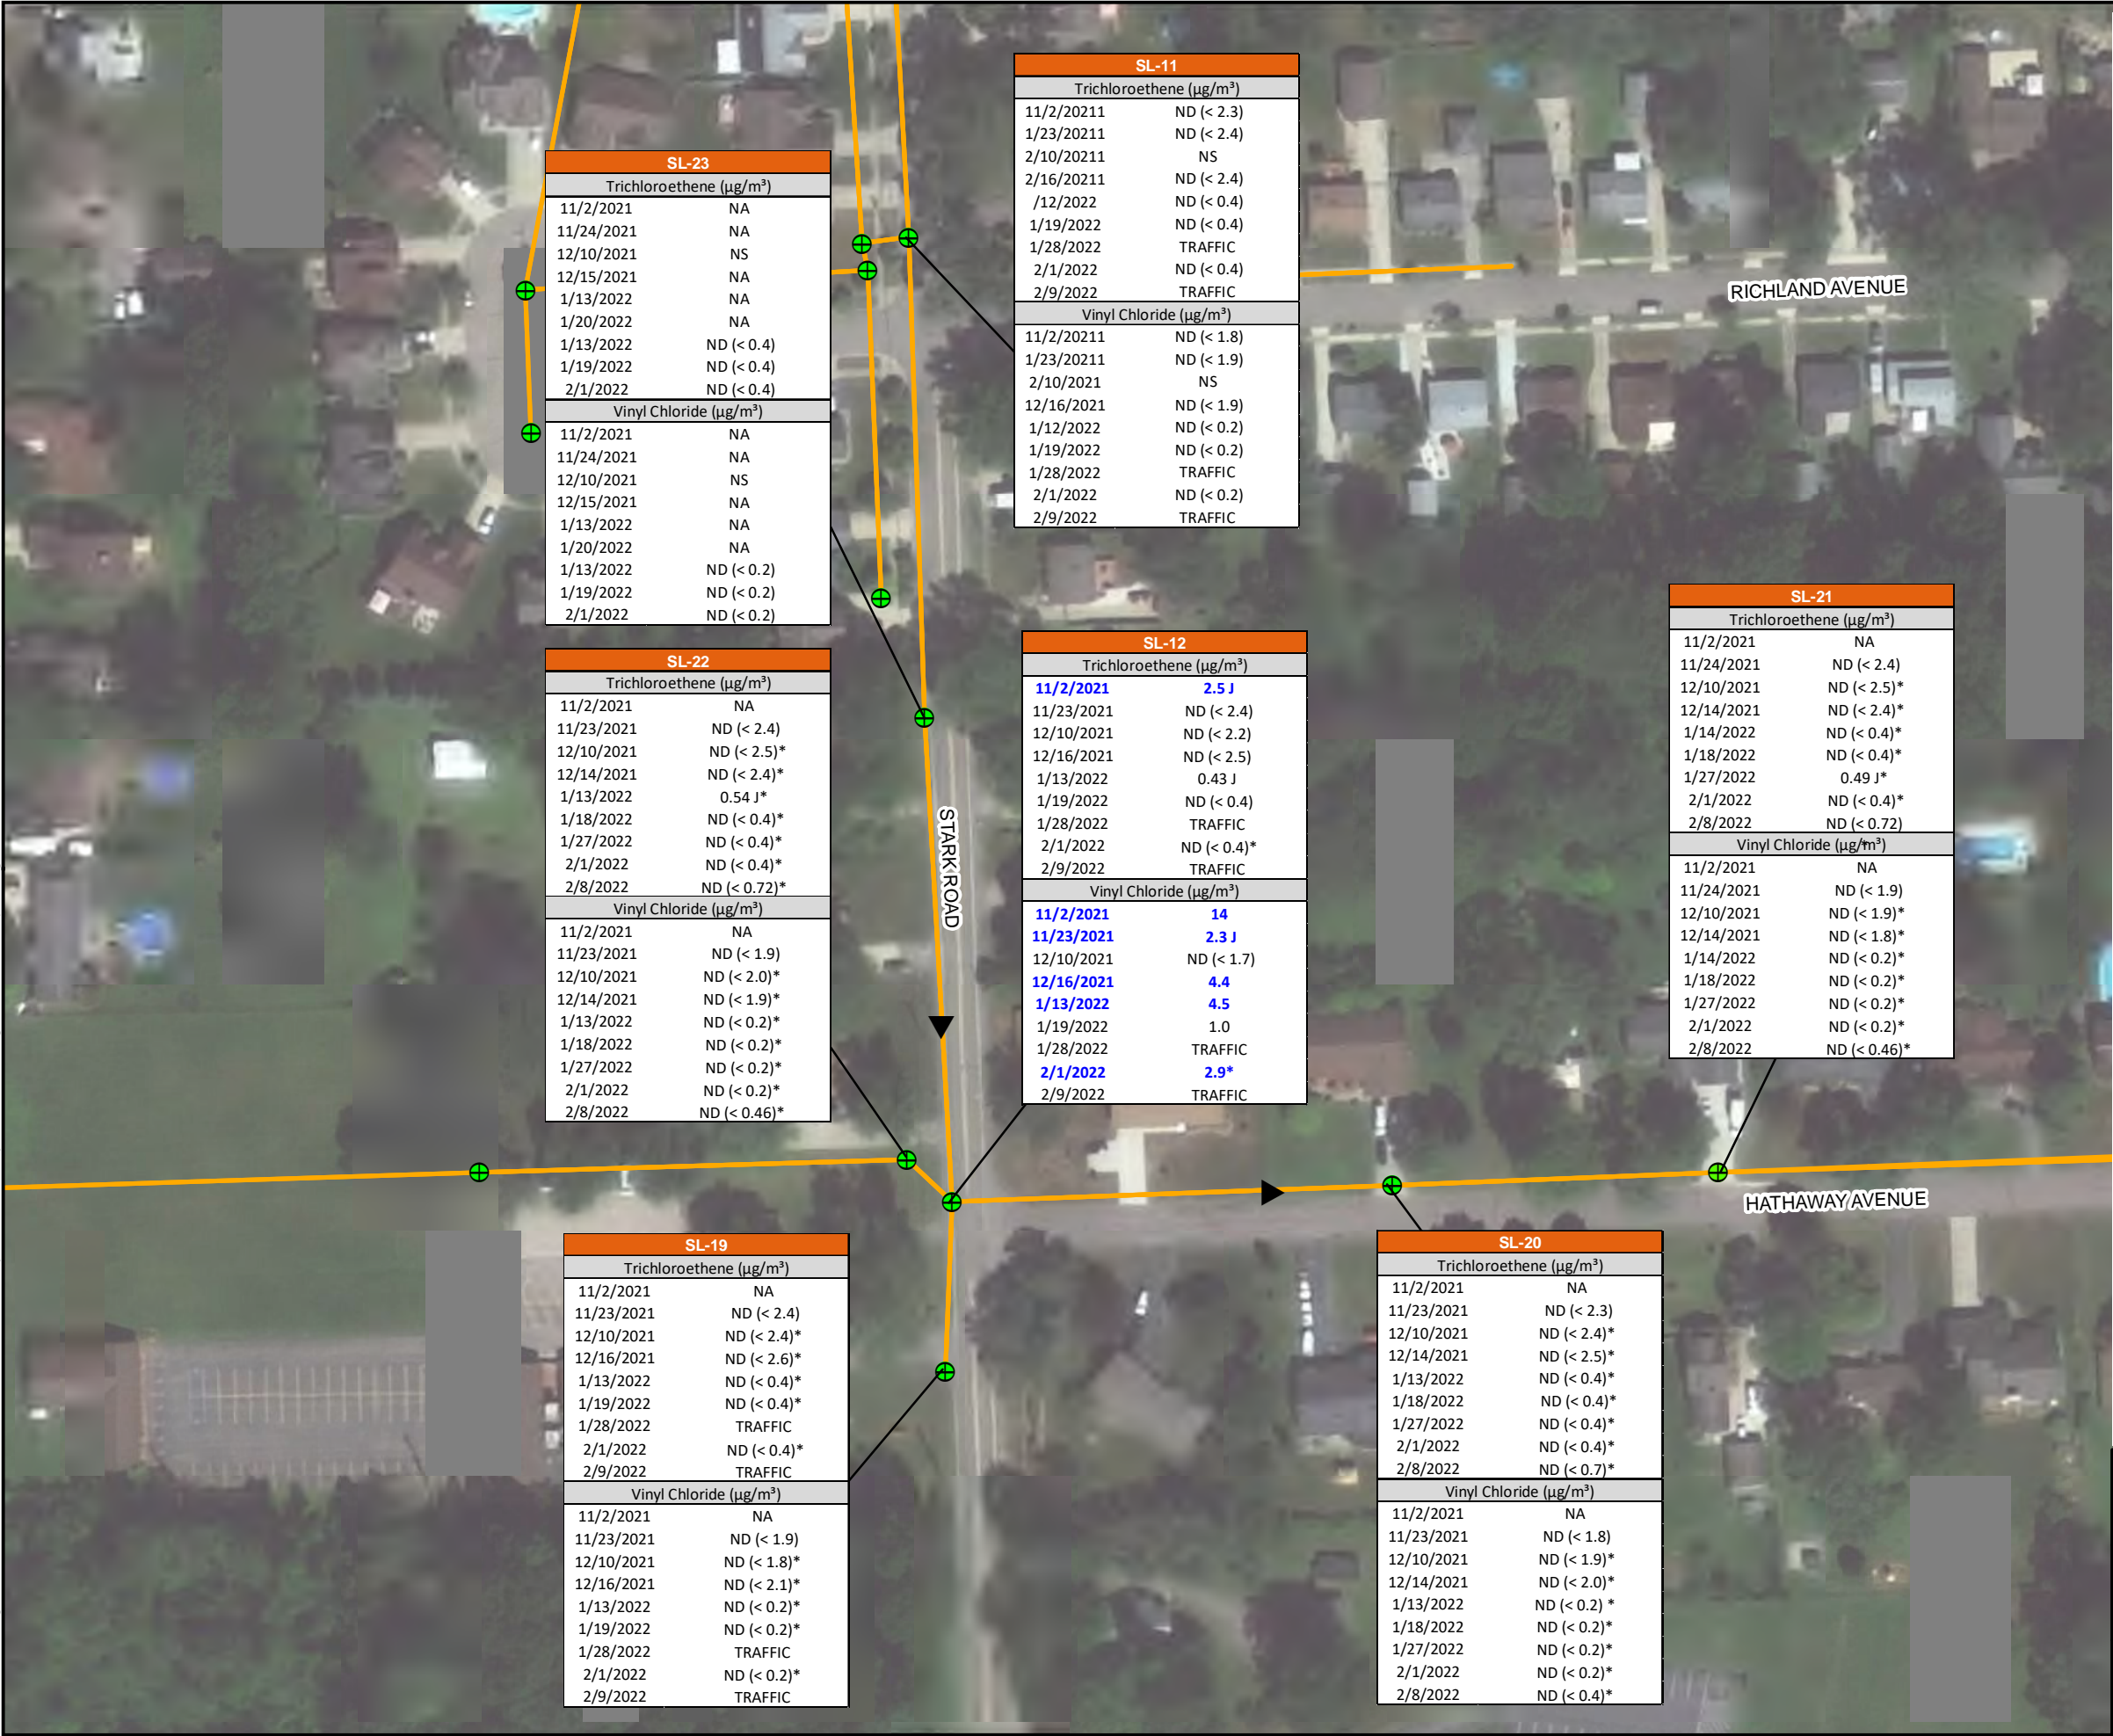
Analytical results for vapor and liquid sanitary samples are provided in **Figures 1** through **4**.

FIGURE SHOWS DATA FOR TRICHLOROETHENE AND VINYL CHLORIDE ONLY. FULL SET OF DATA CAN BE FOUND IN THE CORRESPONDING TABLES.

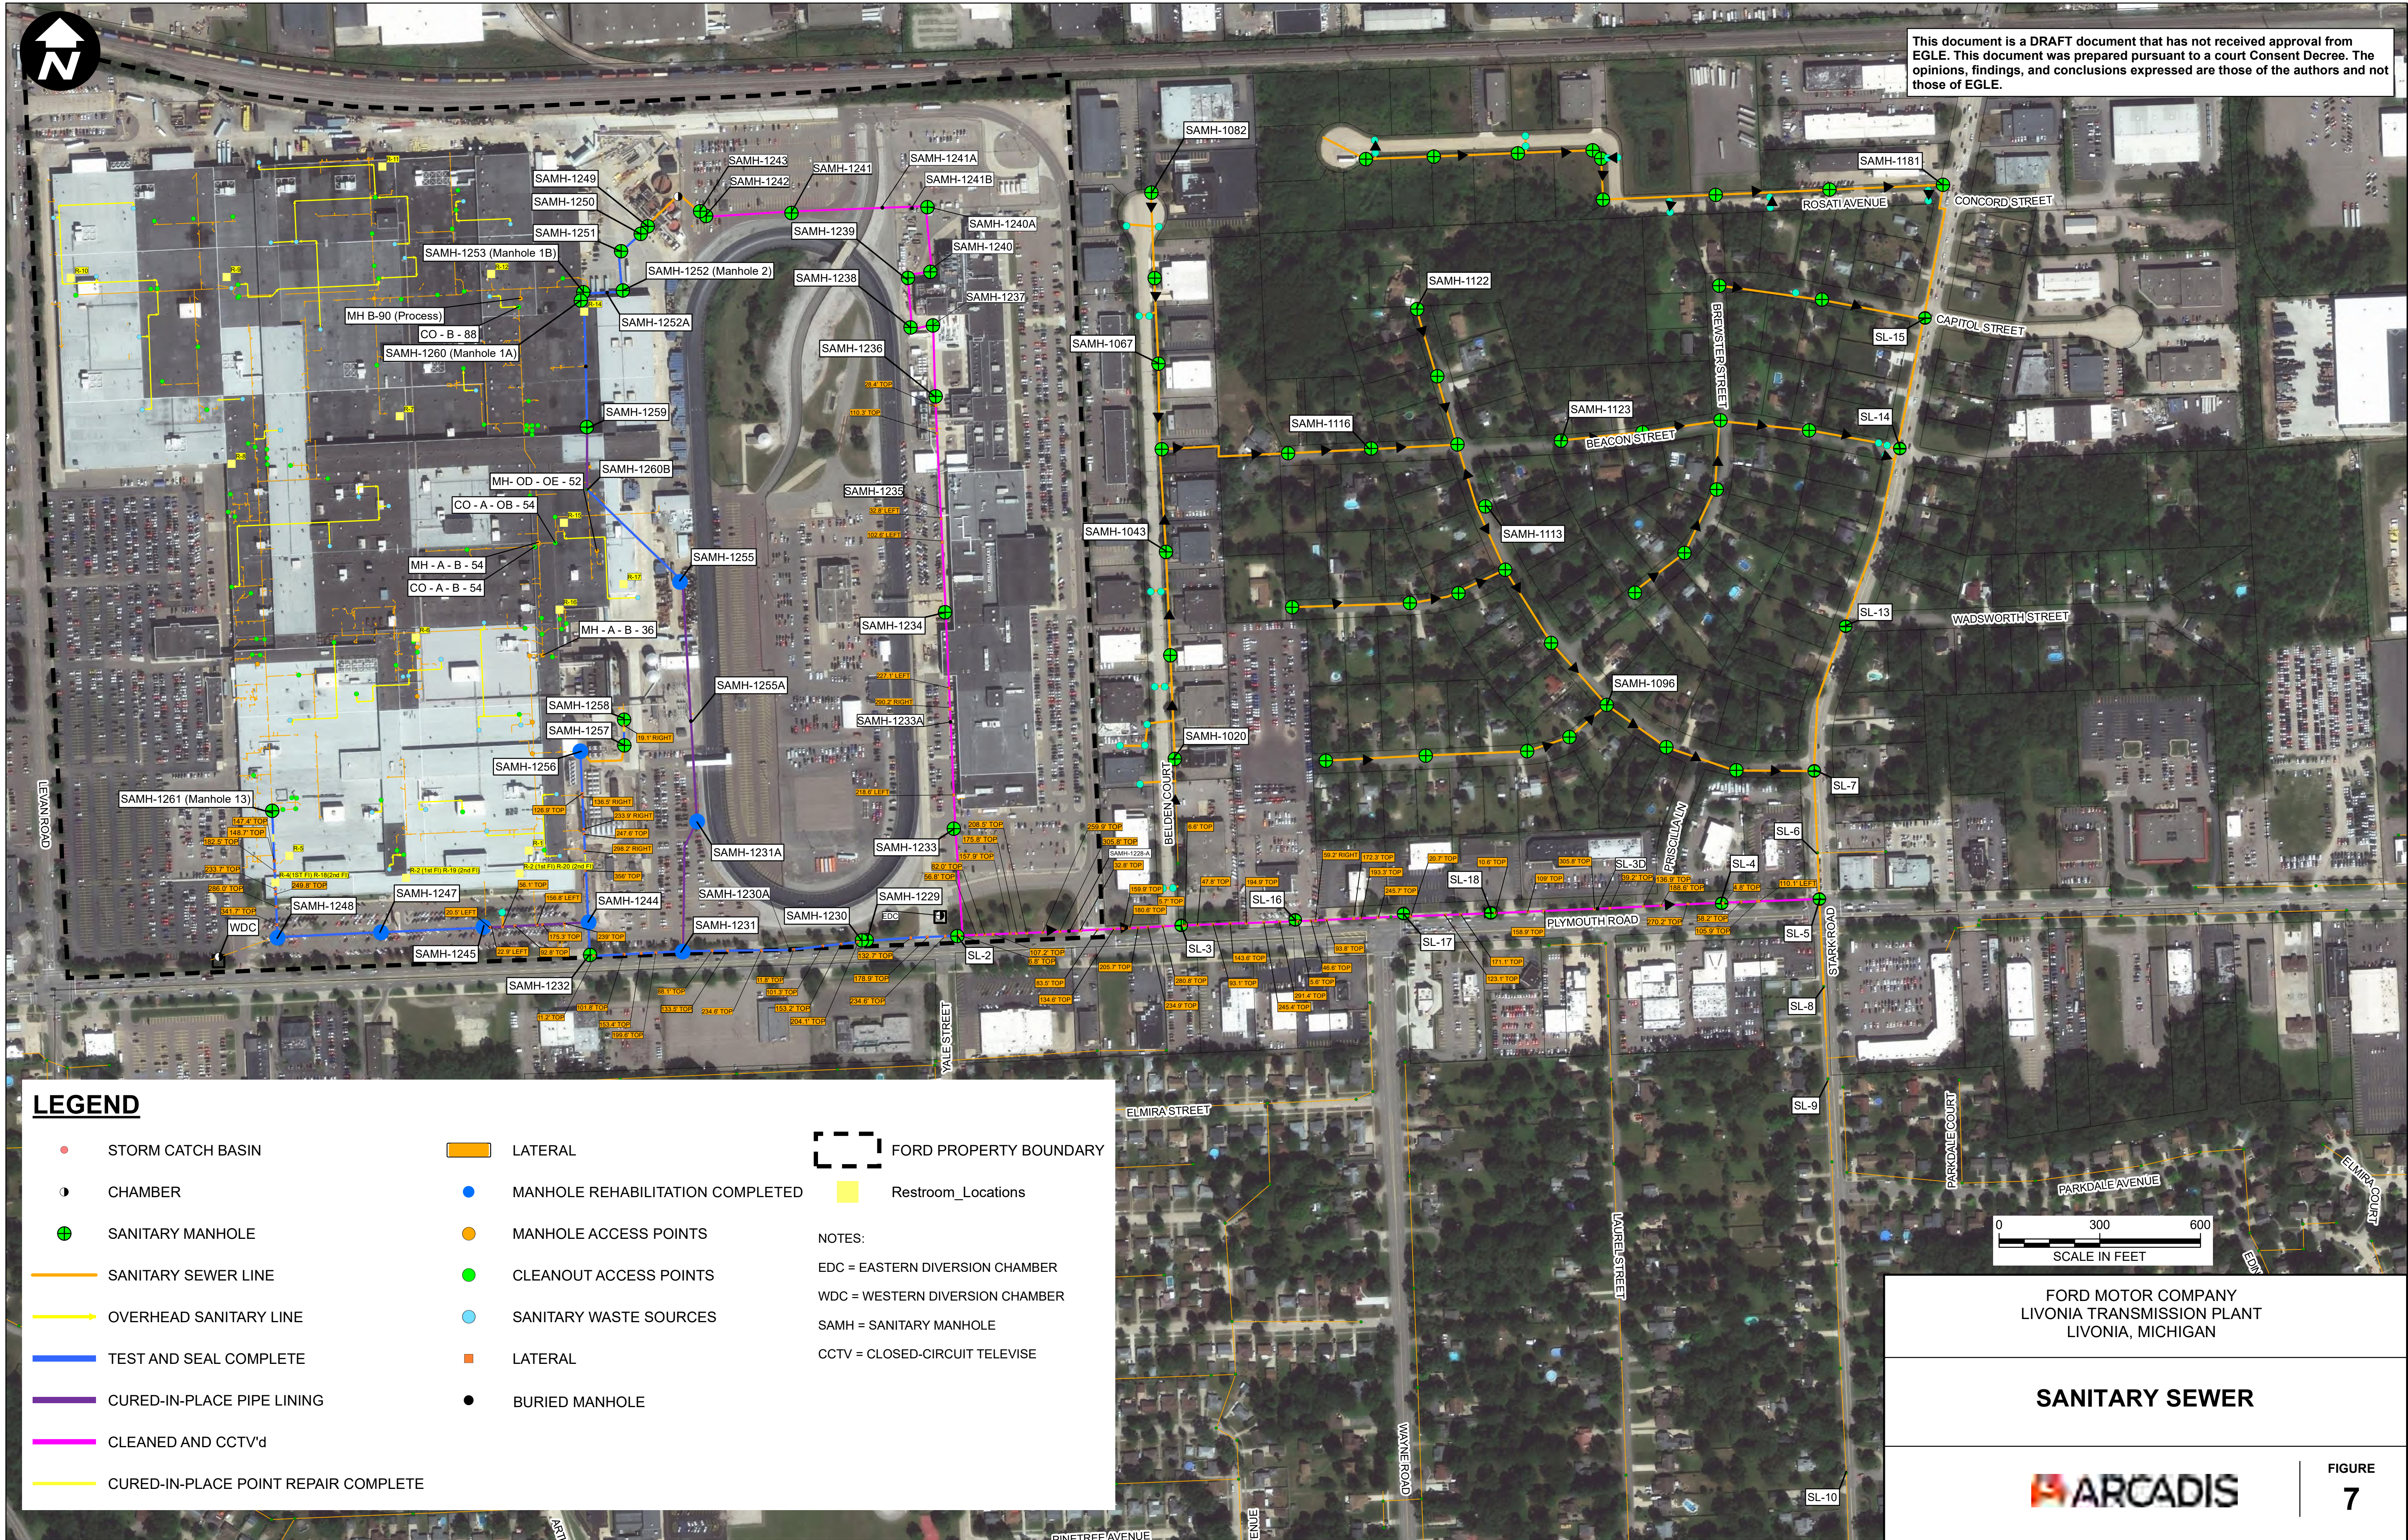
Figure 7 – Sanitary Sewer

**Response:** Please refer to **Figure 7** for lateral connection locations onsite and offsite along Plymouth Road.

**Response:** **Figure 7**, provide the locations and identification for the manholes and restrooms that have been identified to date throughout the plant property. Exhibit 3 has been updated to reflect the current identification names of the manholes that is discussed above. The identification change was made to stay consistent with the pipe rehabilitation identification that was completed from June to November 2021.

In addition, **Figure 7**, also provides the locations of above grade sanitary piping versus below grade sanitary piping as well as onsite lateral connections.

**Response:** **Figure 9**, provides the location of each for offsite manholes identified in the logs. **Figure 7**, provides the locations and names for each manhole that has been investigated. Additional manhole locations and identifications will be provided in the April 1, 2022 memo.

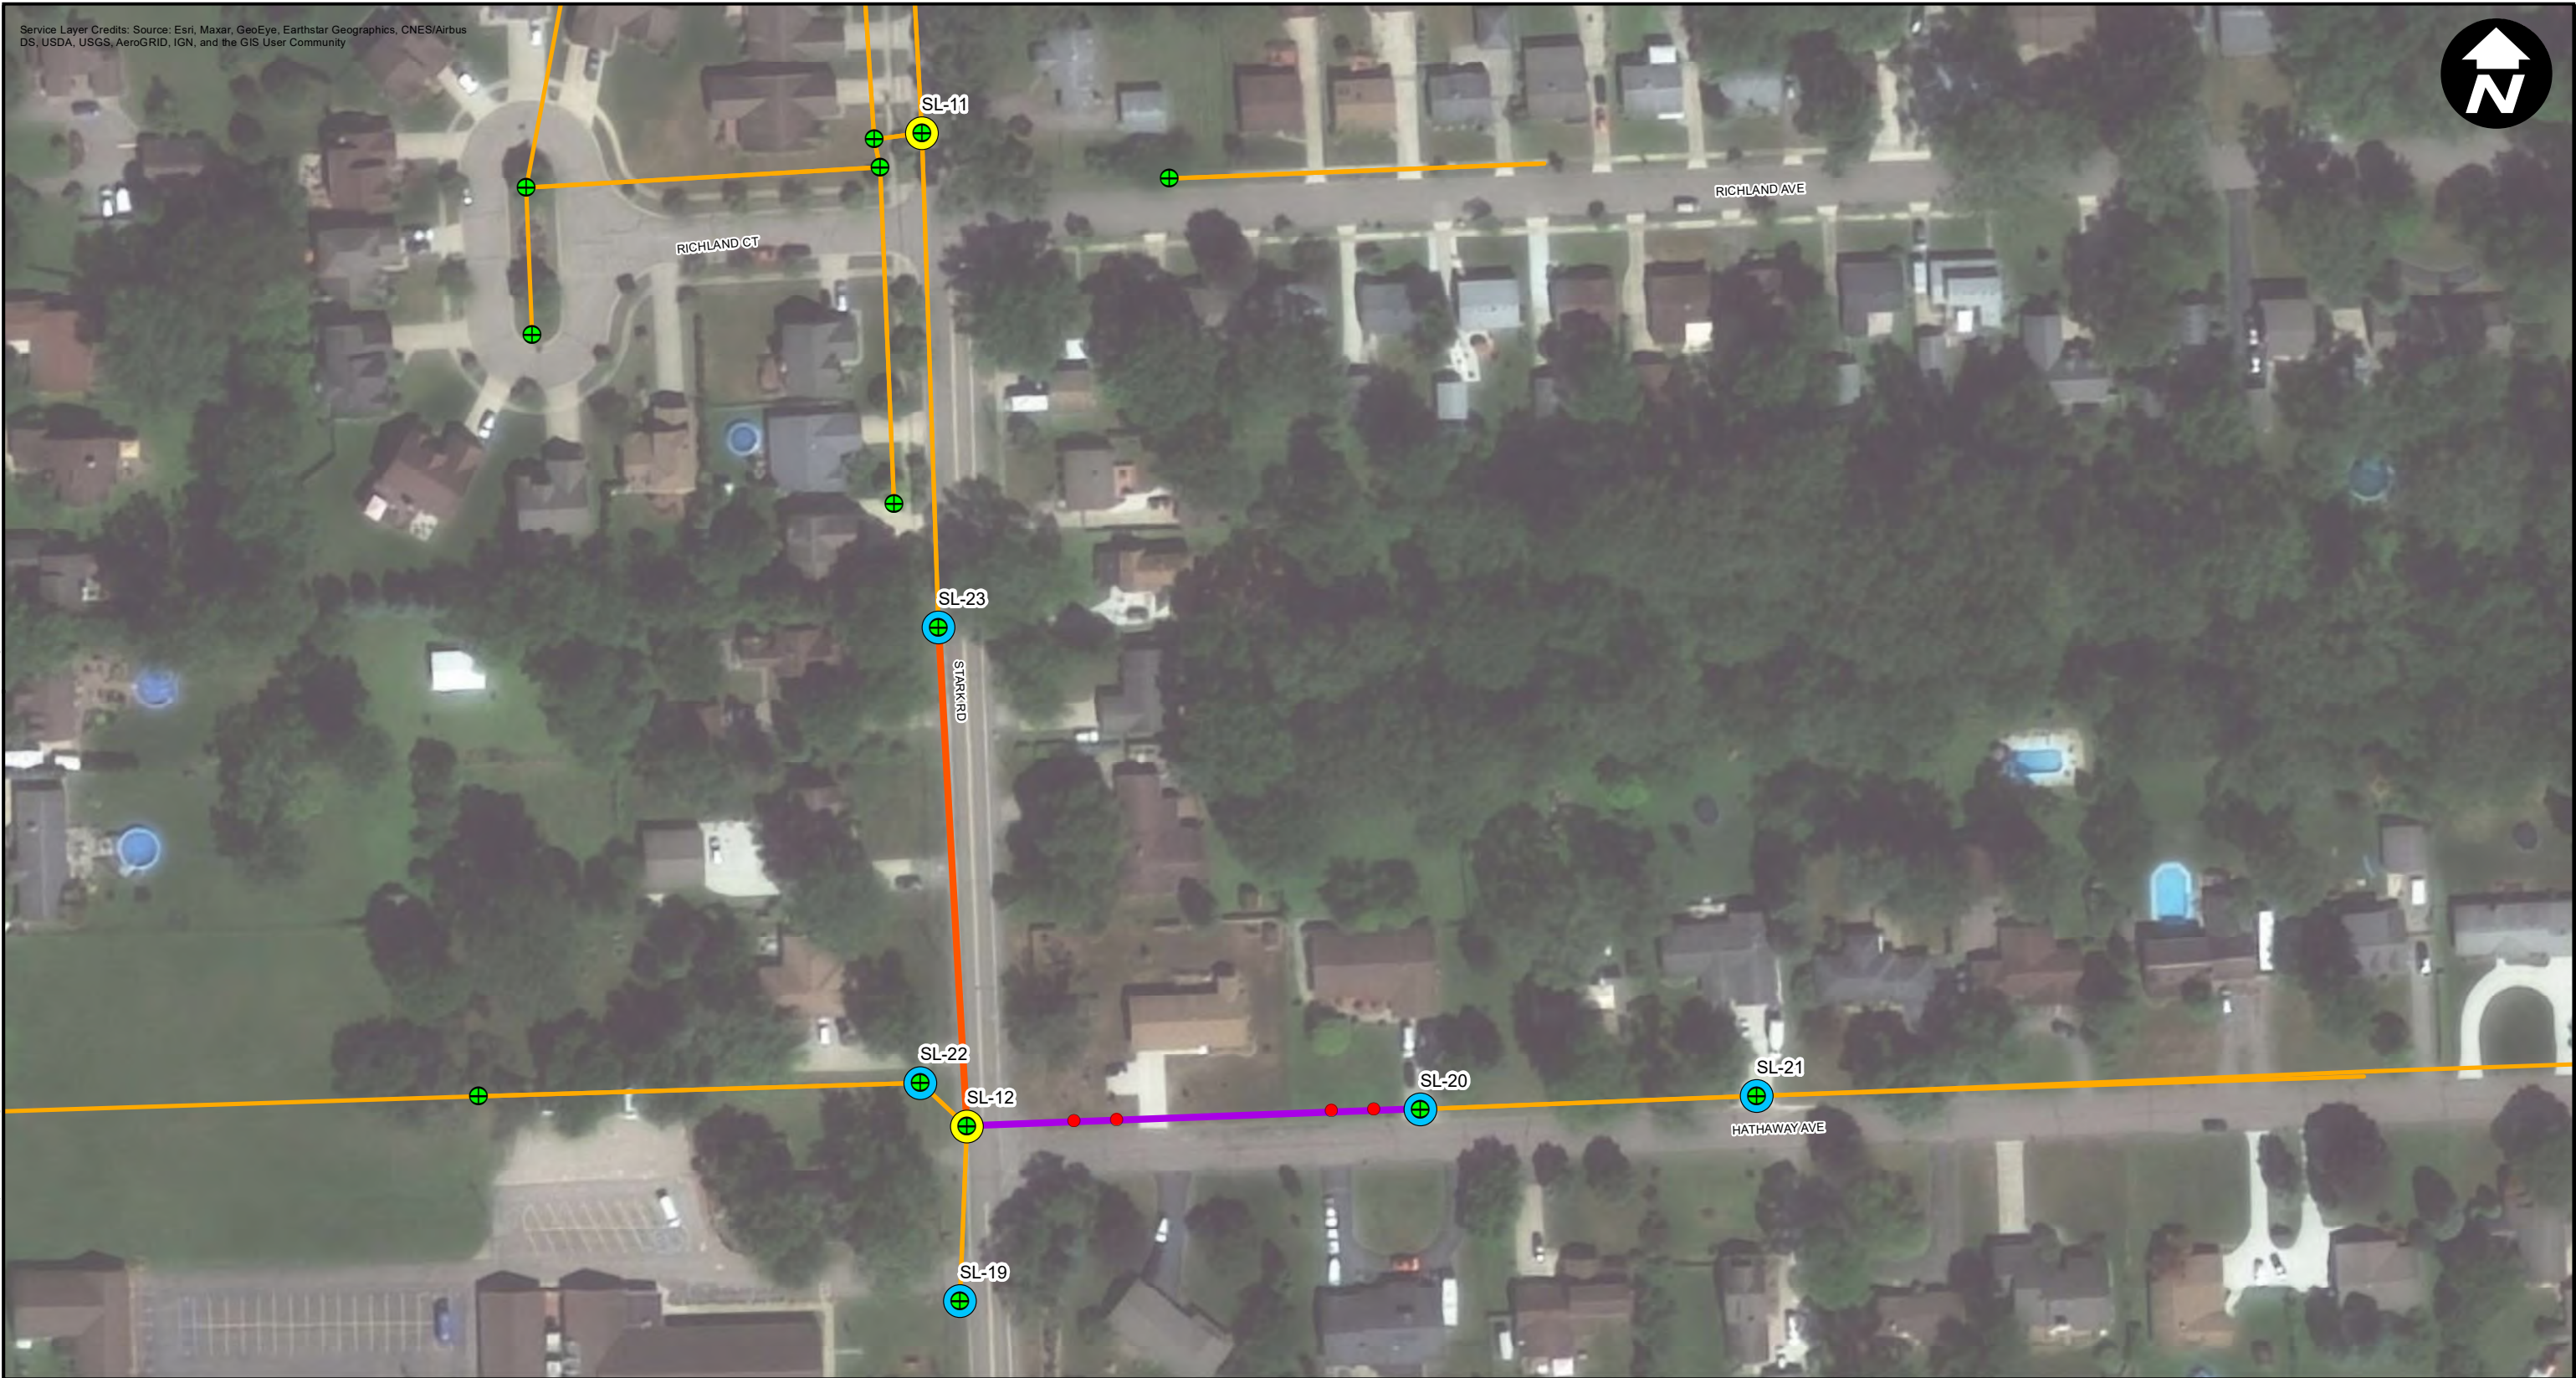
FIGURE  
**8**

In addition, on March 3, 2022, Arcadis oversaw a specialty contractor to identify the laterals between SL-23 and SL-12 on Stark Road, refer to **Figure 8**. The findings will be provided in a subsequent memo submitted to EGLE on April 1, 2022.

After access agreements have been executed the residential properties referenced in Exhibit 1, Arcadis will implement the following process to evaluate deficiencies in the plumbing and confirm where lateral pipes connect to the sanitary sewer mainlines. Lateral connections have been identified for up to four (4) residential properties on Hathaway, as illustrated on **Figure 8**.

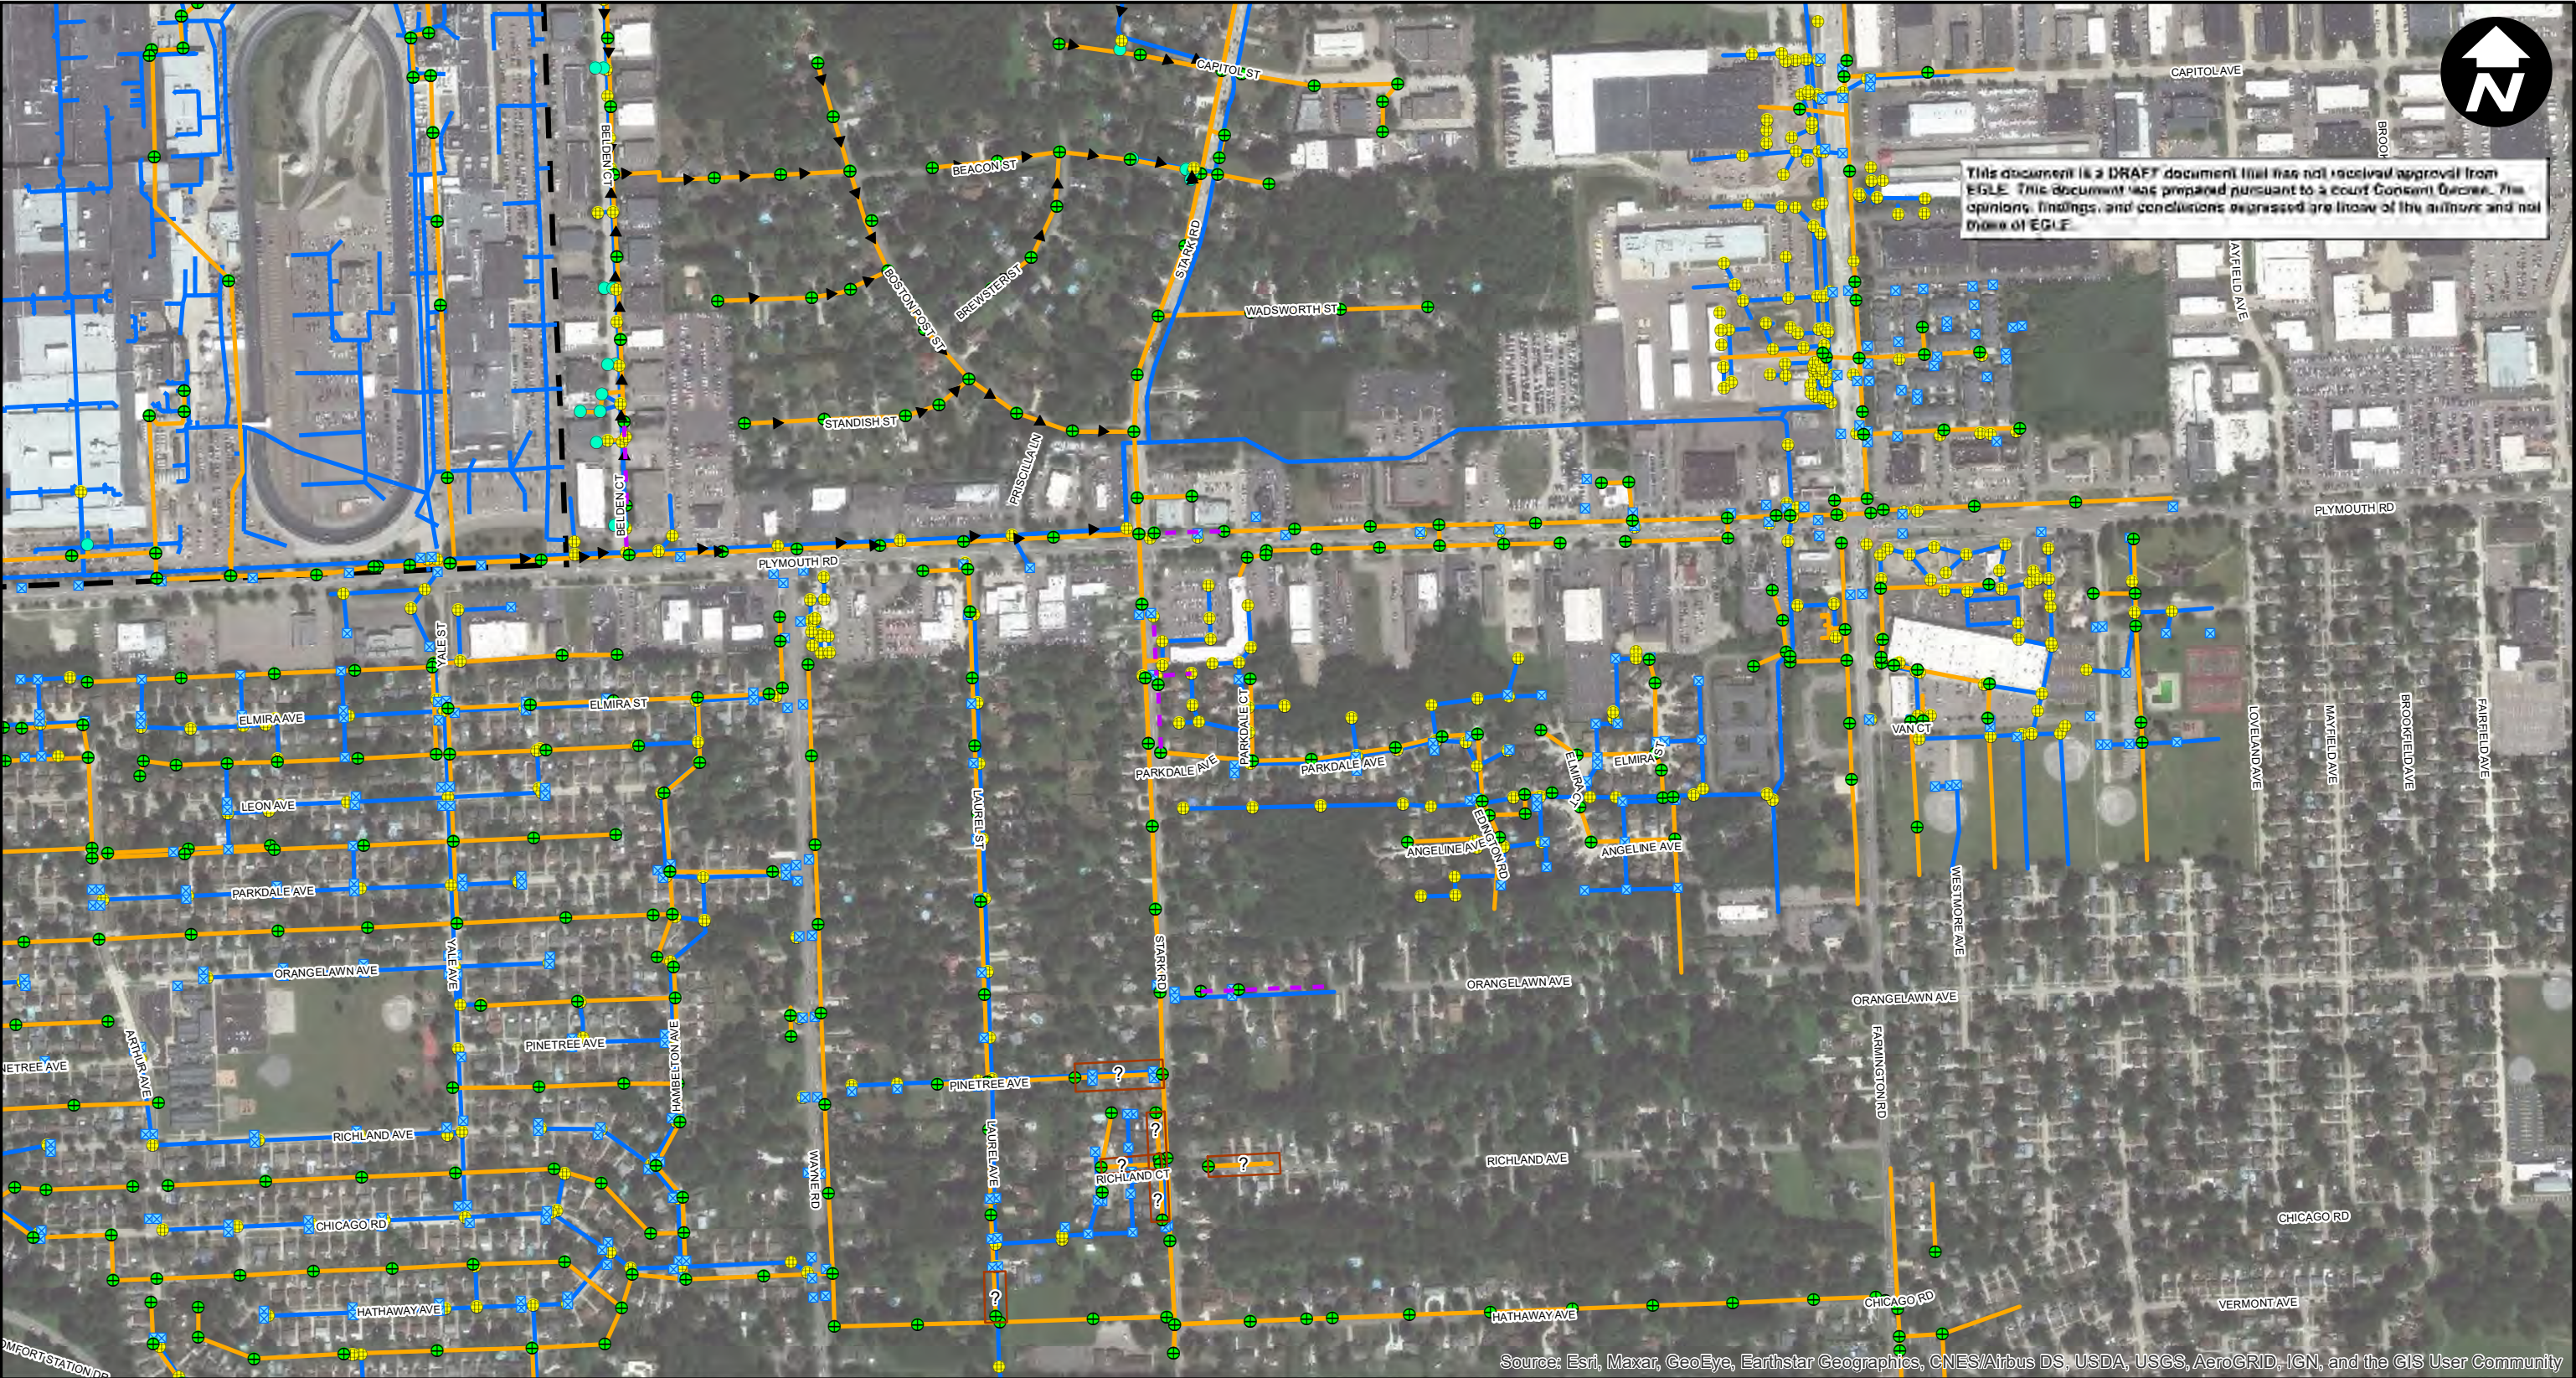
FIGURE 11

**Response:** As of February 14, 2022, Arcadis has been conducting an adaptive investigation to screen the manholes on Ford's property to determine if there is a potential source that is leading to the vapor migration in the sanitary sewers. The FROG 5000 is the instrument that was recommended by EGLE and is currently being utilized in the field. The FROG 5000 can screen for the following constituent of concerns: TCE, Trans-1,2-DCE, CIS-1,2-DCE, and PCE. In addition to the screening, grab samples are also being collected while the FROG is screening to correlate the data quantitatively. The screening locations, draft results from the FROG screening, and grab sampling is provided in **Table 2** and on **Figure 11**.

The FROG screening is an adaptive investigation in which primary locations have been identified as initial screening locations. Based on the primary location results, Arcadis then screens the secondary locations, and then followed by the tertiary, refer to **Figure 11**. The primary and secondary locations are accessible manholes while the tertiary locations have been cleanouts. Based on the data collected as of February 28, 2022, the following findings has been observed.

**Response:** **Figure 10** Provides details to where Arcadis has visually confirmed which sanitary sewer connects to either Plymouth or Stark Road. The remainder of the locations depicted on **Figure 10** has been provided by the City of Livonia. Sewer connection locations that have not been verified in the field, refer to **Figure 11**, will be verified and communicated in the April 1, 2022 memo.
