Transmittal Letter

SUBJECT
Operation, Monitoring, and
Maintenance Field Notes - 12070 Boston Post

Attached are the interim preemptive mitigation (IPM) system Operation, Monitoring, and Maintenance (OM&M) field notes. These field notes were recorded during OM&M visits at the property between March 31, 2020 and March 31, 2022. Please let me know if you have any questions.

12070 Boston Post, 2020-11-12, Full System Inspection

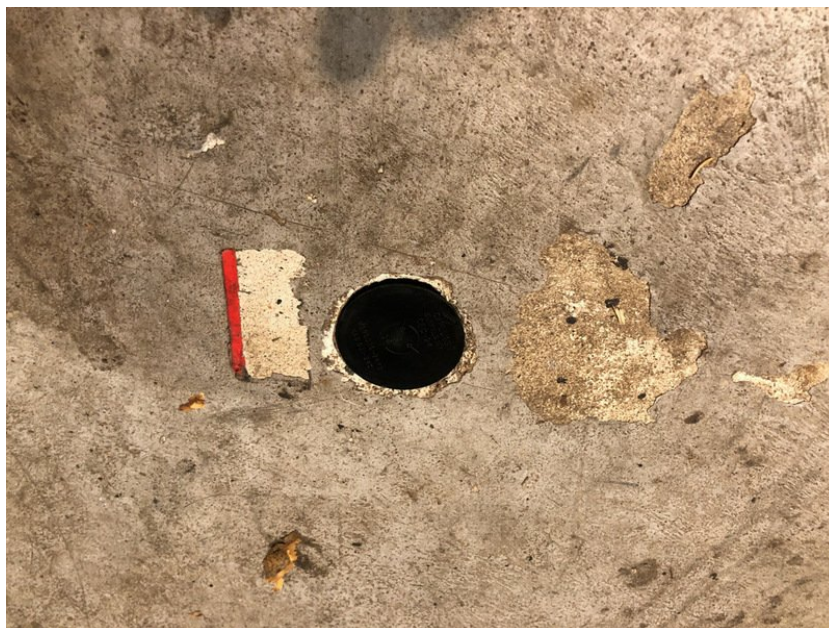
Explain Vacuum Monitoring Repairs

Do any monitoring points (MP/SSMP) need to be repaired or replaced?

Yes

Replaced cap on SSMP-1.

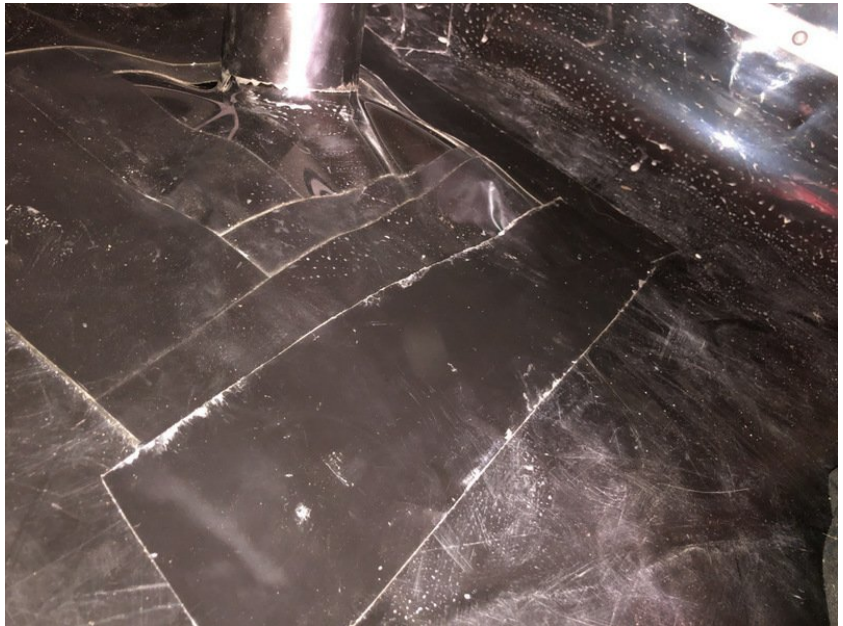
Barrier Comments	Tape was peaking up near MP2. Evidence of past water found in crawl space.
------------------	--

Were any vacuum monitoring points not accessible? Please specify.	No
Do all vacuum monitoring points meet -0.02 in w.c. threshold?	No
Which ones don't and why?	MP2 needed repairs.
Proposed modifications to address vacuum?	Make repairs
Were any ball valve positions changed?	Yes

Were seam repairs completed during this visit?	Yes
Were system repairs completed during this visit?	No
Additional sealing completed:	MP2
Sealing Completion Date	2020-11-12
Sealing Repair Photos

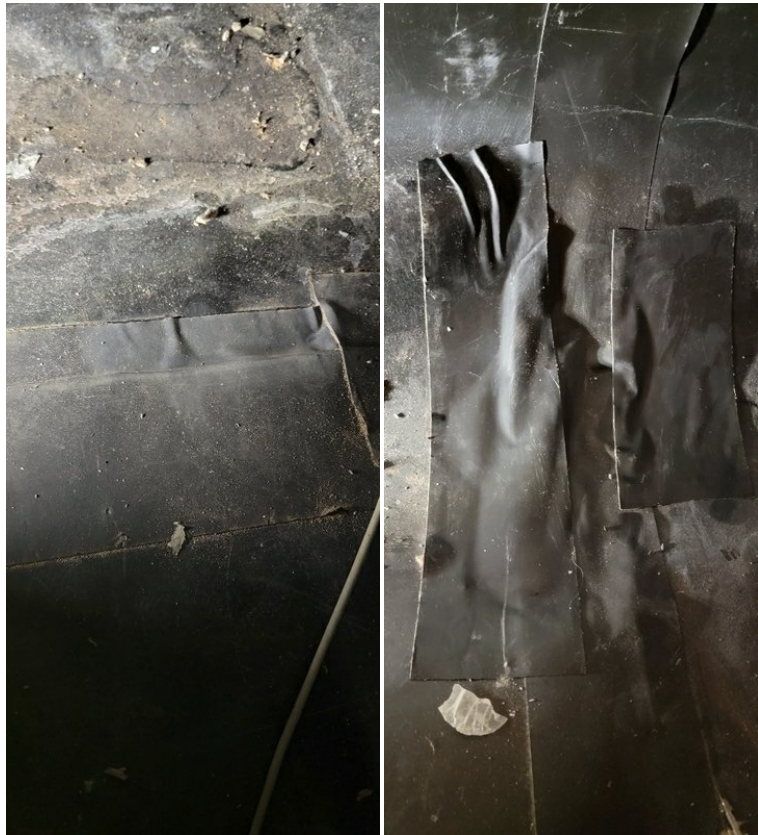
Sealing Repair Photos

Barrier Comments	About 0.5 gallon present of the barrier of the crawlspace.
------------------	--

Additional sealing completed:	Seams repaired where tape was lifting.
-------------------------------	--
