Transmittal Letter

SUBJECT
Operation, Monitoring, and
Maintenance Field Notes - 12101 Brewster

12101 Brewster, 2020-05-19, Water Inspection

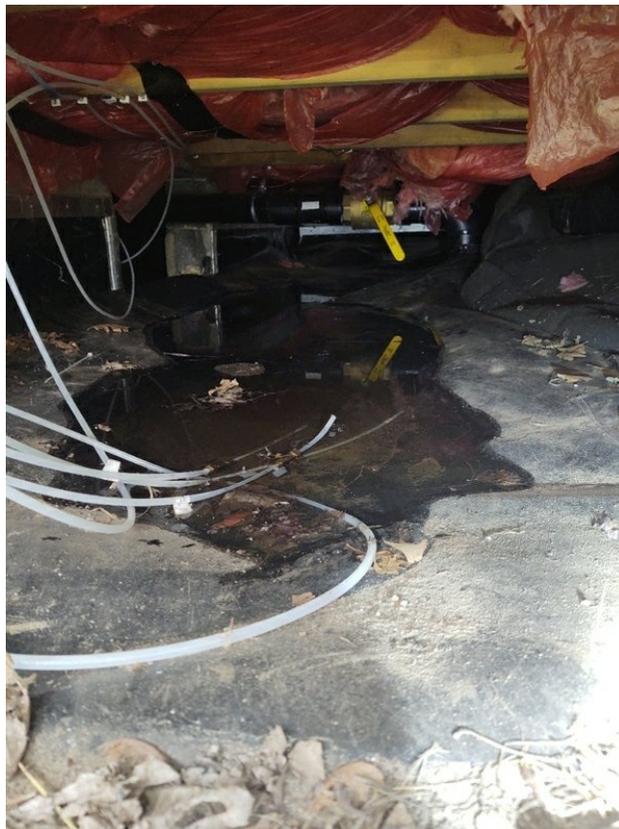
Is water observed on the barrier?	Yes
Location of Water on Barrier	Entrance of crawlspace
Can the source of water be identified?	Yes

Volume of Water on Barrier (gal)	20
Can water be felt under the barrier?	No
Describe Source Location	Possibly the gutters
Do barrier seams need addition sealing or repair?	No

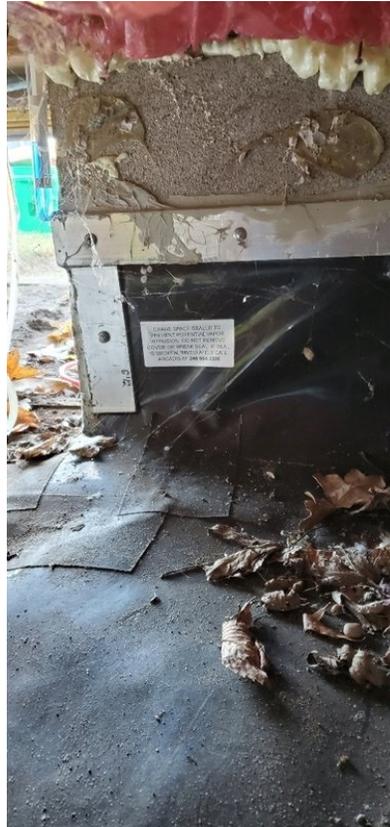
Barrier Label Photos

Are labels present at the crawlspace barrier? Yes

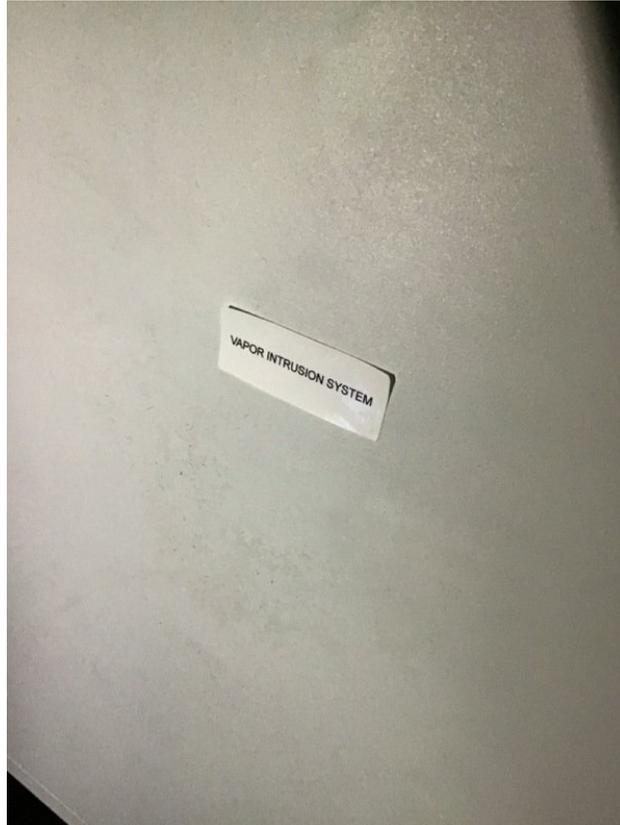
Common Label Photos

Are labels present at the pipe, control panel, u-tube, and breaker? Yes

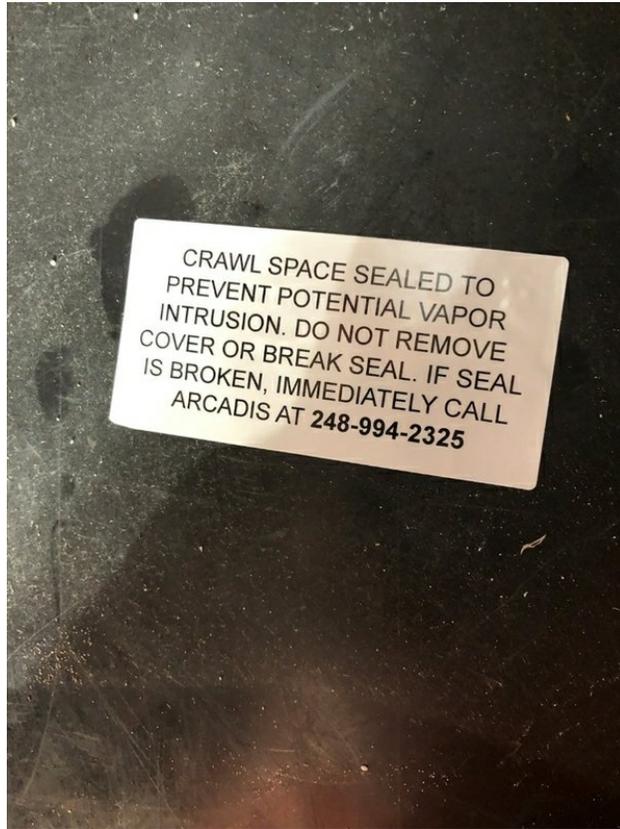
Barrier Label Photos

Are labels present at the crawlspace barrier? Yes

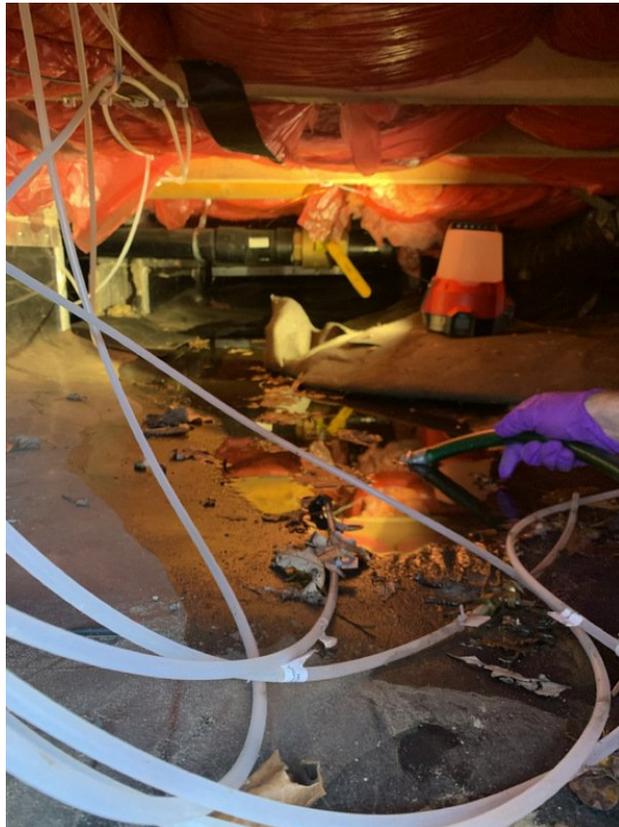
Is water observed on the barrier?	Yes
Location of Water on Barrier	North of crawl space near entry
Can the source of water be identified?	No

Volume of Water on Barrier (gal)	9
Can water be felt under the barrier?	No
Do barrier seams need addition sealing or repair?	No

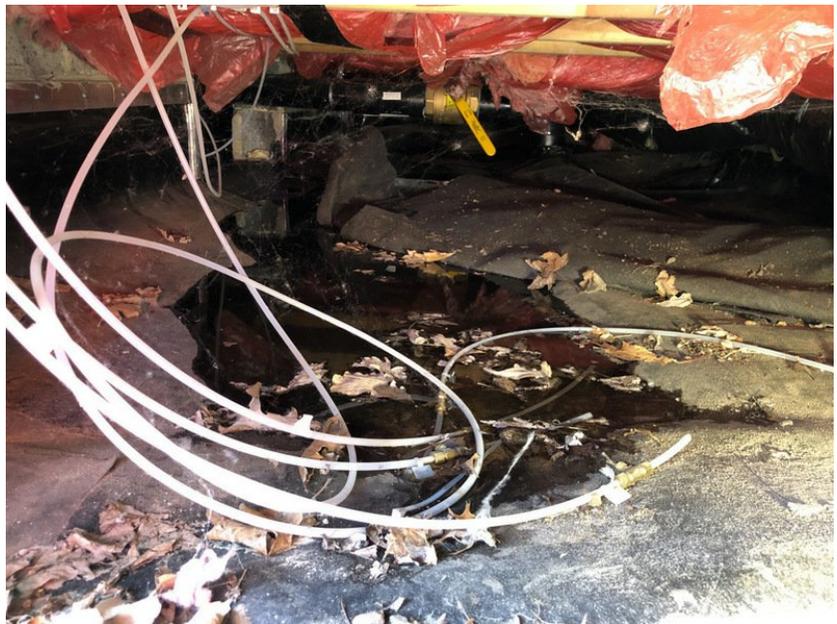
Is water observed on the barrier?	Yes
Location of Water on Barrier	In front of crawl space door
Can the source of water be identified?	Yes

Volume of Water on Barrier (gal)	10
Can water be felt under the barrier?	No
Describe Source Location	Door
Do barrier seams need addition sealing or repair?	No

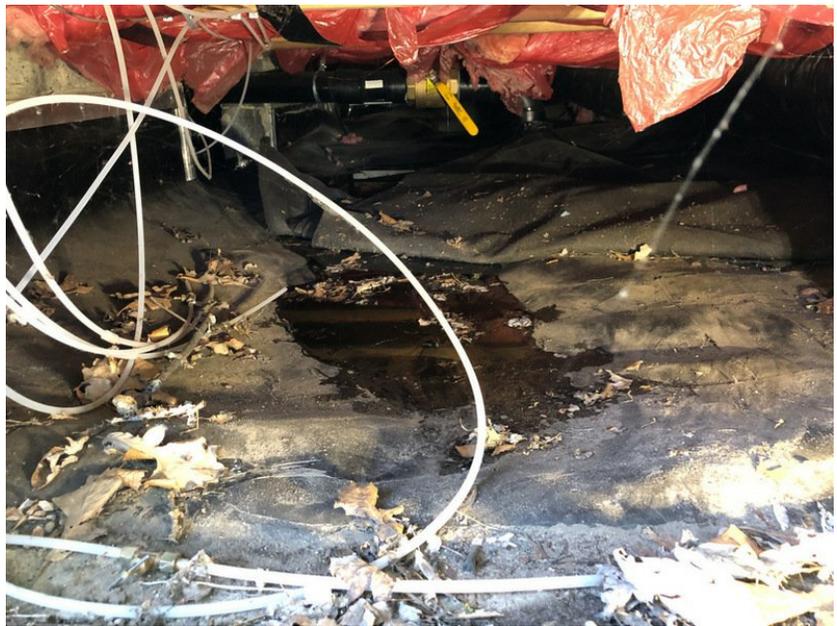
Is water observed on the barrier?	Yes
Location of Water on Barrier	In front of crawl space entrance
Can the source of water be identified?	Yes

Volume of Water on Barrier (gal)	2
Can water be felt under the barrier?	No
Describe Source Location	Entrance door
Do barrier seams need addition sealing or repair?	No

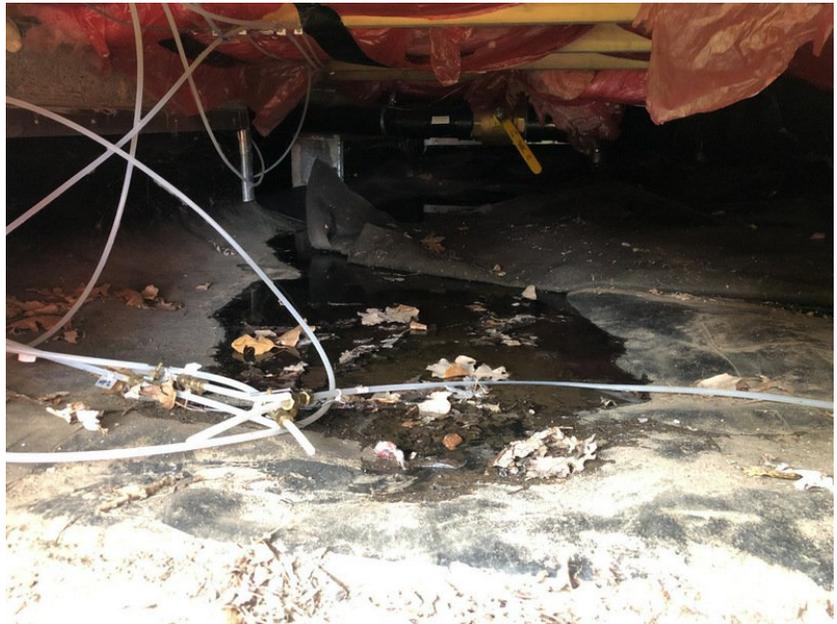
Is water observed on the barrier?	Yes
Location of Water on Barrier	Entrance
Can the source of water be identified?	Yes

Volume of Water on Barrier (gal)	10
Can water be felt under the barrier?	No
Describe Source Location	Entrance door
Do barrier seams need addition sealing or repair?	No

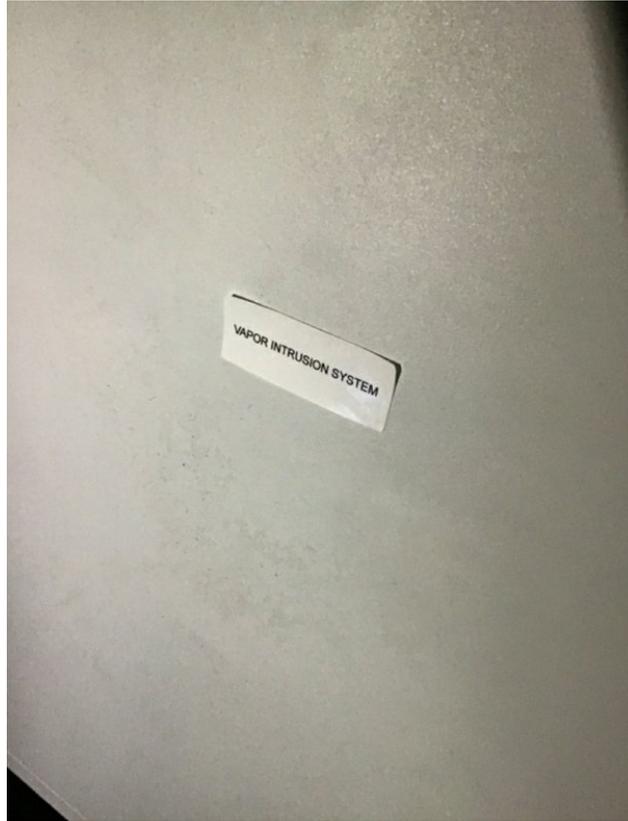
Common Label Photos

Are labels present at the pipe, control panel, u-tube, and breaker? Yes

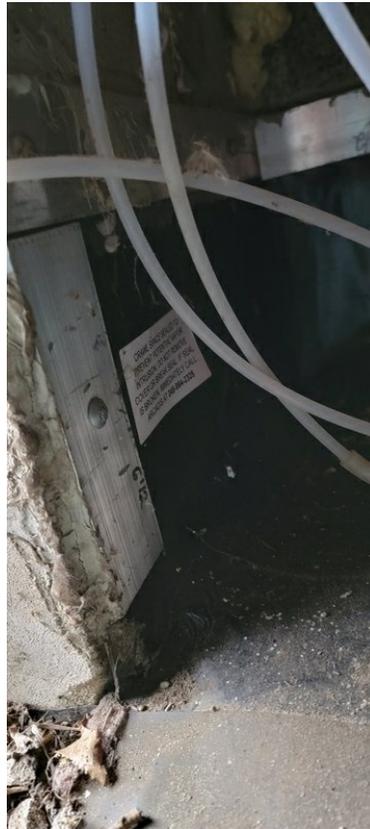
Barrier Label Photos

Are labels present at the crawlspace barrier? Yes
