Date:
July 31, 2017

Arcadis Project No.:
MI001322.0001

Subject:
DEQ Information Request Regarding Ford LTP
On site VI Investigation Plan

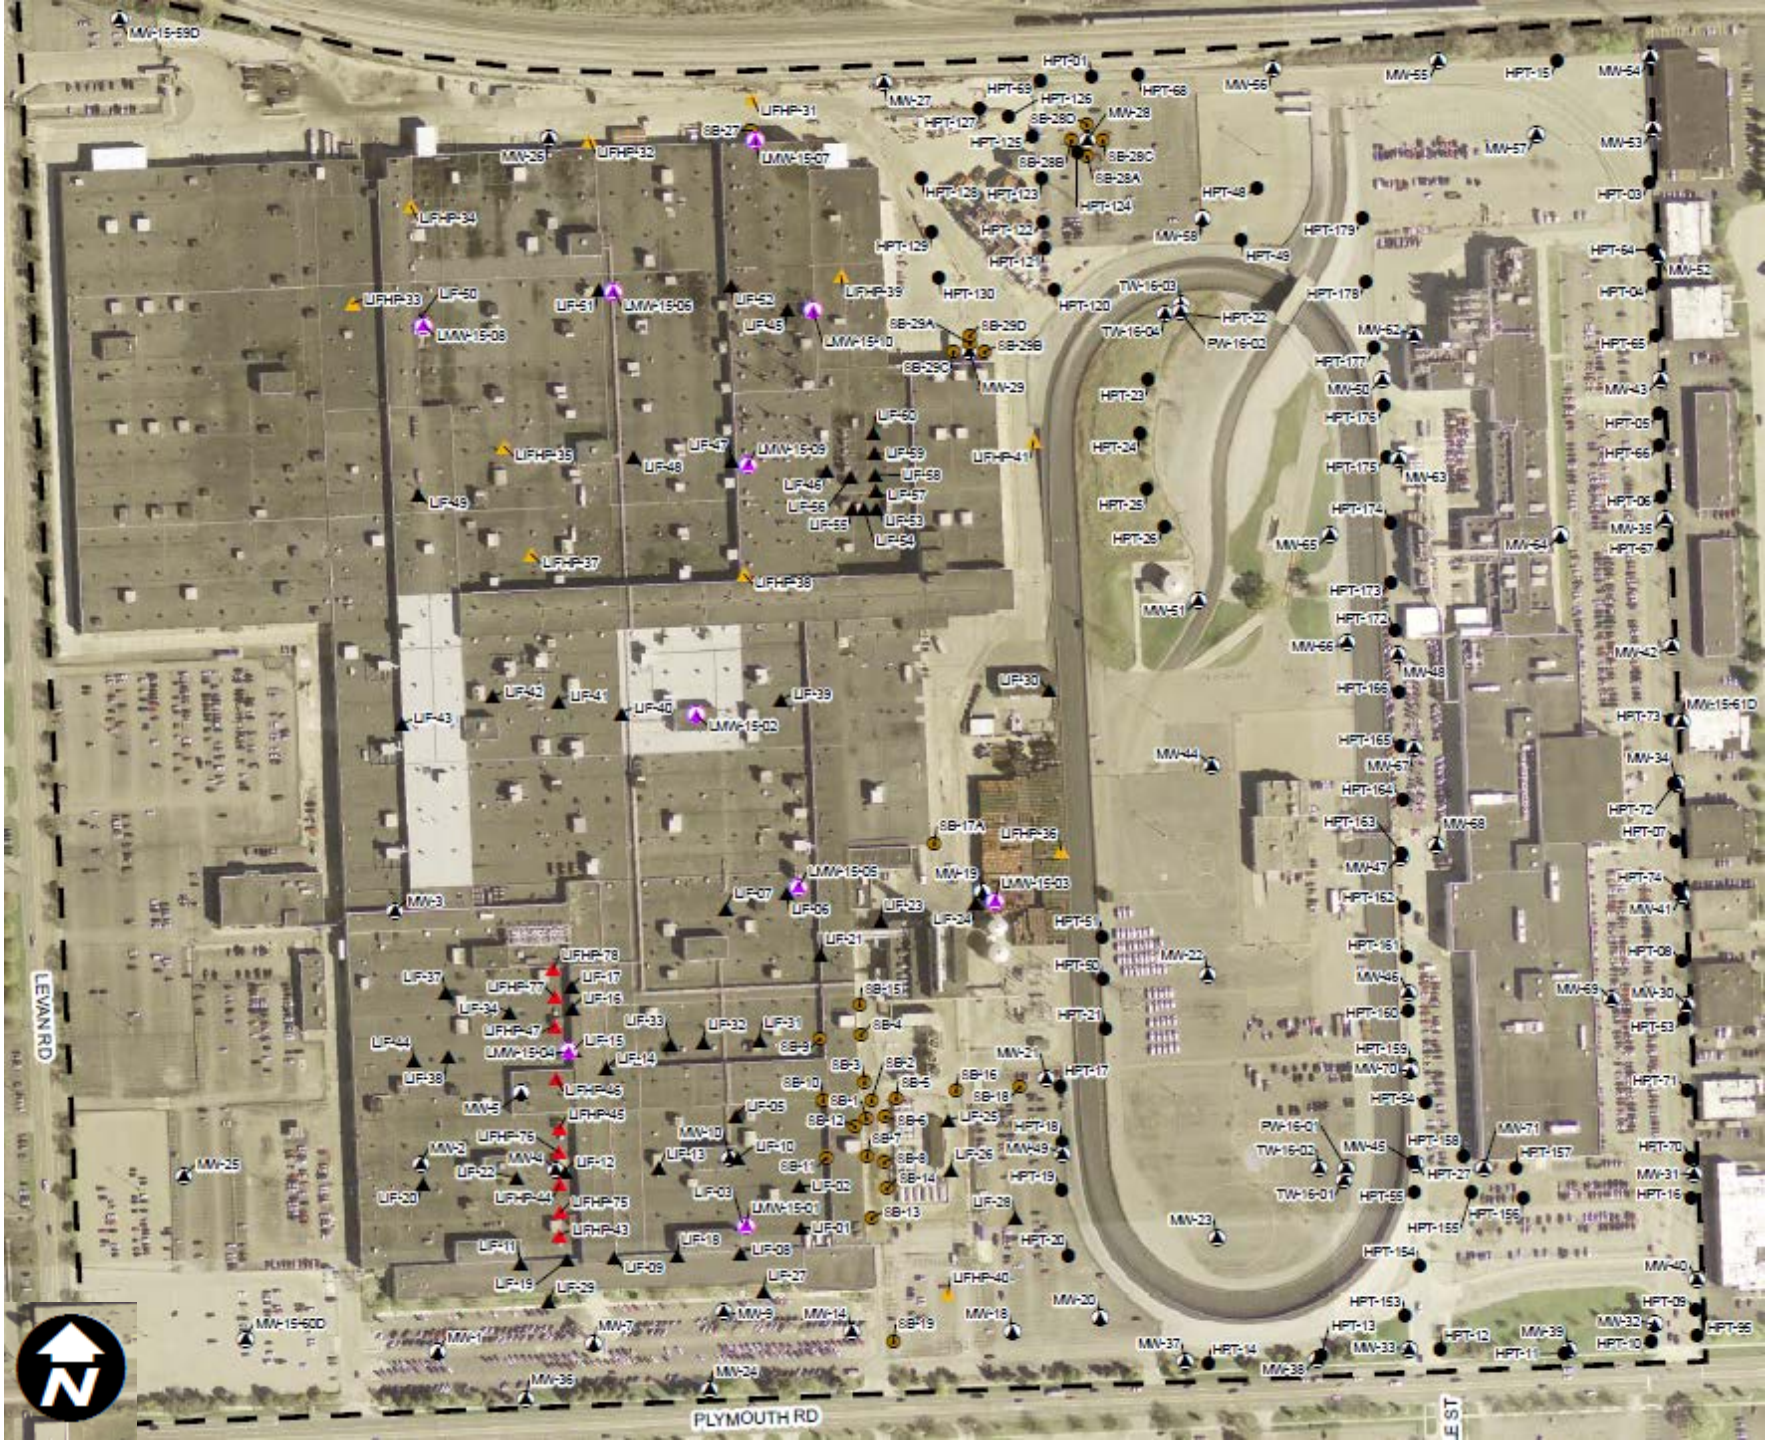
- HPT-VAP BORING (78)
- ▲ LIF BORING (57)
- ▲ LIF-HP BORING (11)
- ▲ LIF-HP-WCSS BORING (9)
- MONITORING WELL (88)
- LNAPL MONITORING WELL (10)
- SOIL BORING (28)
- ▬ FORD PROPERTY BOUNDARY

The current CSM incorporates existing site knowledge (such as geologic setting) with high-resolution permeability profiling and sampling. Borings completed as part of the Remedial Investigation (RI) are included on Slide 4. Exterior work has focused on permeability mapping with the Geoprobe™ Hydraulic Profiling Tool (HPT; Slide 5) and high-frequency vertical aquifer profile (VAP) groundwater sampling to characterize the hydrostratigraphy, contaminant distribution, and mass flux. Beneath the LTP building, high-frequency soil sampling was completed in lieu of VAP sampling to evaluate volatile organic compound (VOC) distribution through the LNAPL and within the saturated soil column. LNAPL delineation used a state-of-the-art laser-induced fluorescence (LIF) hydraulic profiling (LIF-HP) tool to simultaneously map LNAPL distribution and log the relative permeability of the soil. Based on LIF/LIF-HP results, LNAPL monitoring wells were installed for LNAPL sampling and mobility testing.

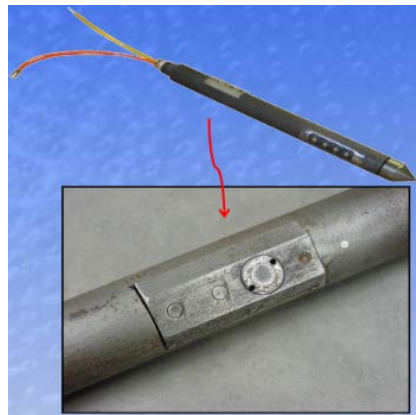
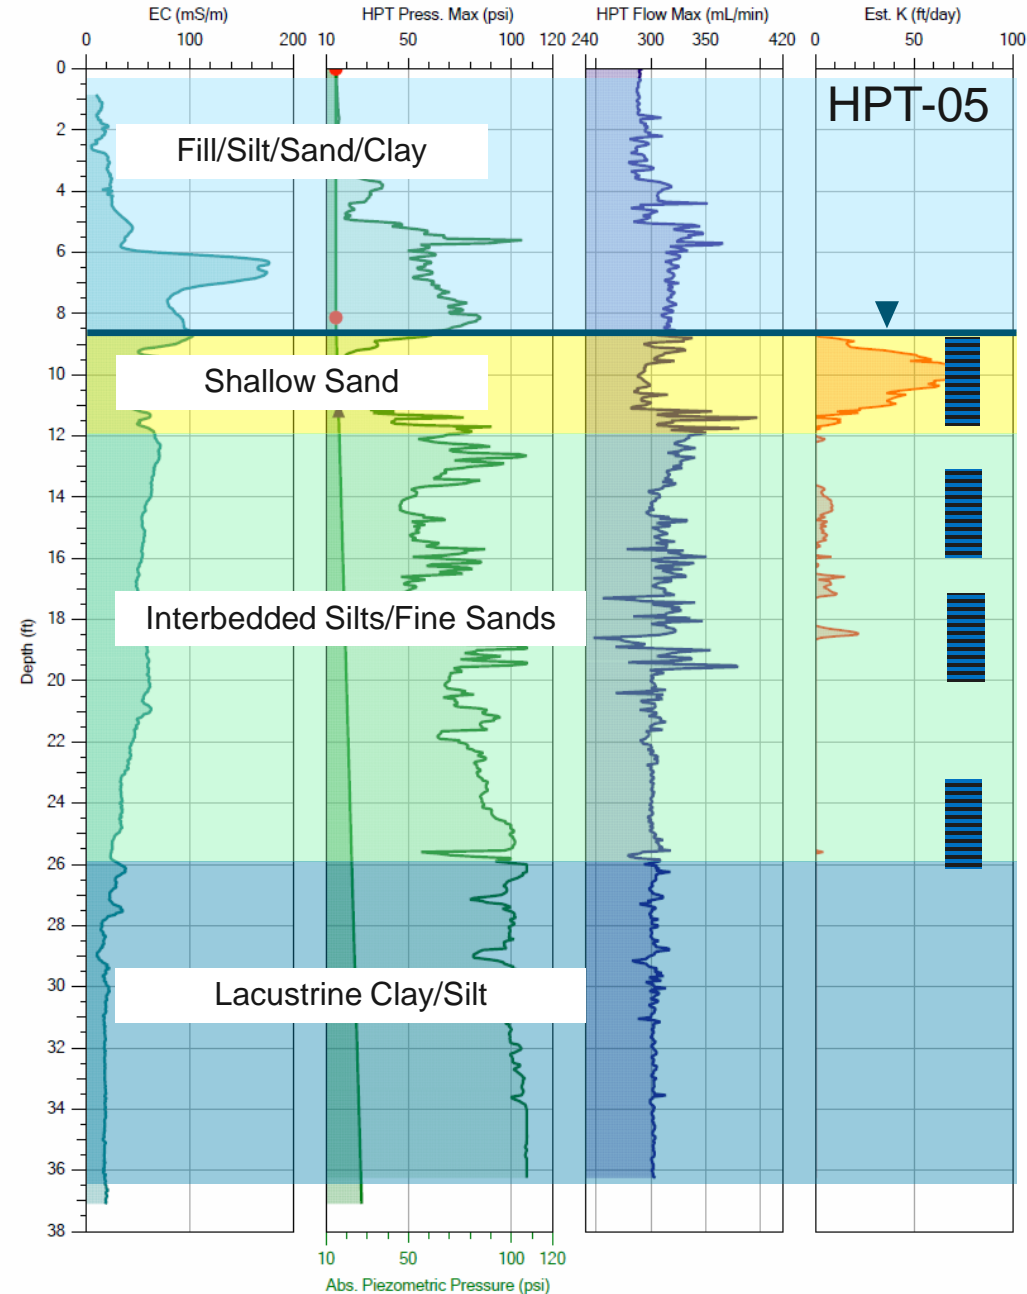
HPT Characterization

Geoprobe® Hydraulic Profiling Tool

- Est. K is Q/P corrected by an empirical relationship developed by Geoprobe

Slide 6 presents fence diagrams constructed with the HPT data. Shallow sediments at the Site are associated with a near-shore lacustrine setting and consist of varying amounts of fill material to depths between 0 and 5 feet below ground surface (ft bgs) followed by sandy outwash from approximately 5 to 12 ft bgs. From approximately 12 ft bgs to 25 ft bgs, a zone of interbedded fine sand and silt is encountered that transitions to a low-permeability clay. Groundwater is typically encountered at 6 to 8 ft bgs. Groundwater impacts at the Site are confined to these shallow sediments. Mass flux at the Site is isolated within the more permeable sand seams located within the top 20 feet of sediments.

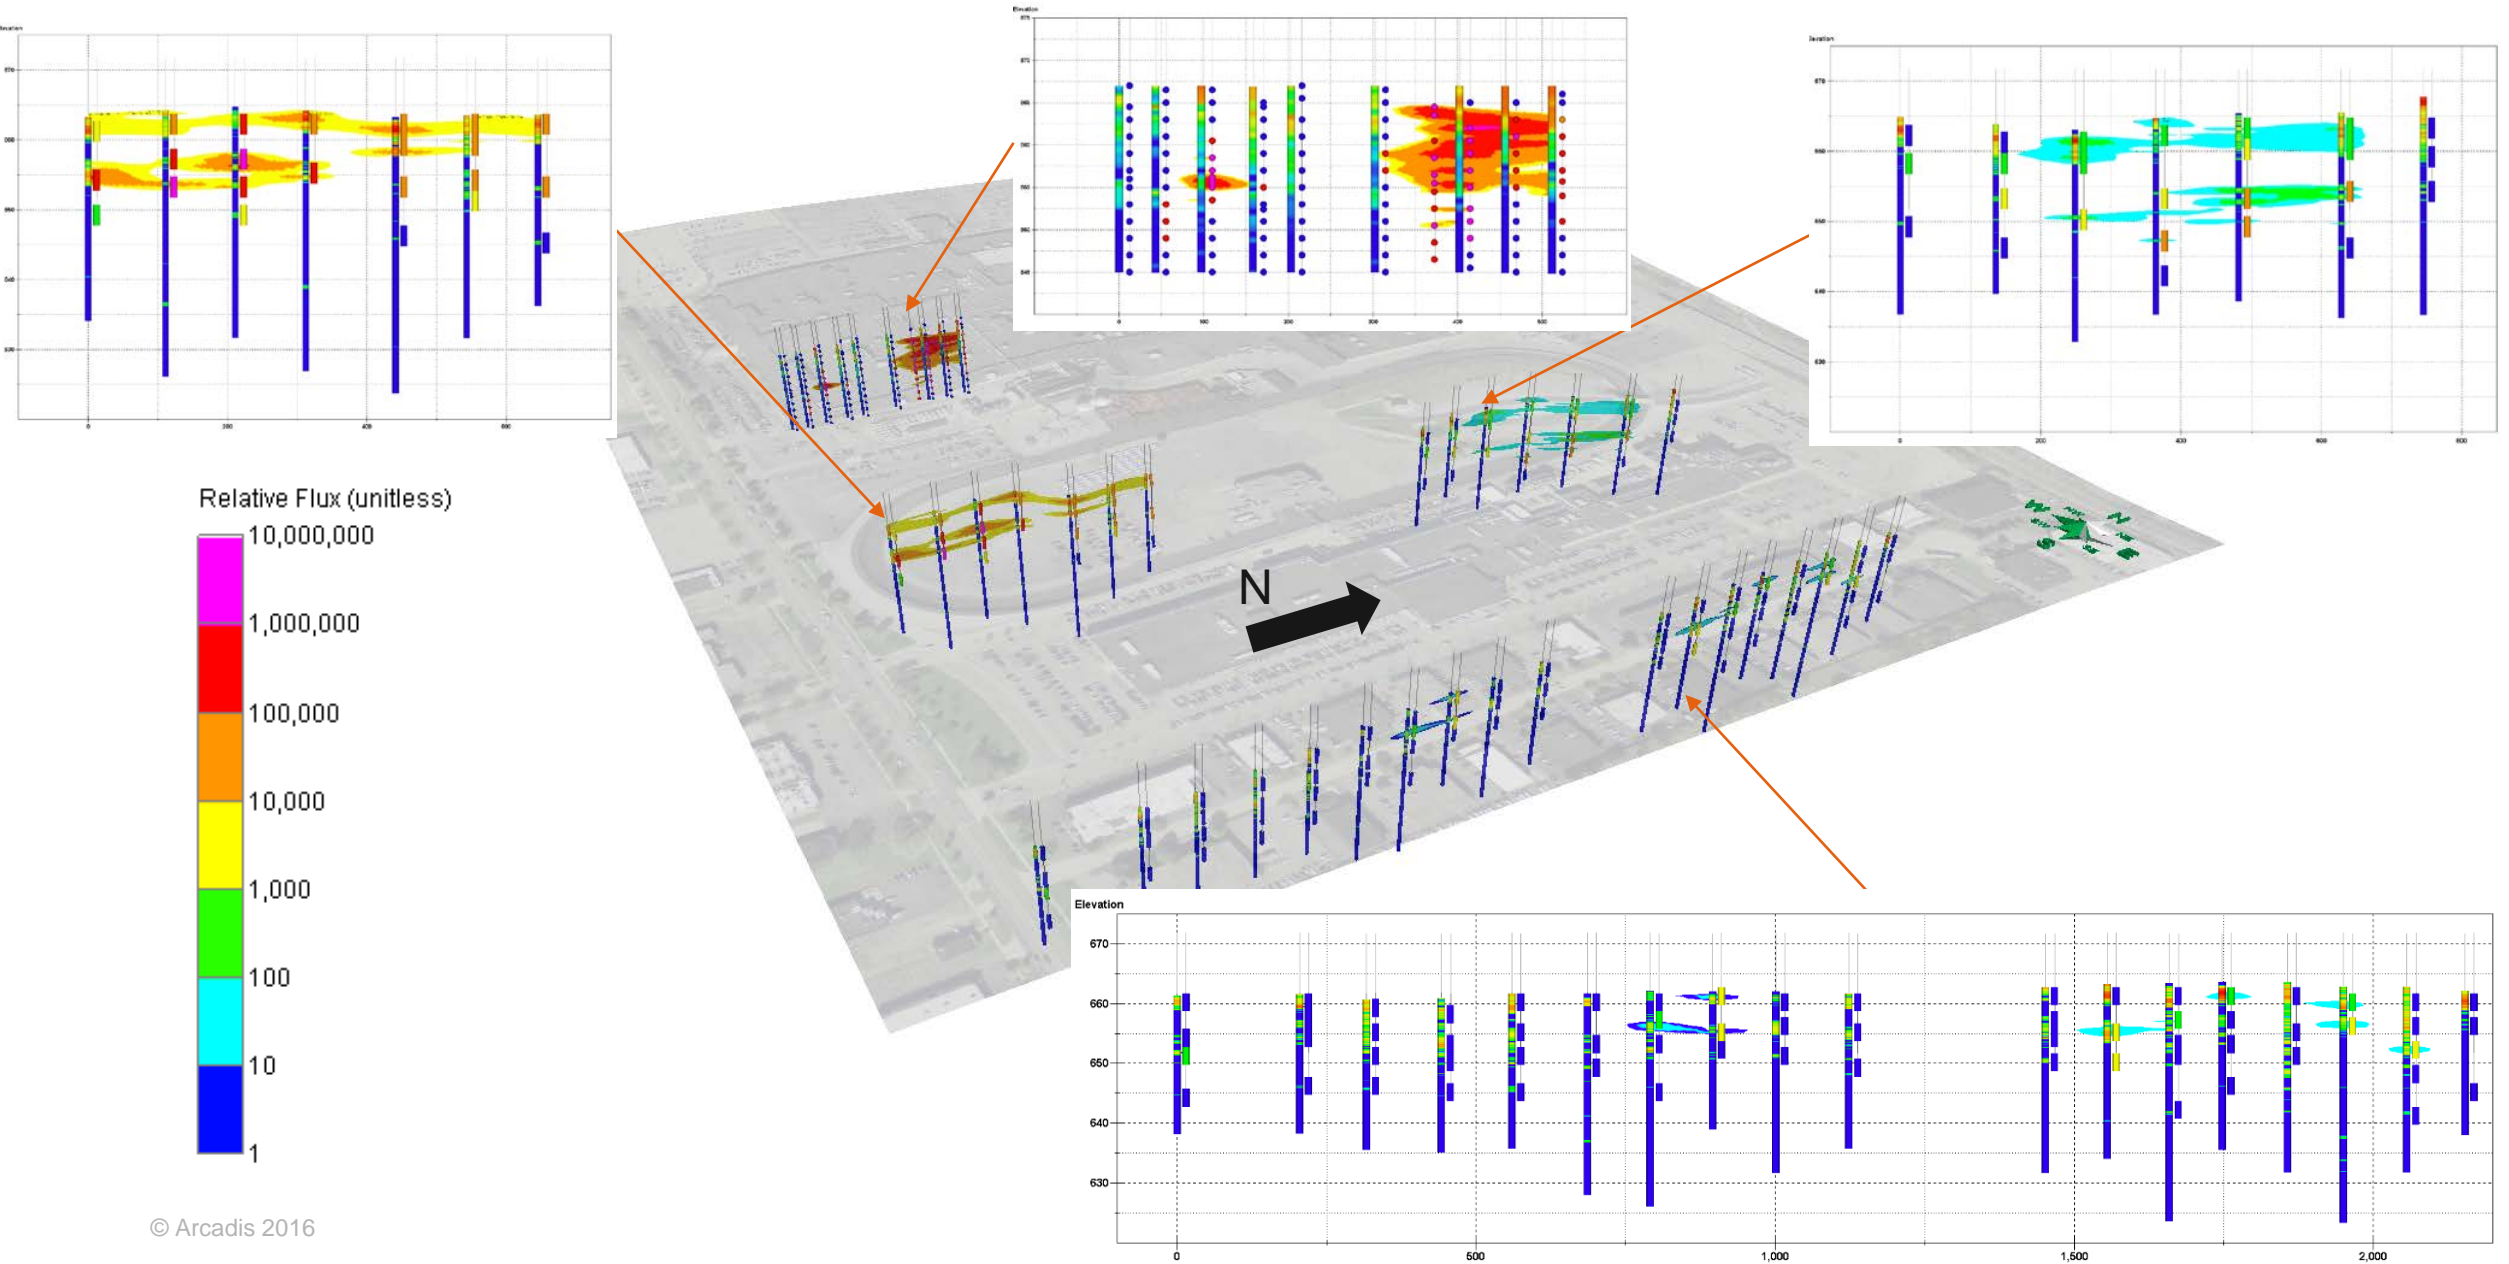
Stratigraphic Flux Model

Relative Flux (unitless)

Slide 19 provides a stratigraphic flux model that illustrates a relative measure of mass flux along each HPT transect. The stratigraphic flux is derived by multiplying the 3-D permeability field determined with HPT or LIF-HP, with the concentration field determined using VAP or saturated soil sampling. The result illustrates a five order-of-magnitude decrease in relative mass flux between the source area(s) located beneath LTP and the eastern property boundary. This result suggests that groundwater impacts attenuate rapidly between the source area and the eastern property boundary, likely due in part to anaerobic dechlorination of chlorinated VOCs (CVOCs) due to conditions created by the presence of LNAPL beneath the LTP building. In addition, migration of groundwater impacts on the southeastern portion of the Site were historically hindered by the presence of the eastern storm drain (Slide 20) as described further below.

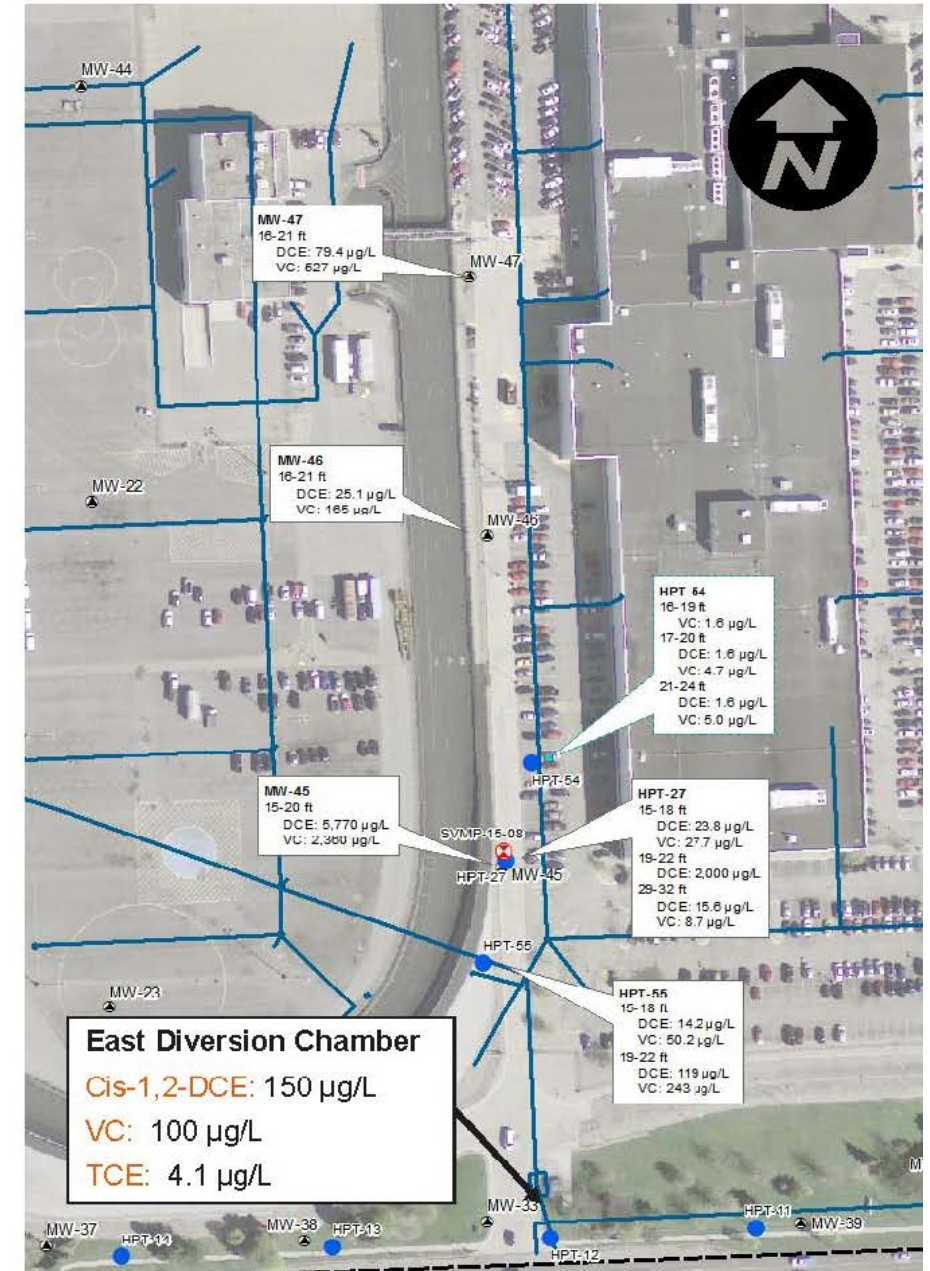
- Groundwater plume at 8 ppm total VOCs west of storm main, diminishes to the east
- Storm water discharges to sanitary sewer, under base flow conditions
- Permit 006-27510-IU issued by Great Lakes Water Authority on March 23, 2017
- Groundwater low around MW-45 area

- HPT-VAP BORING
- ⊗ SOIL VAPOR SAMPLING LOCATION
- ▲ EXISTING MONITORING WELLS
- STORM SEWER
- ▭ APPROXIMATE PROPERTY BOUNDARY

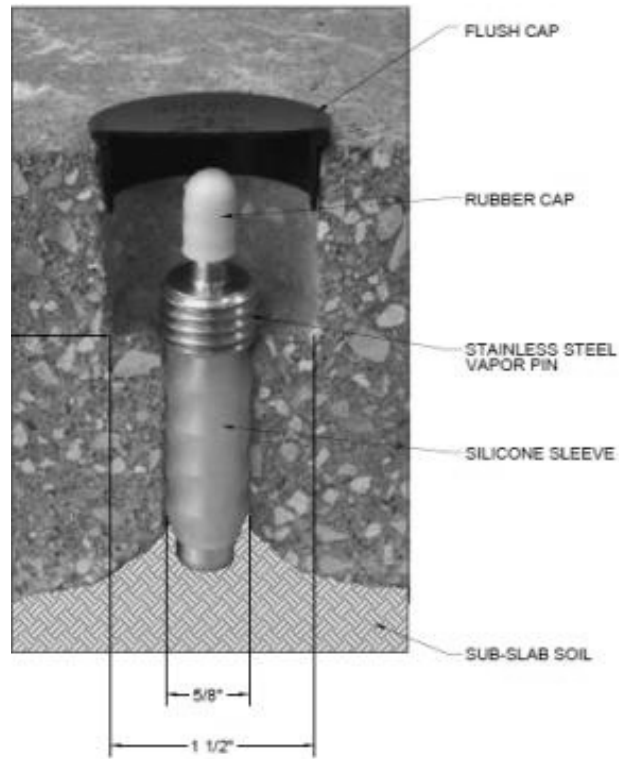
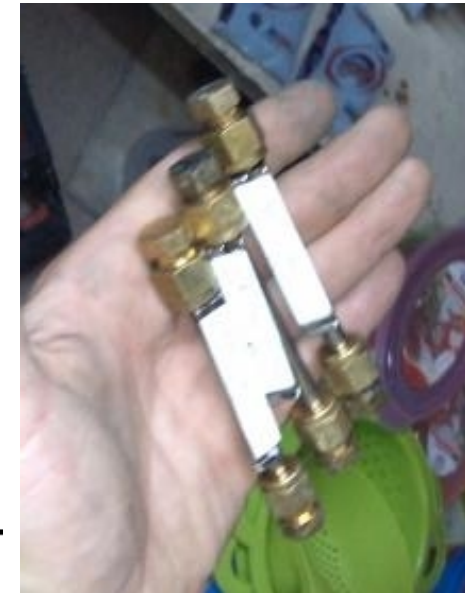
Sampling Methods - VOCs

Permanent, flush-mounted sample points installed through slab

Each installation leak tested prior to use

VOC samples collected using sorbent tubes

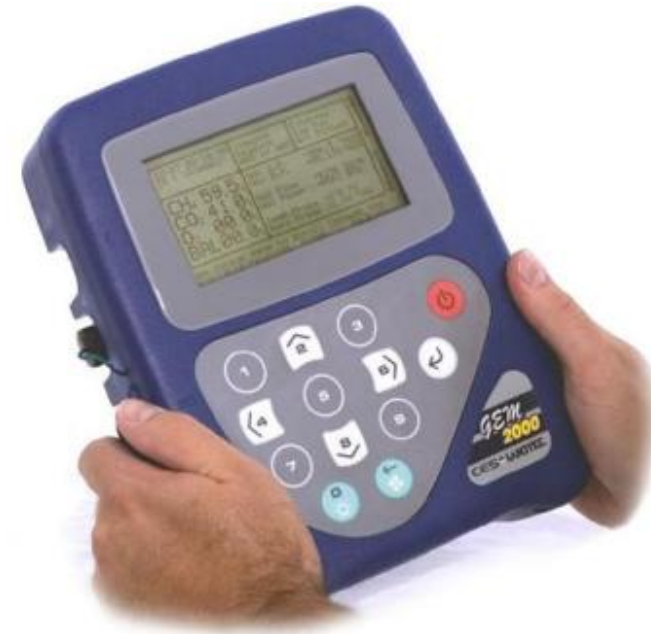
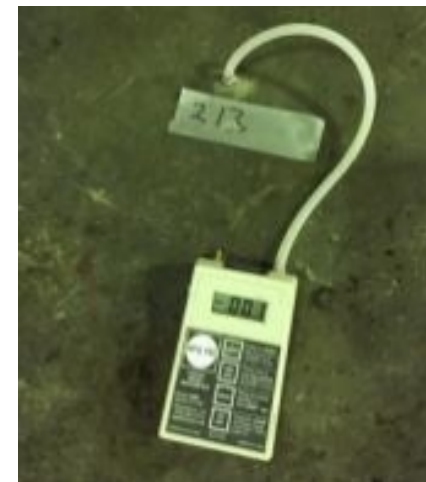
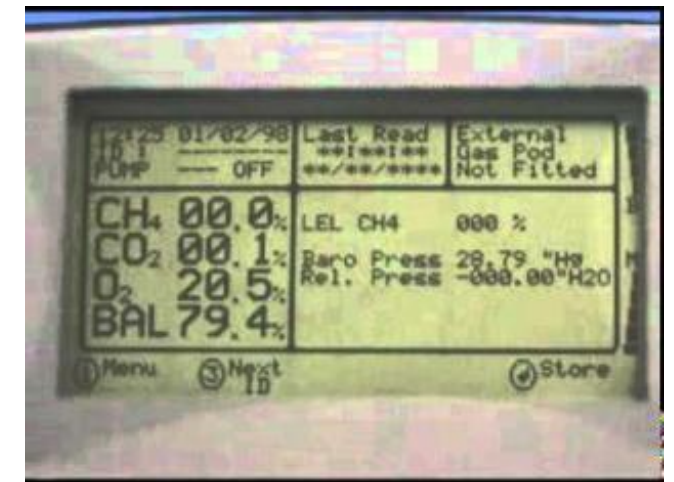
Real-Time Monitoring

- Differential Pressure
 - < 0.1 in water column pressure noted
 - Sub-grade pressure not sufficient to generate mass flow into building
- Methane
 - 0 – 46 % by volume
- CO₂
 - Indicator of biogenic methane production
- O₂
 - Indicator of attenuation
- No pathways to indoor air noted during monitoring
- Plant H&S staff conducted additional methane monitoring

- No significant pressure was noted beneath the floor slab during differential pressure measurements (Slide 31).
- The floor slab of the facility is 8 inches thick in most locations, and most of the plant is covered in an epoxy covering. Although the epoxy coating was added to enable smooth travel of carts and personnel inside the facility, it also likely provides some impediment to vapor movement.

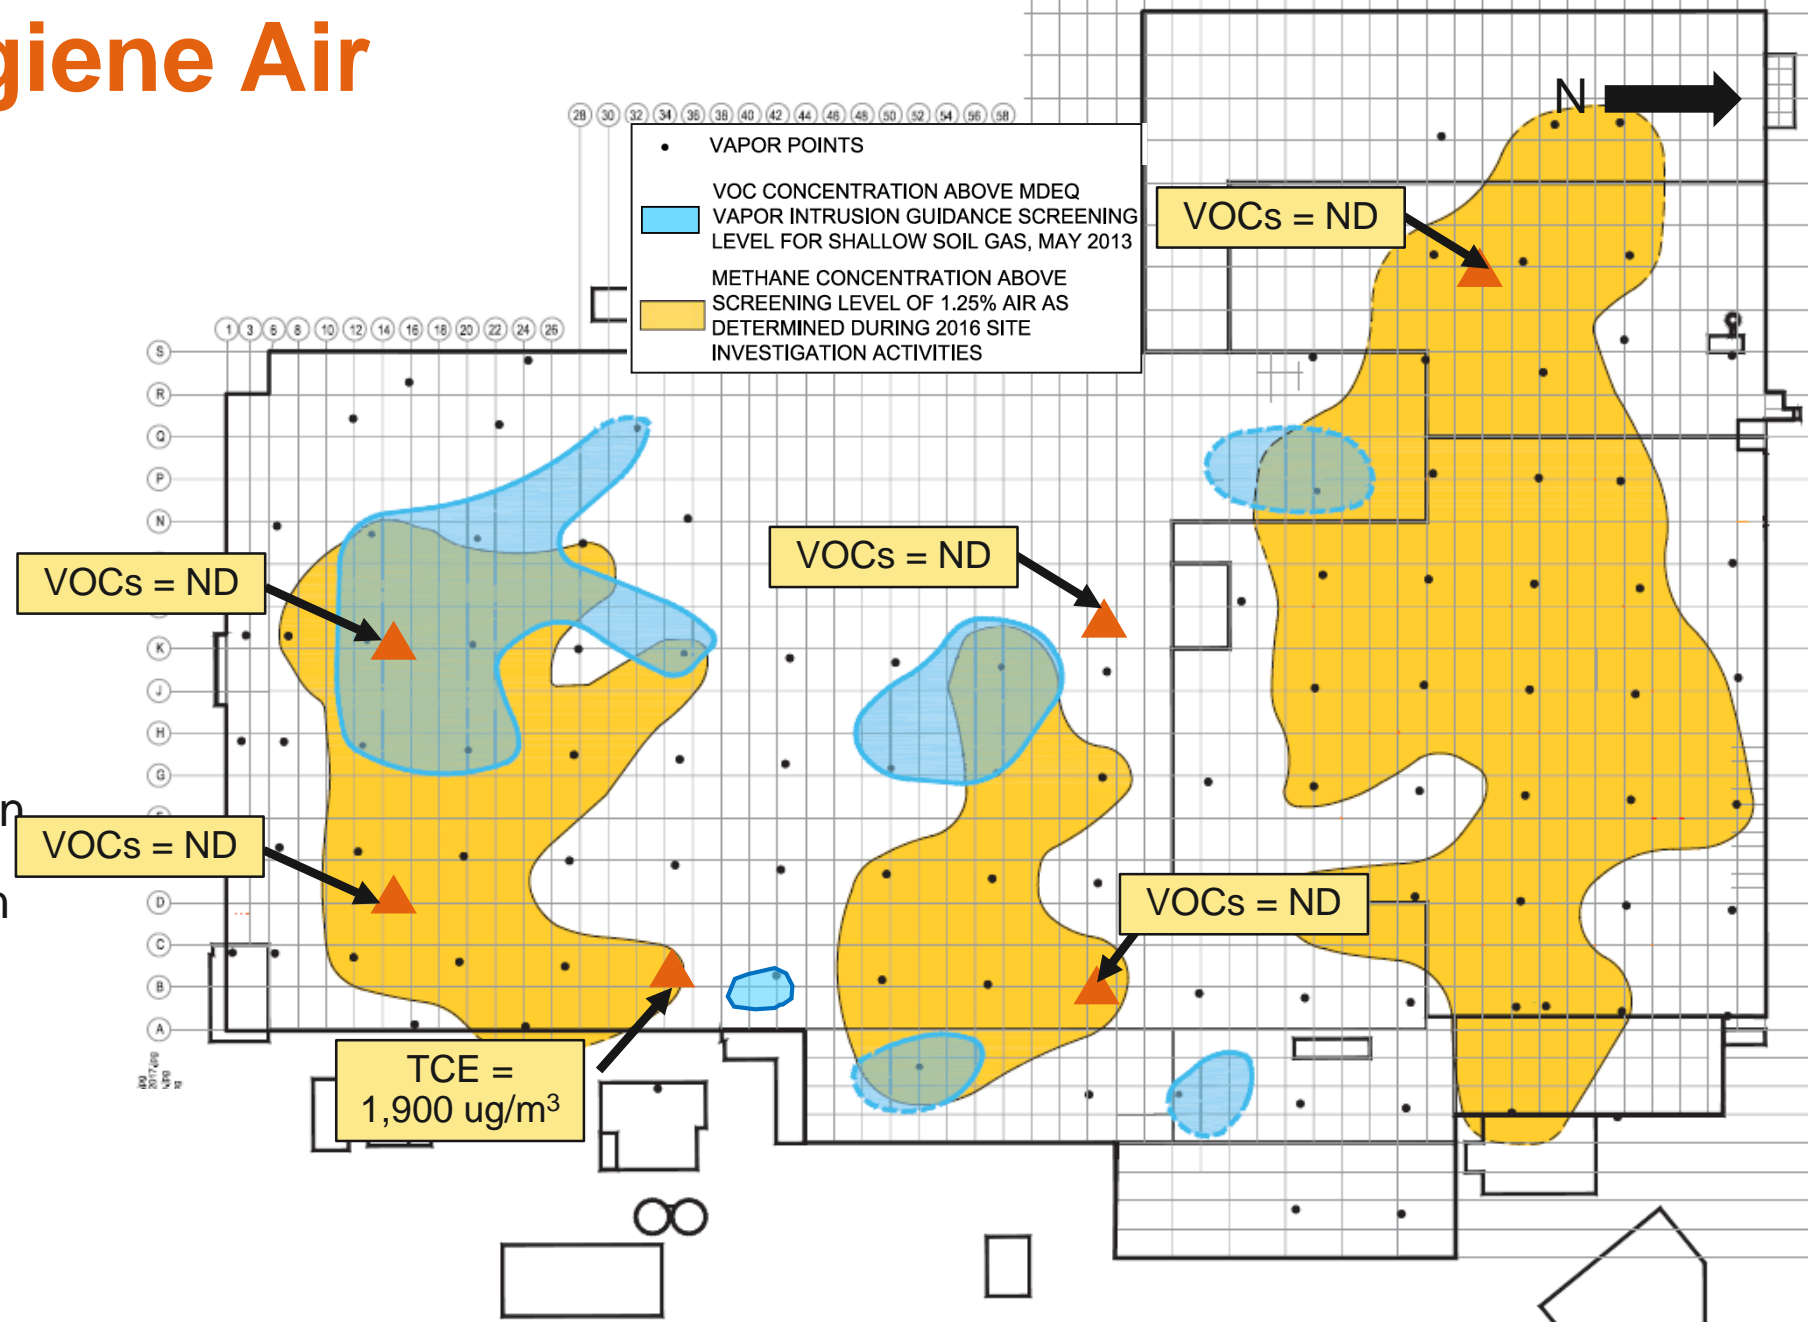
Industrial Hygiene Air Sample Data

- Six samples collected 7/30/2015 using industrial hygiene methods
- Elevated detection limits limit data utility
- VOCs not-detected at 5 locations (DLs = 0.1 ppmv)
- TCE detected at 360 ppbv (1,900 ug/m³) at final location
- Sample collected near an open trench during construction
- Not considered a representative indoor air sample

- Indoor air sampling at six locations inside the plant in July 2015 (Golder) using industrial hygiene sampling methods (Slide 35). The detection limits of these samples (0.1 parts per million by volume [ppmv] for VOCs) limit the utility of the data for assessing the potential for vapor intrusion. VOCs were not detected in five of the six indoor air samples. At the sixth sample location, TCE was detected; however, a trench to the sub-grade was open during construction, skewing the sampling results high and not representing normal operating conditions.

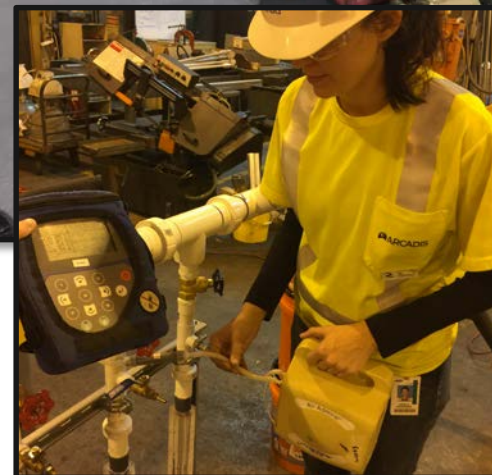
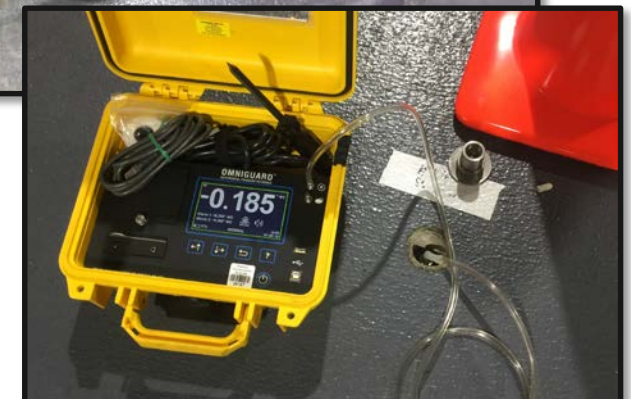
Sub-Slab Depressurization (SSD) Pilot Test

- Completed Dec. 28-30, 2016
- Five test areas across the plant

Testing was not completed in production area due to limited access and consistent results at other test locations

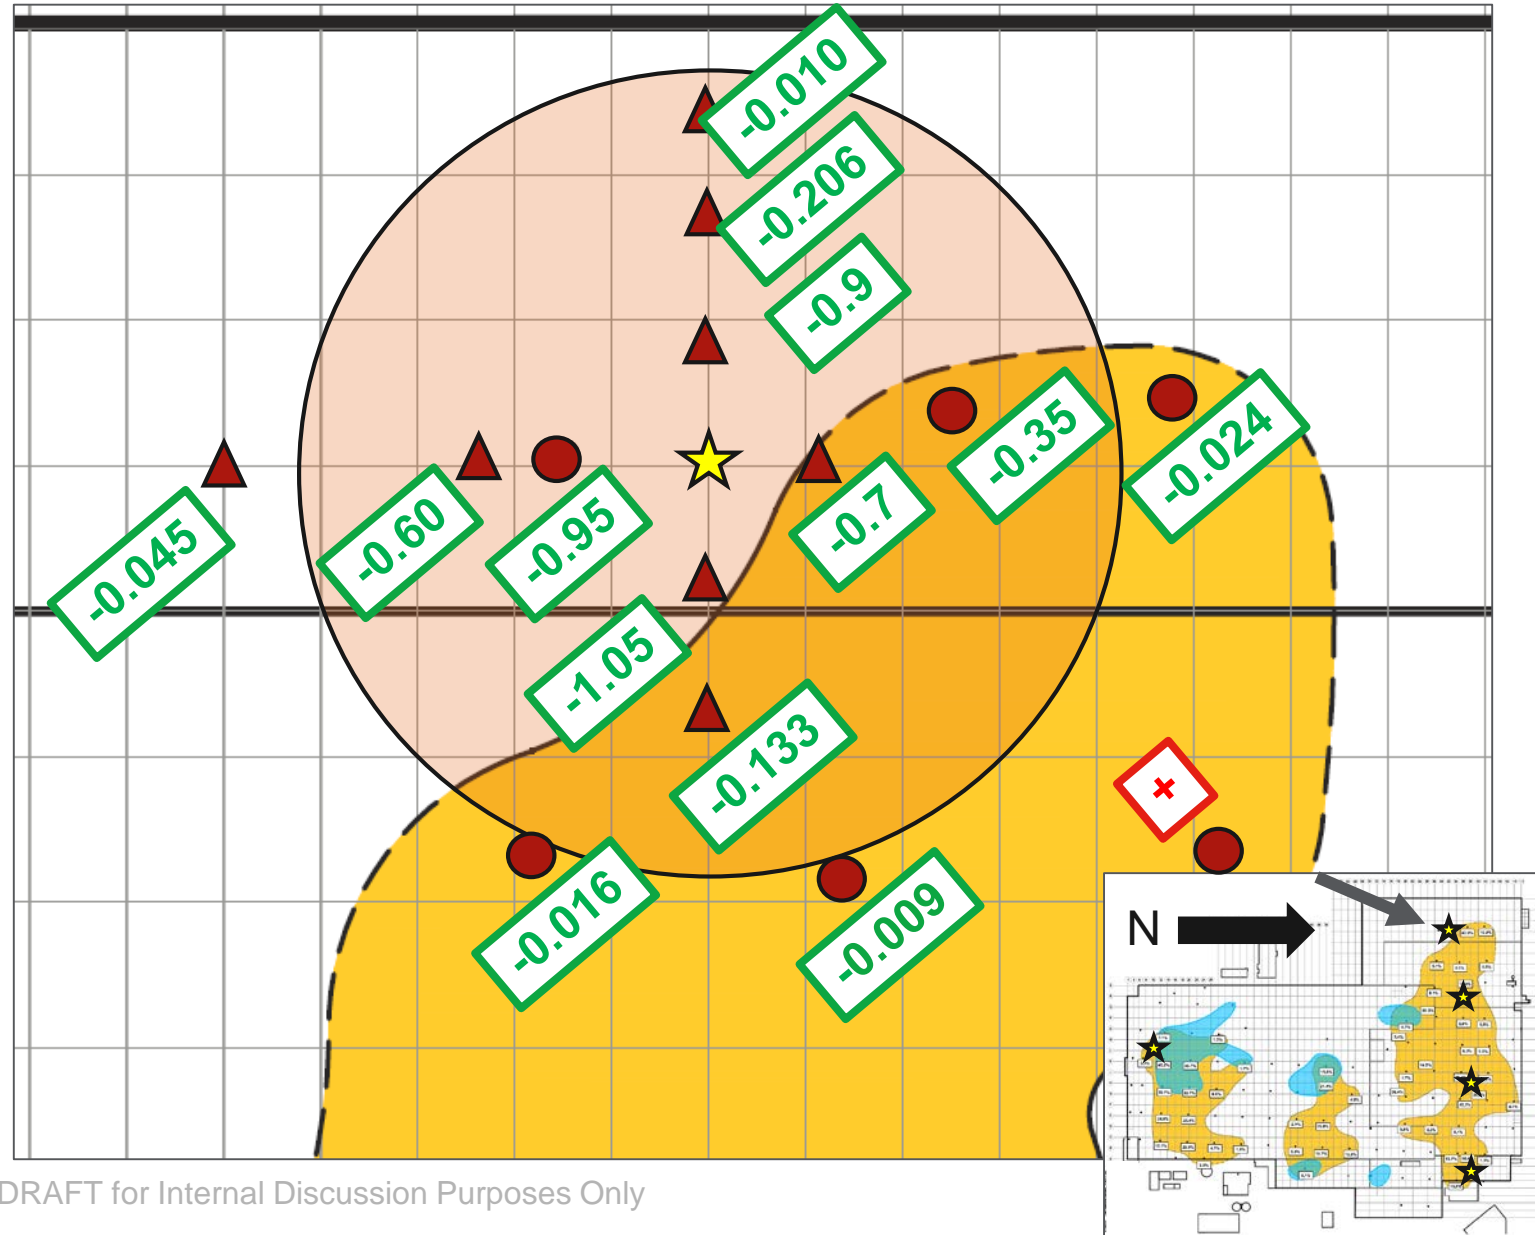
SP-X92 SSD Pilot Test Results

-1.0 Observed pressure (in H2O)

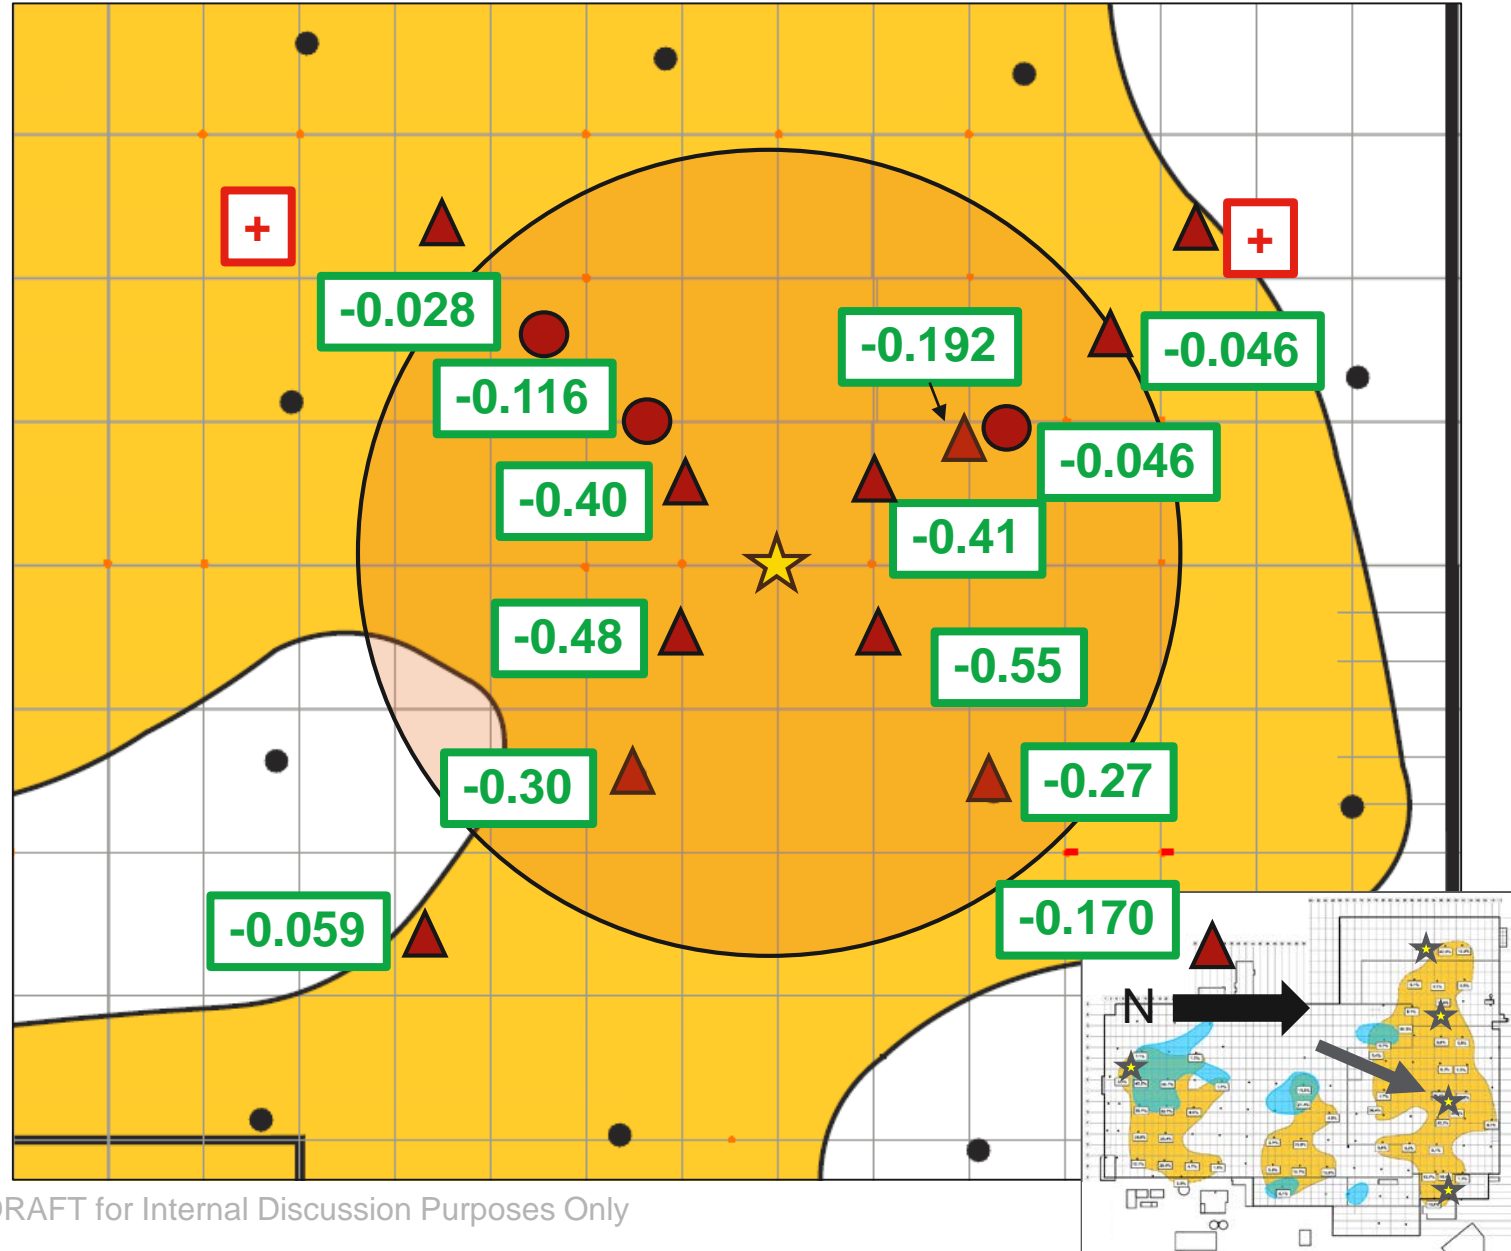
SP-H98 SSD Pilot Test Results

- ★ Suction Pit
- ▲ Temporary Monitoring Point
- Existing Vapor Pin
- 1.0 Observed pressure (in H2O)

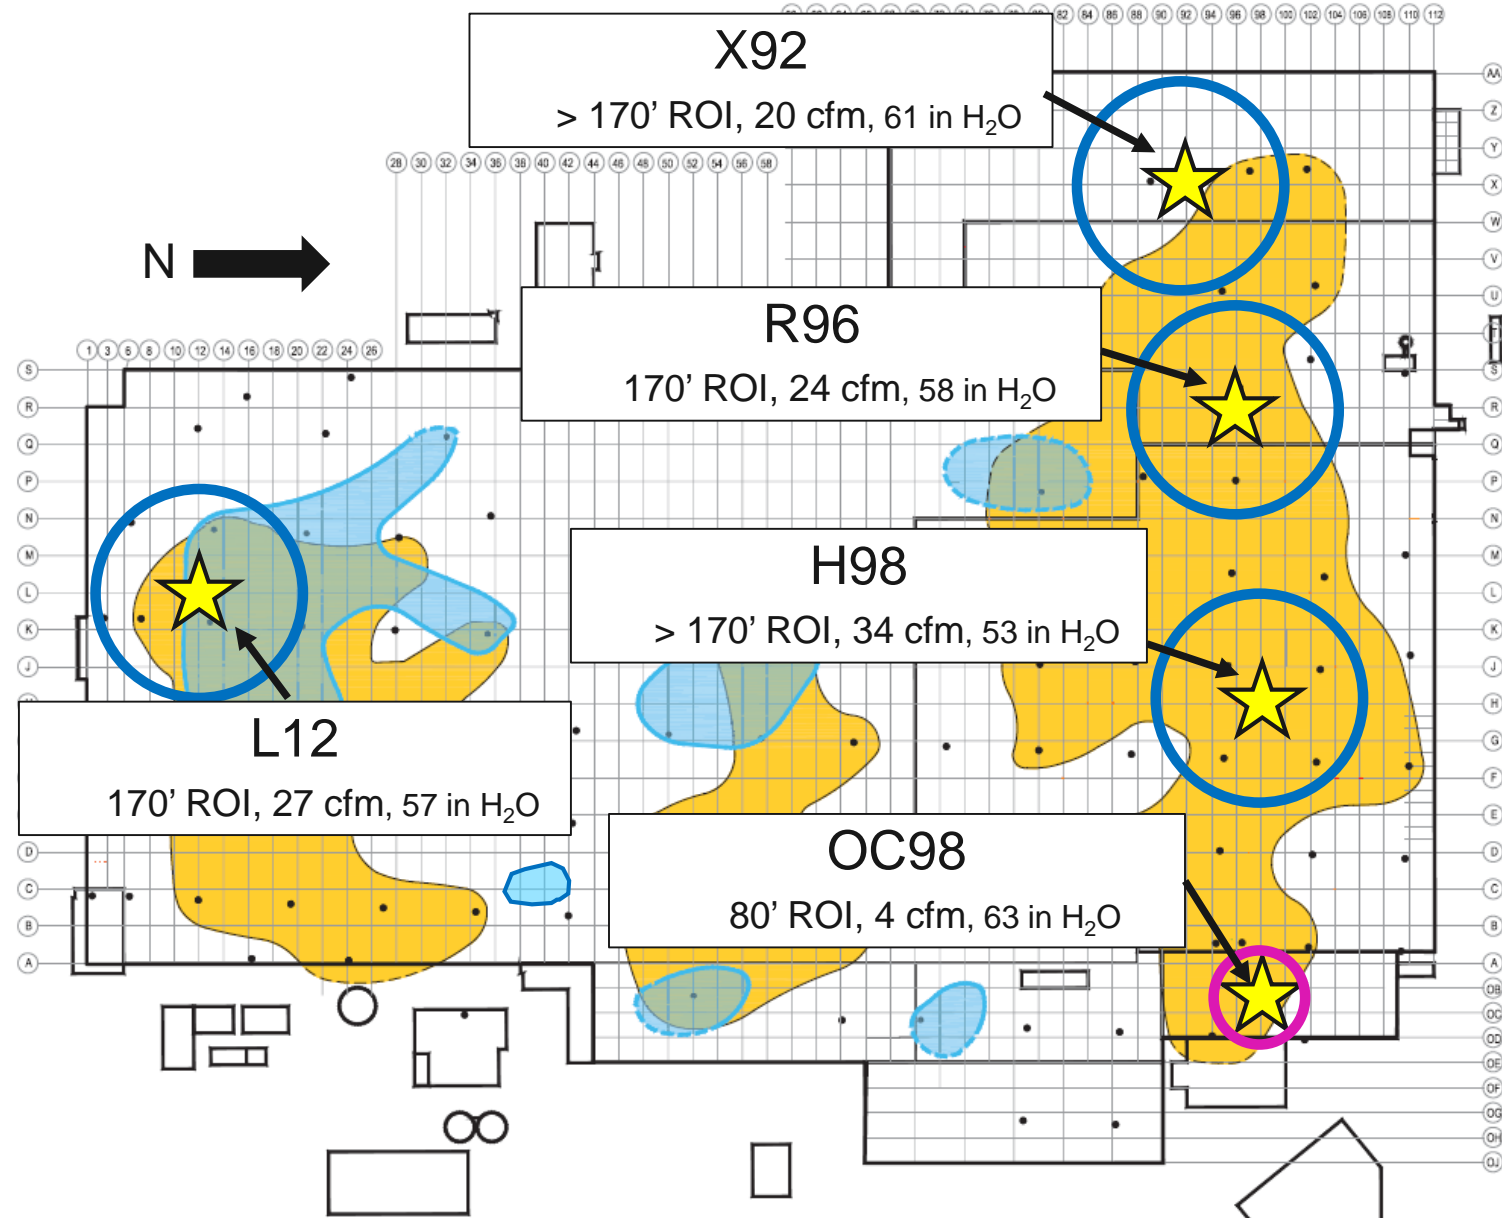
SSD Pilot Test Summary

- Consistent results at all test locations except OC98
- Target vacuum of 0.004 in H₂O achieved >170 ft. at 4 of 5 test locations
- Target vacuum achieved to 80 ft. at OC98

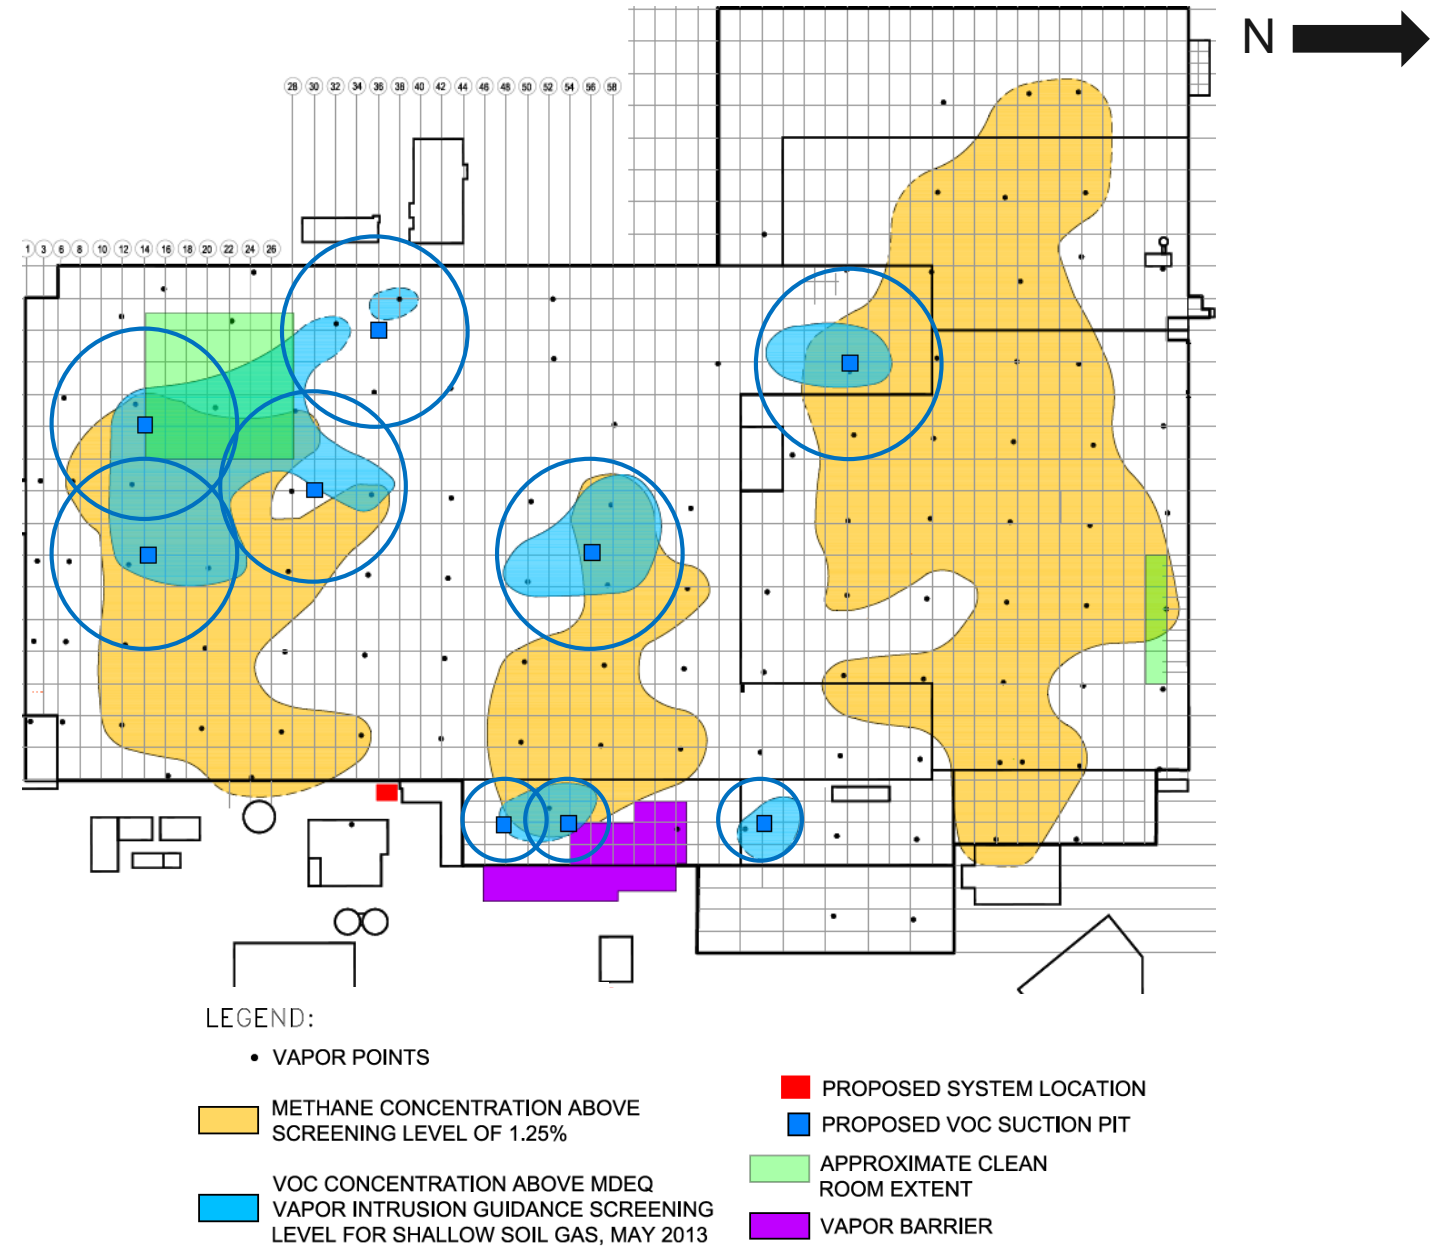
VOC SSD System

- Active VI mitigation
- Nine SP extraction system
- Mitigates VOC areas exceeding 2013 VI shallow soil-gas screening levels
- Currently being designed
- Clean room(s) are under positive pressure
