Date:
July 31, 2017

Arcadis Project No.:
MI001322.0001

Subject:
DEQ Information Request Regarding Ford LTP
On site VI Investigation Plan

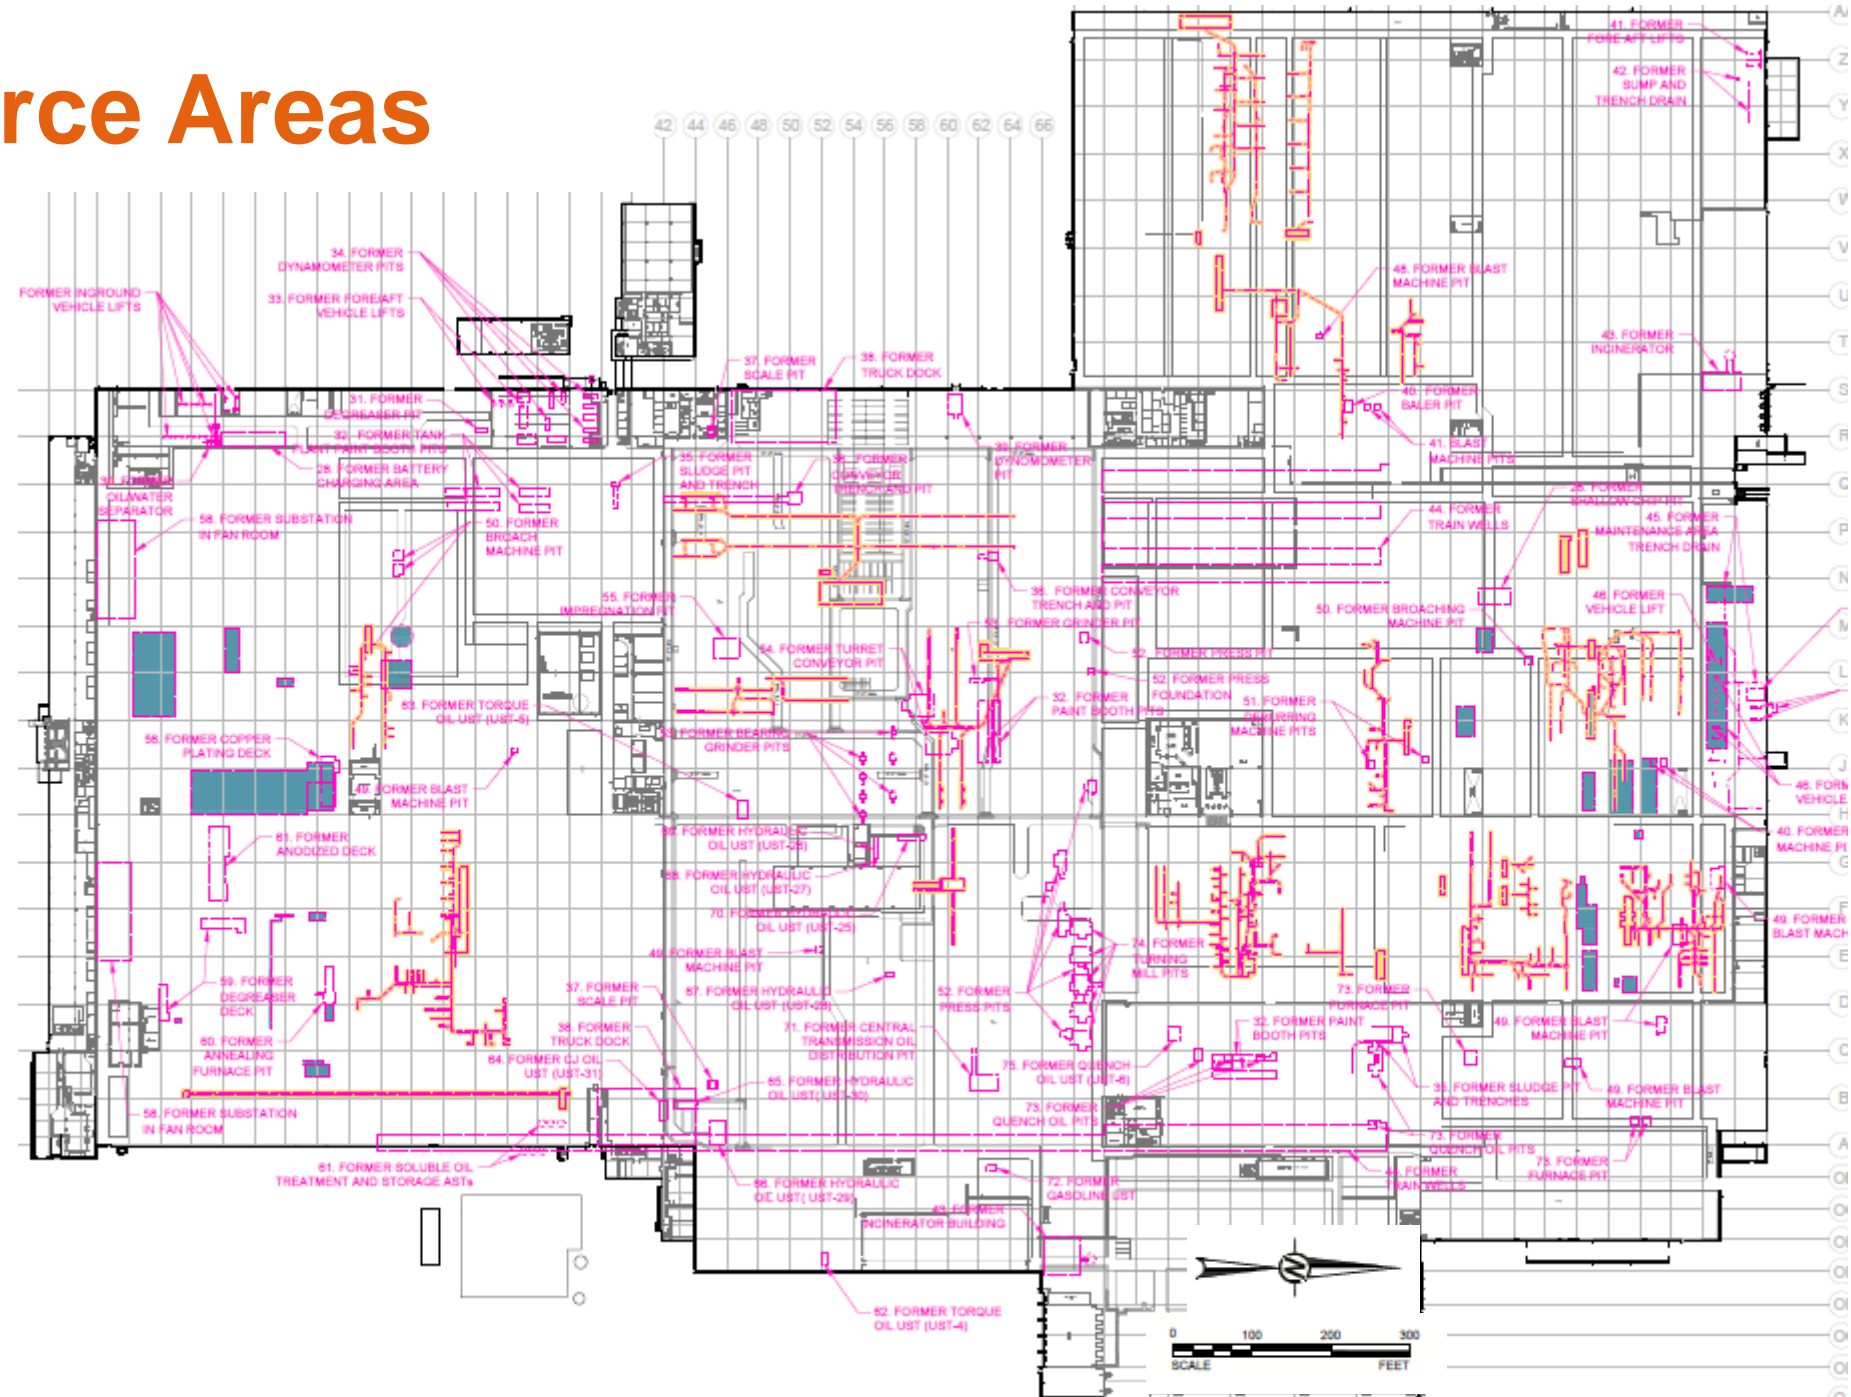
Potential Historical Sources

- Historical operations include many pits, tanks, and process lines, making specific source identification difficult
- Recent re-configuration of the plant includes bringing the floor to grade level across the plant and placing many of the utilities overhead
- There are currently no ongoing sources suspected beneath the building

Based on historical operations, there are multiple potential historical sources beneath the LTP building (Slide 46). As shown on Slide 46, numerous pits, tanks, and pipe runs were historically present beneath the building that may have contributed to the release of LNAPL and solvent compounds. In particular, the waste conveyance lines may have contributed to impacts at the Site from potential leaks. However, the results of the sampling data have suggested several areas that may be contributing to soil, groundwater, and vapor impacts at the Site. Based on the occurrence of VOCs in sub-slab soil gas samples, as well as the distribution of VOC impacts observed in soil, groundwater, and LNAPL samples, six areas have been

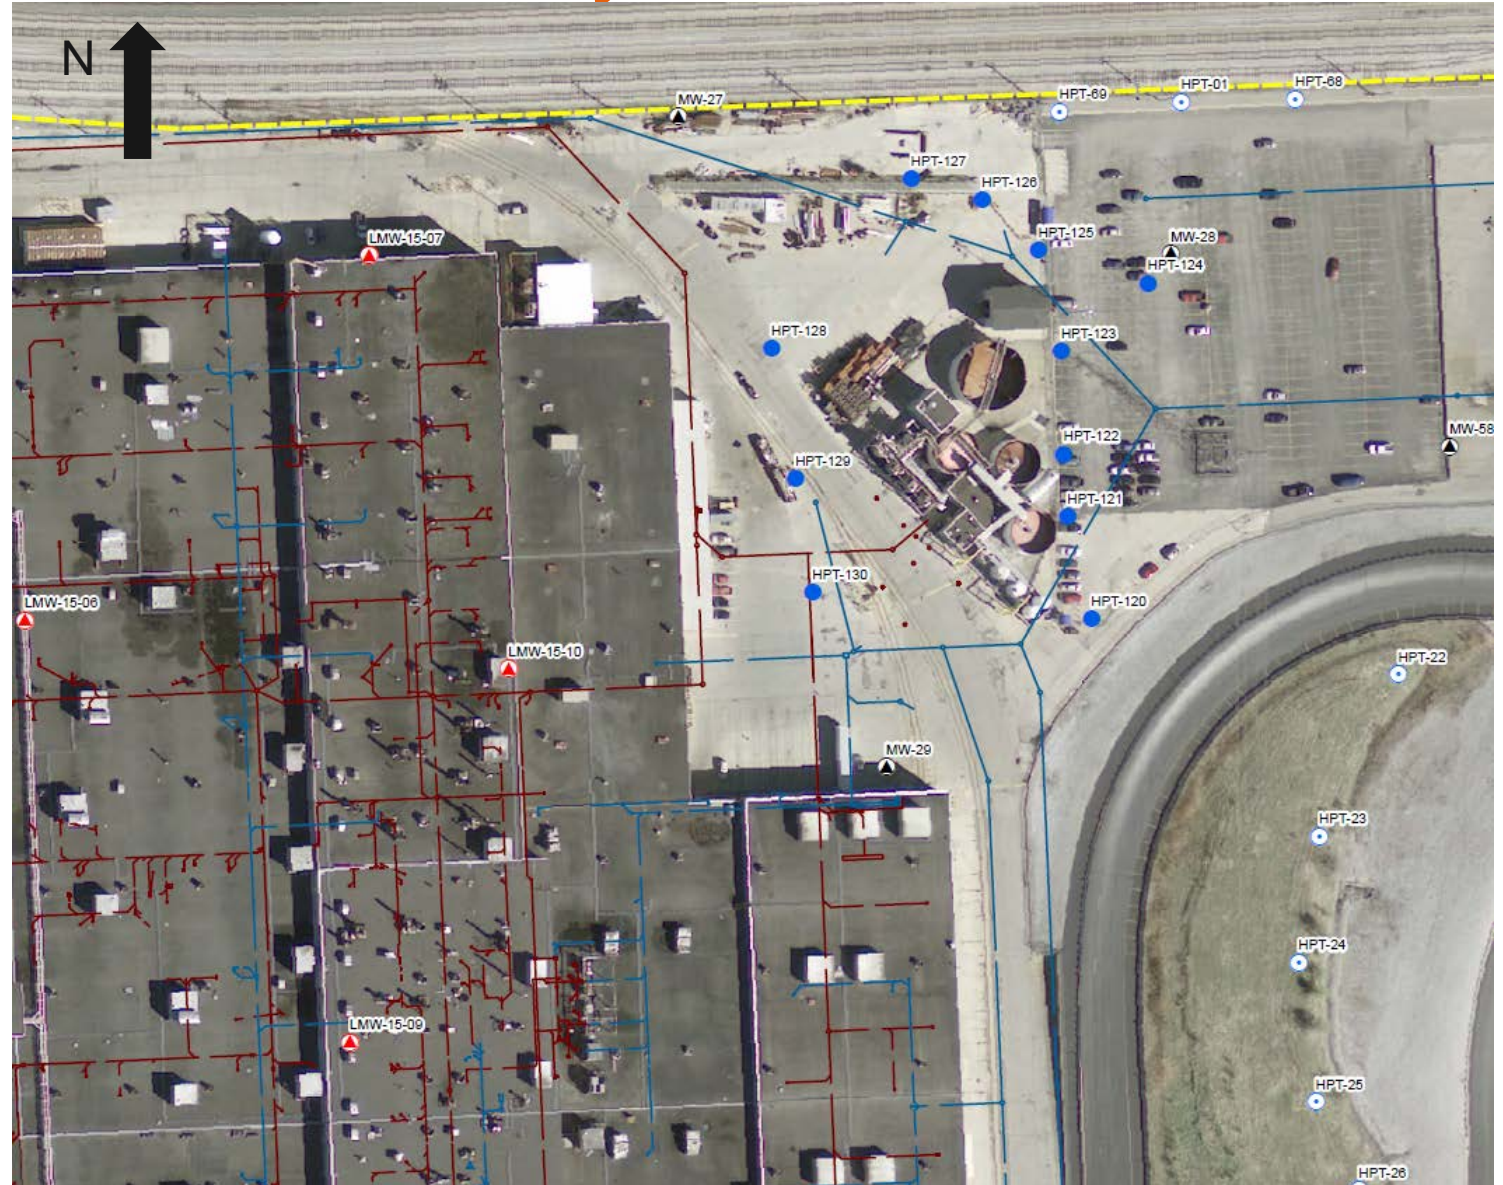
PS-6: Wastewater Pre-Treatment Facility Area Investigation

Completed additional HPT/VAP borings around pre-treatment facility to evaluate potential sources of the northern VOC impact area.

Pre-treatment operations do not present ongoing source of VOCs

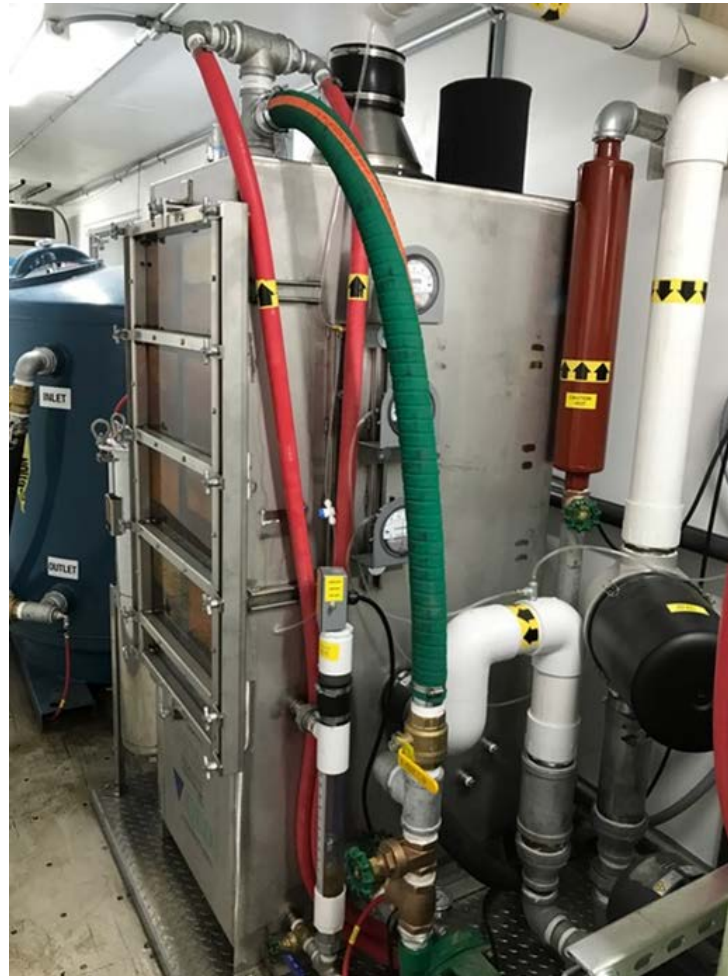
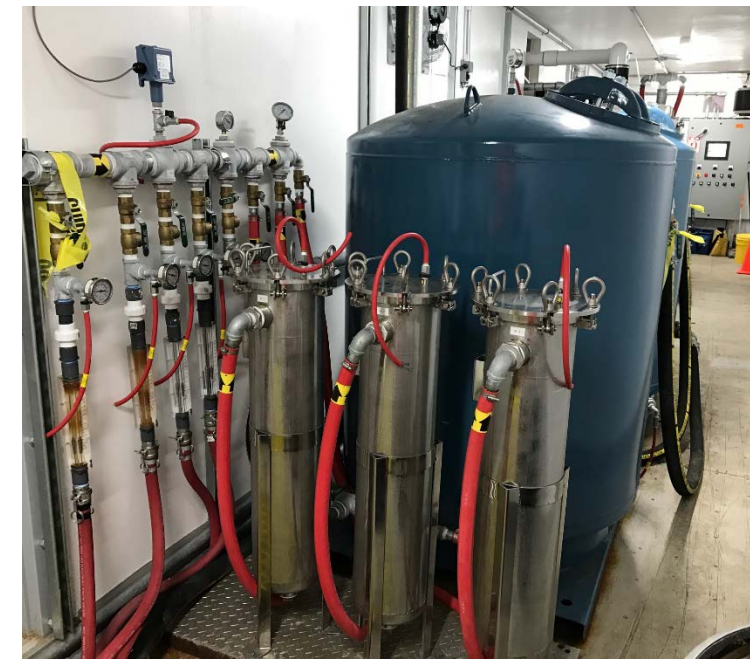
Groundwater Treatment System: OMM

- Visits Conducted Weekly
 - Data Collection
 - Bag Filter Replacement
 - Air Stripper Inspection/Cleaning
- OMM Data Collection:
 - Pressure
 - Flow
 - Power Usage
 - Maintenance Record and Observations
 - Samples Collected

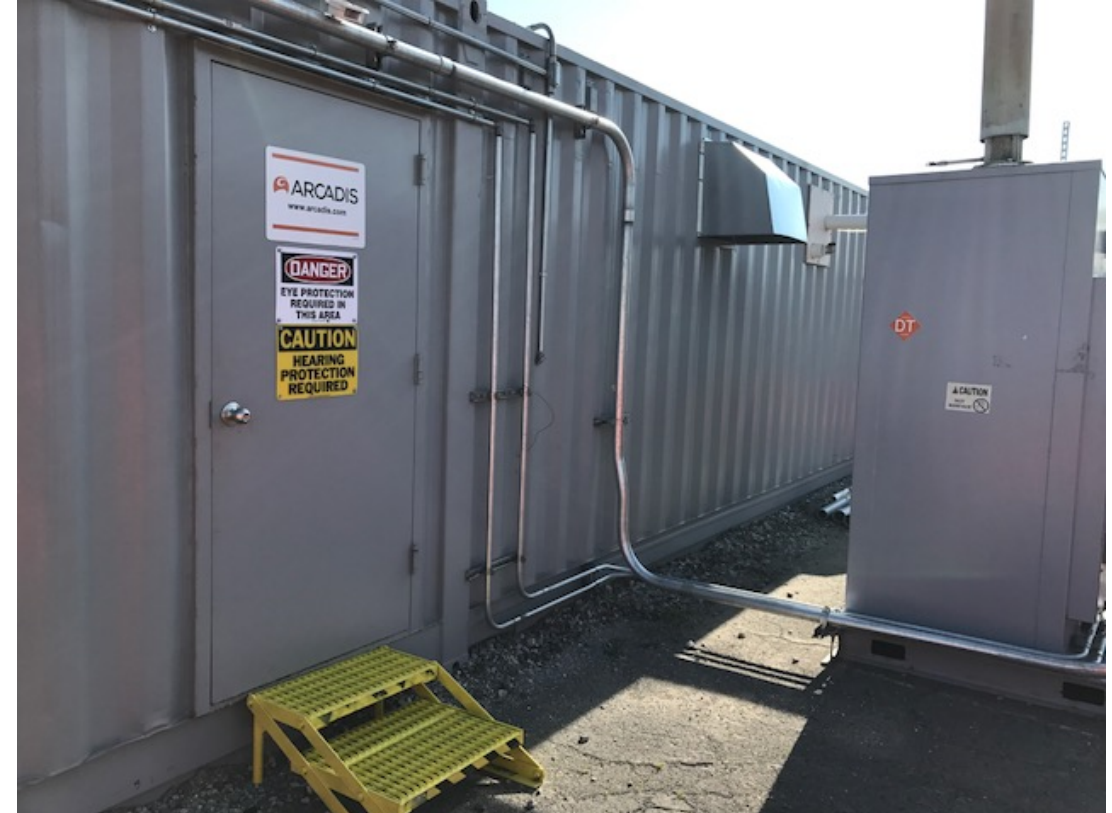
Operational Timeline

- System Startup: March 2017
- System Optimization: April - Present
 - Initial 6 months of operation
 - Adjust and optimize pumping rates
 - Develop and refine operation and maintenance procedures
- Evaluate Capture:
 - Capture zone evaluation
- Compliance Monitoring:
 - Discharge Permit Compliance: GLWA Total Toxic Organics (TTO) List

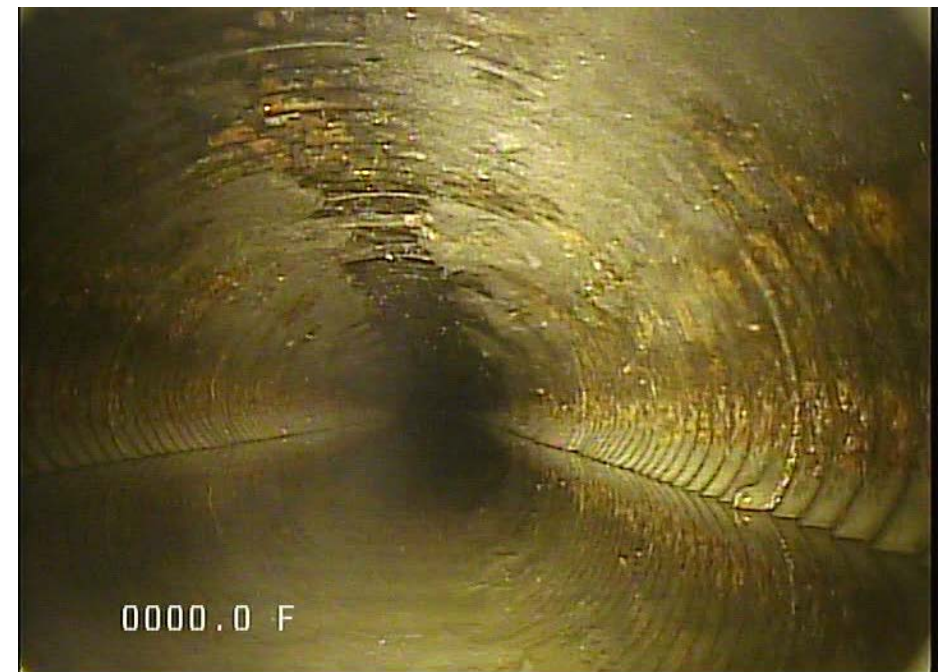
Technologies Implemented at the Livonia Transmission Plant

- **Closed-Circuit Television** - is a TV system in which signals are not publicly distributed but are monitored. The purpose of Closed Circuit Television Inspection (CCTV) is to determine:
 - Structural condition
 - Location of O&M and structural defects
 - Evidence of inflow and infiltration (I/I)
 - Size and material of construction
 - Locations of service laterals

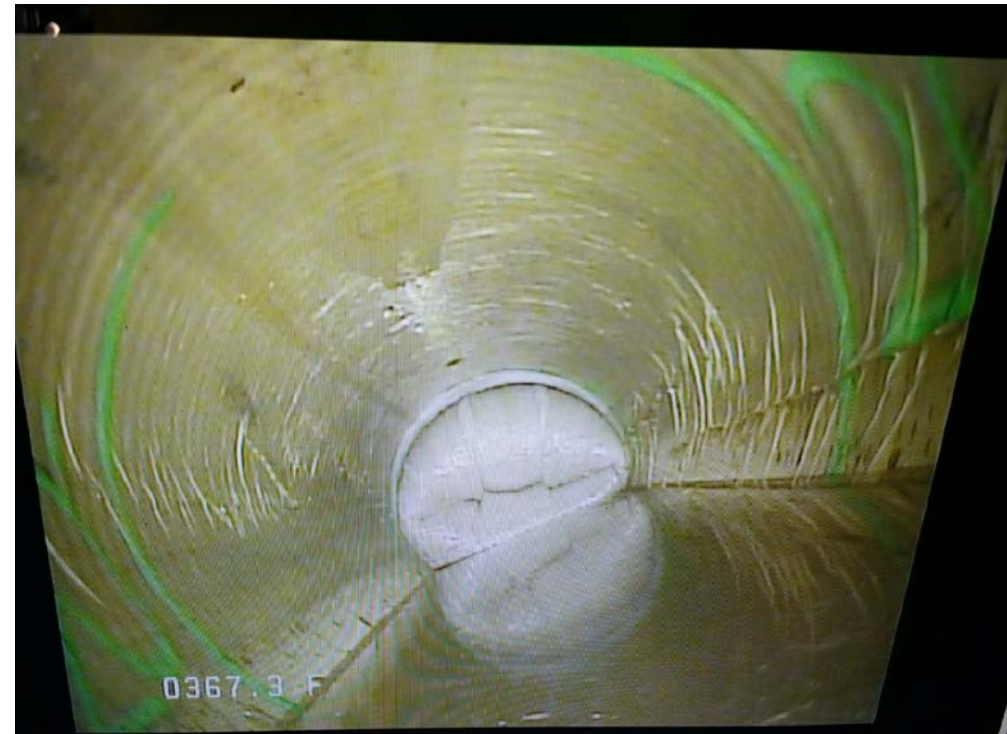
Technologies Implemented at the Livonia Transmission Plant (cont.)

Cured-in-Place Pipe Lining – CIPP is a thermos-set resin system delivered via a felt, fiberglass, or carbon fiber tube of the designed thickness specified. The resin-saturated tube is installed either by directly inverting the tube into position using water or air or by pulling the resin-saturated tube into place and inflating the tube directly or with a calibration tube. Once in place and properly inflated, the raw material resin system is cured. After cleaning and inspection, the existing pipe is used as a mold. The resin-impregnated tube is inserted into the existing pipe and then is cured by hot water, steam, or UV light, resulting in a hard new pipe within a pipe.

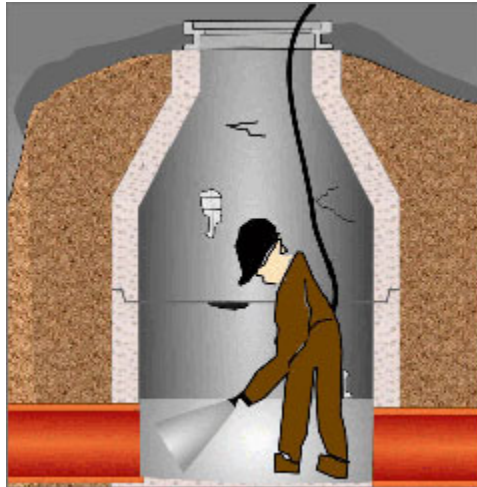
Technologies Implemented at the Livonia Transmission Plant (cont.)

Manhole Rehabilitation – There are many methods available for the rehabilitation of manholes. Each method must be evaluated to determine the best solution. Different methods include grouting, lining (cementitious or polymer coating), and chimney seals.

Man Entry Injection Grouting – Grout is injected through drilled holes into the pipe where leakage was found.
