Transmittal Letter

SUBJECT
Operation, Monitoring, and
Maintenance Field Notes - 34450 Beacon

34450 Beacon, 2020-06-09, Water Inspection

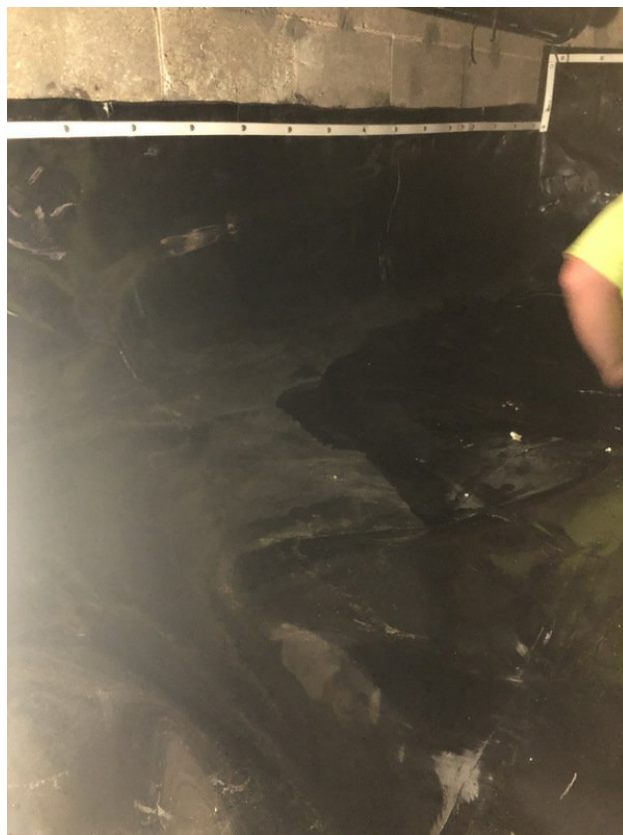
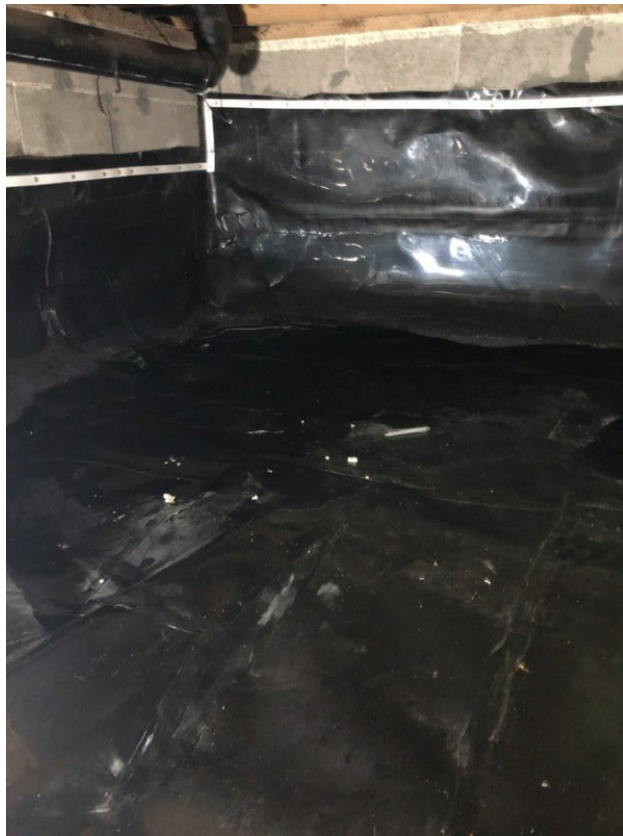
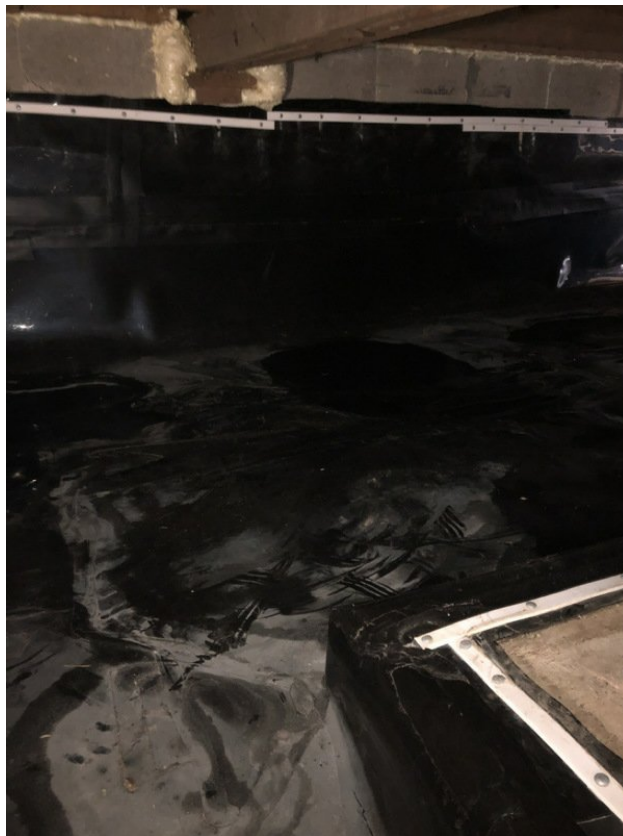
Is water observed on the barrier?	Yes
Location of Water on Barrier	Low points on barrier
Can the source of water be identified?	Yes

Volume of Water on Barrier (gal)	28
Can water be felt under the barrier?	No
Describe Source Location	Suction point penetration

Has water been removed today? Yes

How much water was removed? 28 gallons

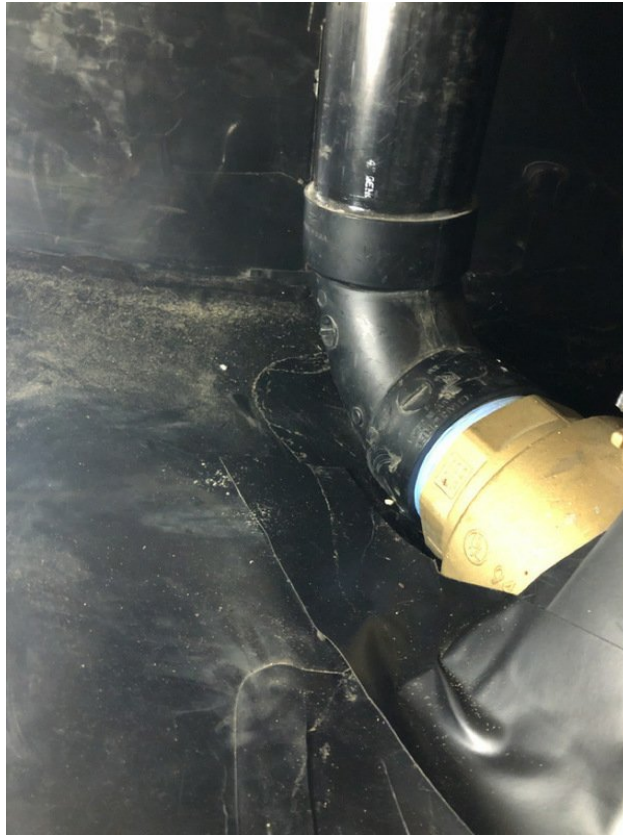
Barrier Repairs Needed

Do barrier seams need addition sealing or repair? Yes

Describe Repair Location and Mark Next to suction point penetration

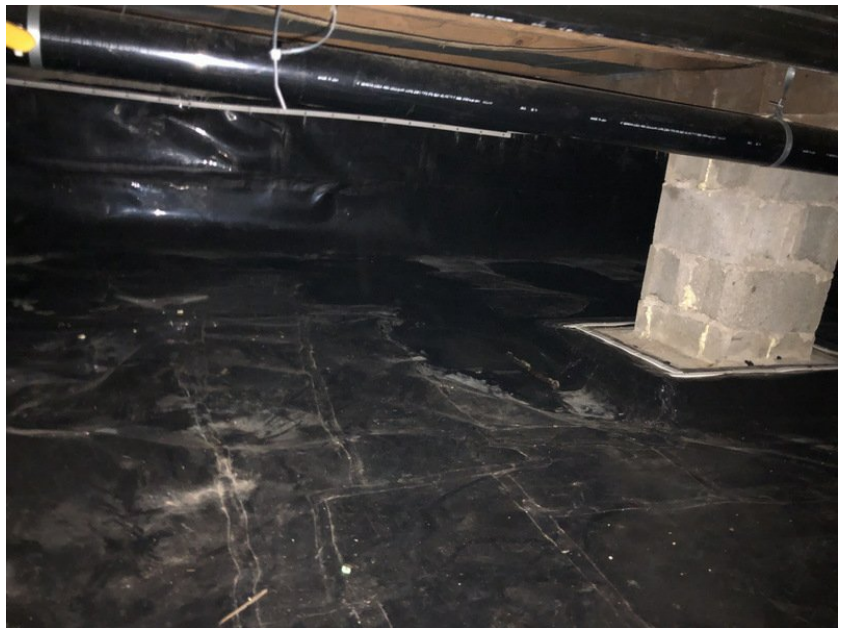
Is water observed on the barrier?	Yes
Location of Water on Barrier	Low spot next to column
Can the source of water be identified?	No

Volume of Water on Barrier (gal)	6
Can water be felt under the barrier?	No
Do barrier seams need addition sealing or repair?	No

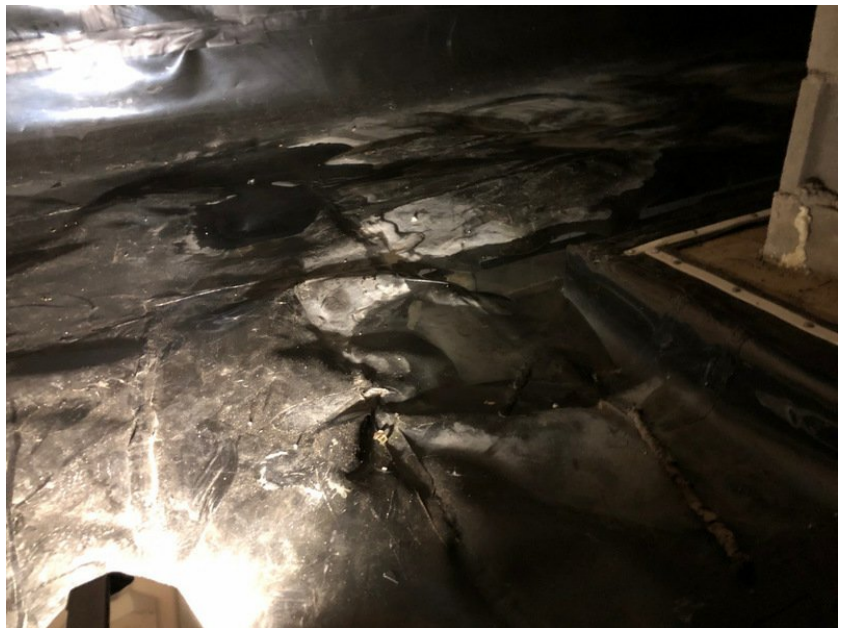
Is water observed on the barrier?	Yes
Location of Water on Barrier	Next to column
Can the source of water be identified?	No

Volume of Water on Barrier (gal)	2
Can water be felt under the barrier?	No
Do barrier seams need addition sealing or repair?	No
