# TRANSMITTAL LETTER

Ford Livonia Transmission Plant-Quarterly Residential Mitigation Update Letter 36200 Plymouth Road, Livonia, Wayne County, Michigan

EGLE Site ID No. 82002970

January 31, 2025

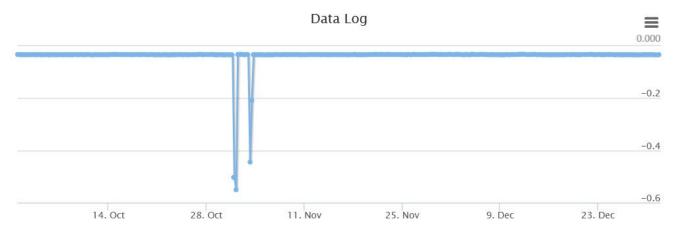
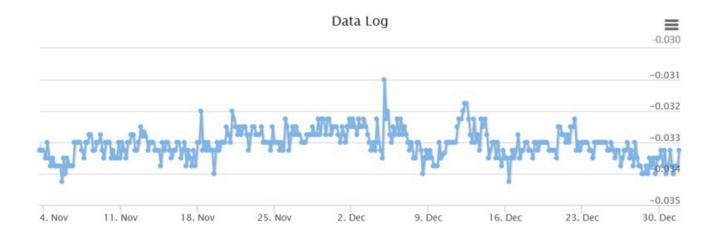
An update of the data logged by the vacuum transmitter connected to SSMP-1 is presented below.

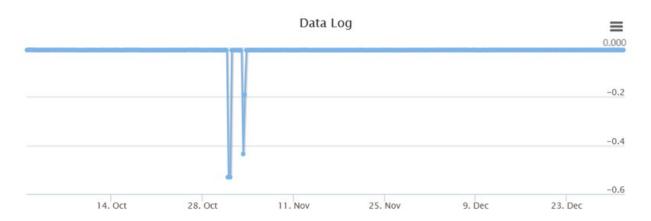
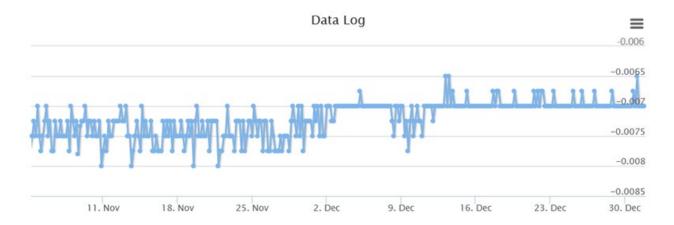
An update of the data logged by the continuously monitored vacuum transmitter connected to sub-membrane monitoring point MP-5 is presented below.

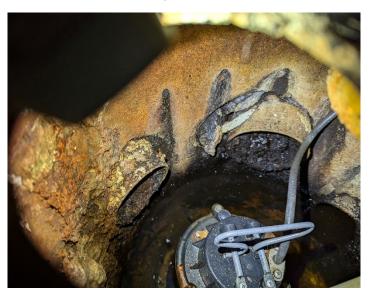
On November 7, 2024, Arcadis conducted a site visit with a local foundation contractor to evaluate the existing sub-slab perimeter drain and to determine potential methods to install additional dewatering features under the basement concrete slab to reduce hydrostatic pressure which is causing the Retro-Coat TM delamination. The contractor confirmed that the existing sub-slab drain lines appear to be plugged with red

ochre. Arcadis has obtained a proposed scope of work and quote from the contractor for removing the existing sub-slab perimeter drain and replacing it with an equivalent system that has additional maintenance and cleanout ports for preventative maintenance to prevent the red ochre from returning.

**Photograph 2 –** The sump basin with clogged inlet pipes.

On December 9, 2024, a Response Activity Plan for a Revised Interim Response Activity Plan – 34940 Beacon Street was submitted to EGLE with recommendations to resolve the delamination observed to date. EGLE approved the plan in a letter dated January 3, 2025 and coordination to implement the recommendations incorporating EGLE's comments is underway. In accordance with this letter, Arcadis will complete monthly indoor air sampling events until repairs at the IPM are completed. The next scheduled monthly indoor air sampling event will be completed during the week of January 27, 2025, based on the homeowner's request.

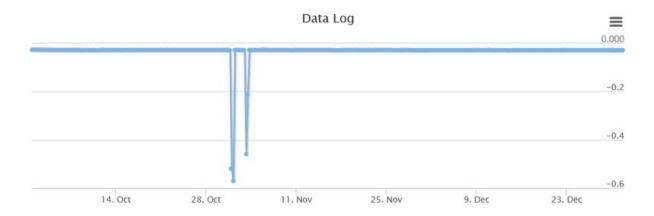
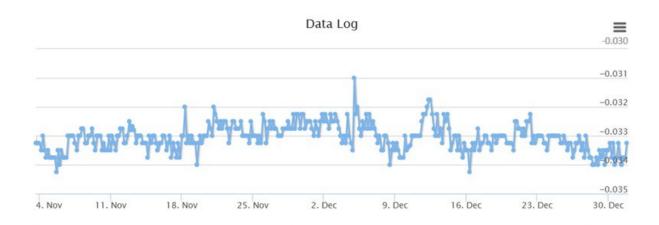
- 34950 Beacon The system is currently in operation and is being maintained and monitored.
- **34990 Beacon –** The system is currently in operation and is being maintained and monitored. An update of the data logged by the vacuum transmitter connected to MP-7 is presented below.

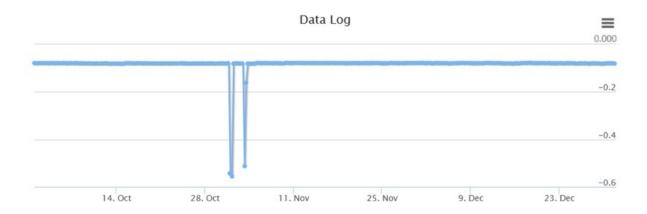
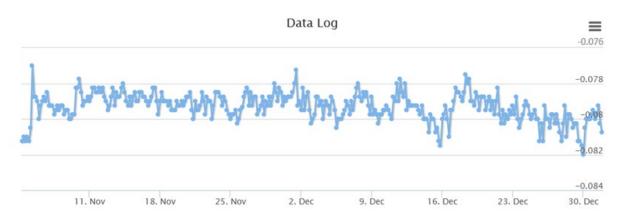
- 12066 Boston Post The system is currently in operation and is being maintained and monitored.
- 12067 Boston Post The system is currently in operation and is being maintained and monitored.
   An update of the data logged by the vacuum transmitter connected to MP-1 is presented below.

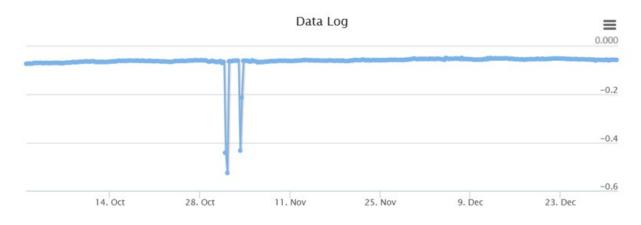
- 12070 Boston Post The system is currently in operation and is being maintained and monitored.
- 12089 Boston Post The system is currently in operation and is being maintained and monitored.
- 12100 Boston Post The system is currently in operation and is being maintained and monitored. An update
  of the data logged by the vacuum transmitter connected to sub-slab monitoring point SSMP-4 is presented
  below.

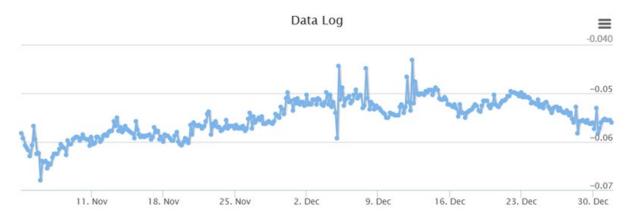
Below is a zoomed in portion of the data plot showing the IPM system continuing to maintain vacuum level at the monitoring point which is typical of normal operation at this property.

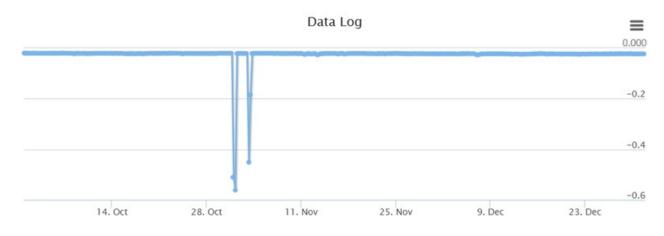
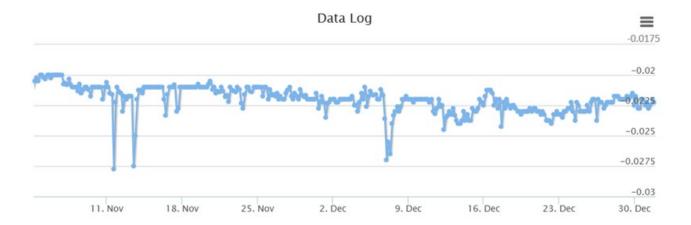
12131 Boston Post – The system is currently in operation and is being maintained and monitored.
 The update of the data logged by the vacuum transmitter connected to MP-4 is presented below.

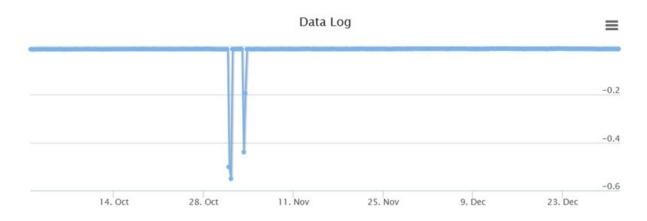
12141 Boston Post – The system is currently in operation and is being maintained and monitored.
 An update of the data logged by the vacuum transmitter connected to MP-4 is presented below.

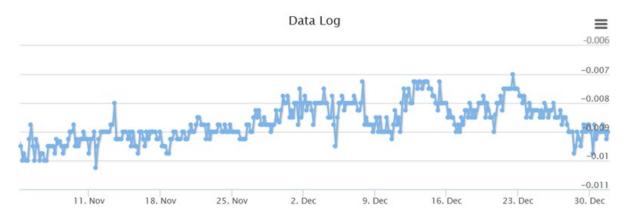
Below is a zoomed in portion of the data plot showing the IPM system continuing to maintain vacuum level at the monitoring point which is typical of normal operation at this property.

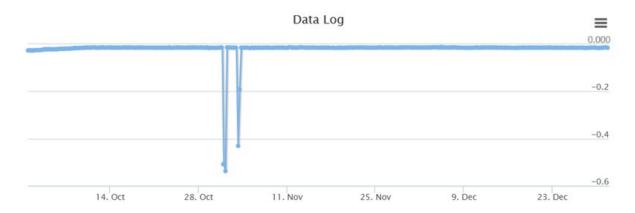
• **12036 Brewster –** The system is currently in operation and is being maintained and monitored. An update of the data logged by the vacuum transmitter connected to SSMP-2 is presented below.

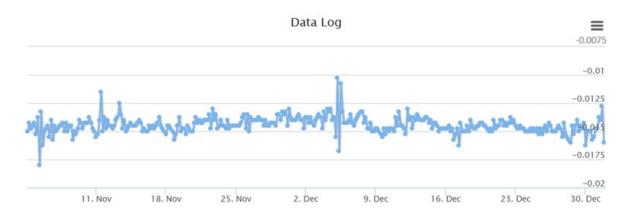
Below is a zoomed in portion of the data plot showing the IPM system continuing to maintain vacuum level at the monitoring point which is typical of normal operation at this property.

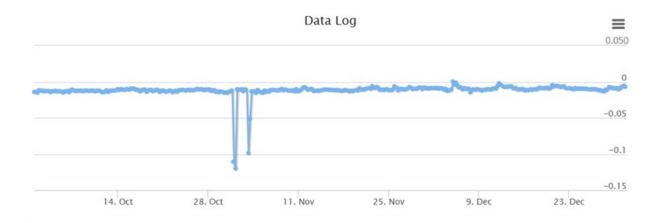
34480 Capitol Avenue - The system is currently in operation and is being maintained and monitored. An update of the data logged by the vacuum transmitter connected to SSMP-2 is presented below.

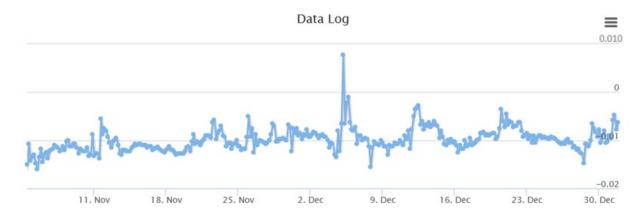
Below is a zoomed in portion of the data plot showing the IPM system continuing to maintain vacuum level at the monitoring point which is typical of normal operation at this property.
