# MEMO

Arcadis Project No.:  
30050315

Subject:  
CSM and Requested Property Specific Monitoring Program for Eleven  
Offsite Mitigation Properties related to the Ford Livonia Transmission Plant,  
36200 Plymouth Road, Wayne County, Michigan EGLE Site ID No.:  
82002970

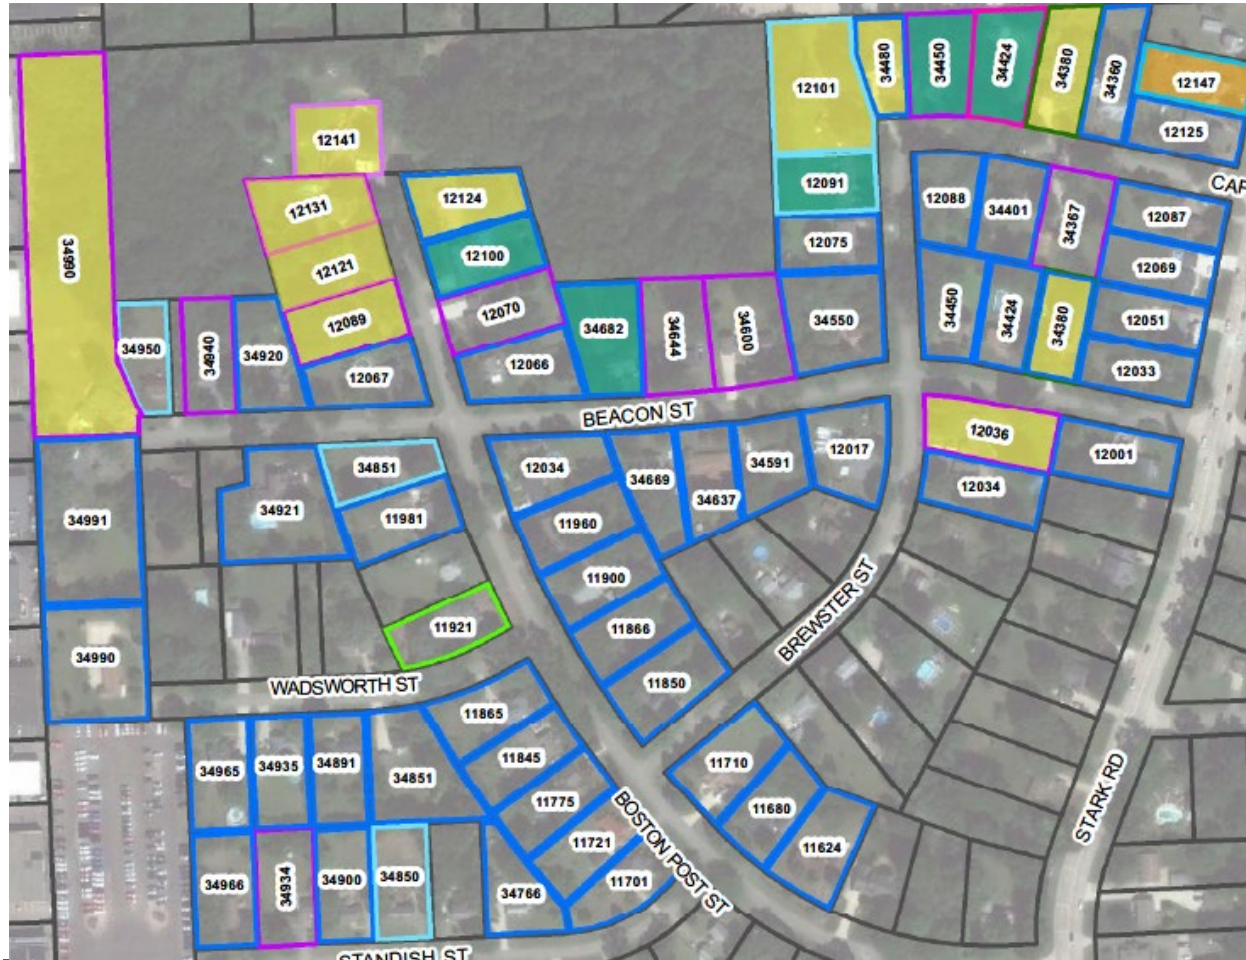
# Extensive Characterization - VI Sampling

- 3,408 total Sub-slab, indoor air, ambient air, and duplicate samples and 60 sump samples collected to date
- 2-10 rounds of samples have been collected at each location
- No VI related air exceedance in SS or IA
- All data demonstrates that VI is not occurring
