Transmittal Letter

SUBJECT Operation, Monitoring, and Maintenance Field Notes - 34480 Capitol

Attached are the interim preemptive mitigation (IPM) system Operation, Monitoring, and Maintenance (OM&M) field notes. These field notes were recorded during OM&M visits at the property between March 31, 2020 and March 31, 2022. Please let me know if you have any questions.

34480 Capitol, 2020-11-16, Full System Inspection

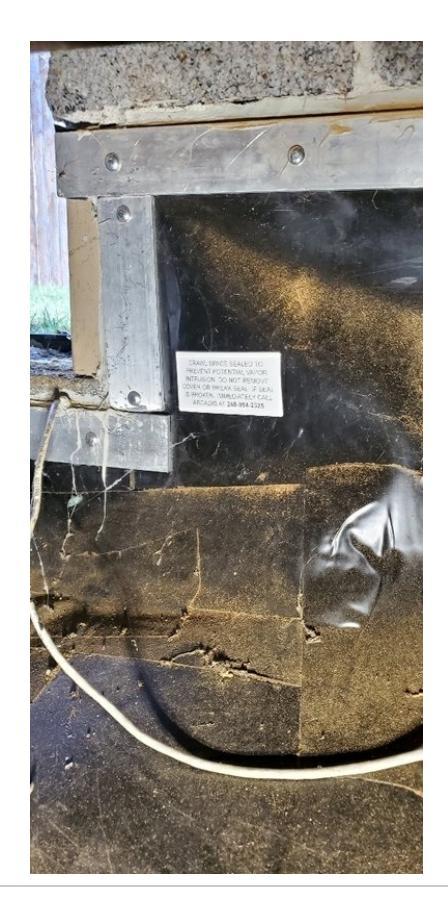
Do any drain seals need to be repaired or replaced?	No
Garage Retrocoat	
Is retrocoat damaged or missing?	No
Crawlspace Barrier	
ls water present on the vapor barrier?	No
Labels	
Are labels present at the pipe, control panel, u- tube, and breaker?	Yes
Garage Retrocoat Label Photos	<complex-block></complex-block>

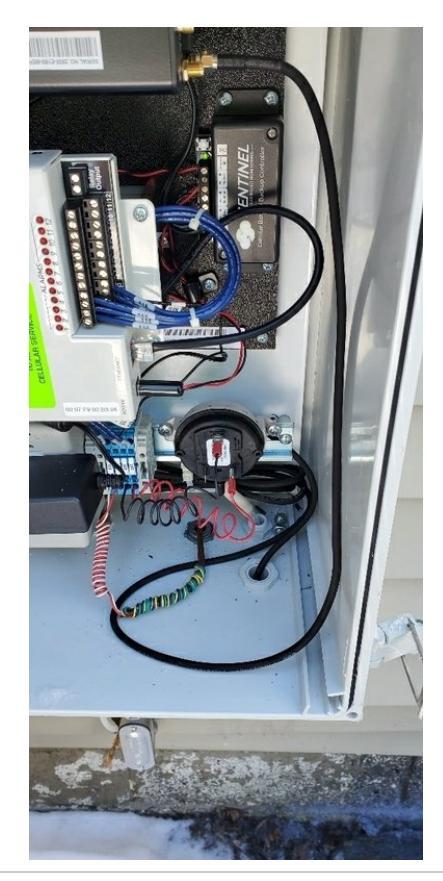
Vacuum ID Link	34480 Capitol, SSMP-2
Vacuum ID	SSMP-2
Date	2021-02-19
Time	10:44
Vacuum Reading (in. w.c.)	-0.003
Number Vacuum Reading	-0.003
Threshold pressure not met, troubleshoot and discuss with engineer as needed.	+/- 0.003, windy

Valve Position at Departure (% Open)	75
Were interim vacuum readings taken between initial and final vacuum readings?	No
Inspection Reading Analysis	
Manometer	
ls the system manometer steady?	Yes
SSMP/MPs	
Were any vacuum monitoring points not accessible? Please specify.	None
Do all vacuum monitoring points meet -0.02 in w.c. threshold?	No
Which ones don't and why?	ssmp-2, mp-2, mp-3
Proposed modifications to address vacuum?	Transmitter present at ssmp-2.
Were any ball valve positions changed?	No
Alarm Testing	
Sensaphone Link	N/A
Repairs	
Sample Delay	
Send Sample Delay Email	N/A
email body	
Repair Completion	
Were seam repairs completed during this visit?	No
Were system repairs completed during this visit?	Yes
System repairs completed:	Vacuum switch changed from 1" to 1/4".
System Repair Completion Date	2021-02-19

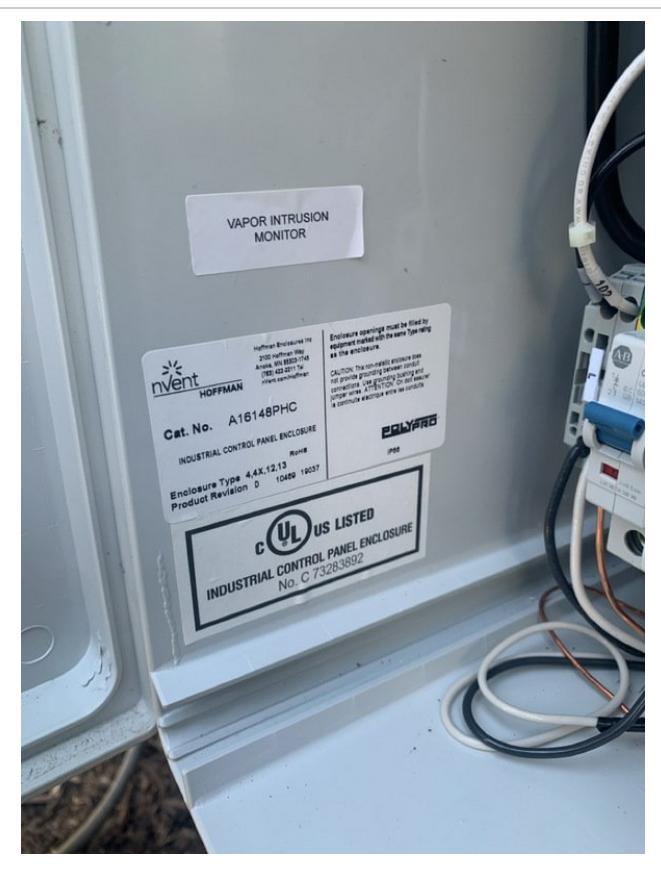
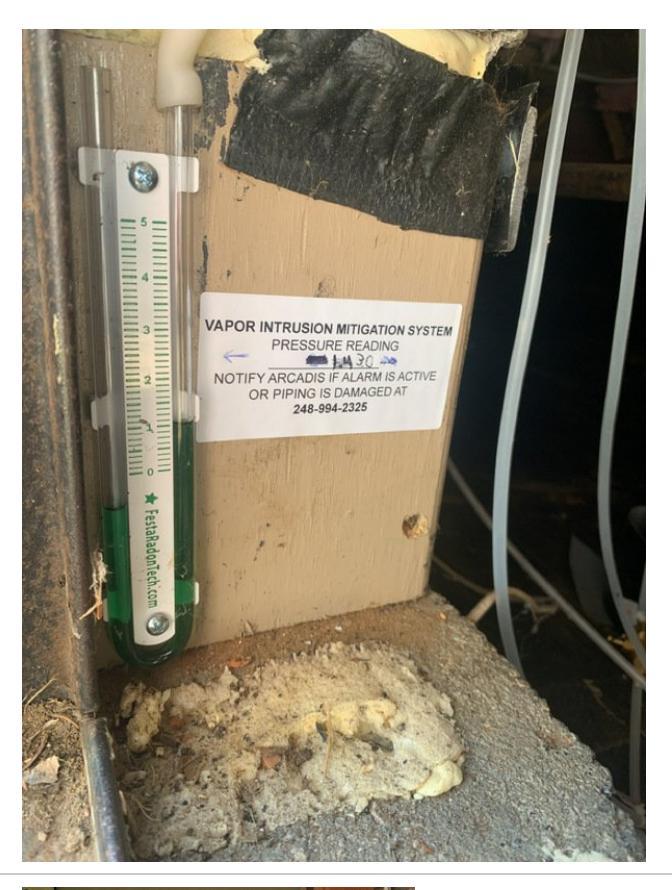
Common Label Photos

Are labels present at the pipe, control panel, u-Yes tube, and breaker?

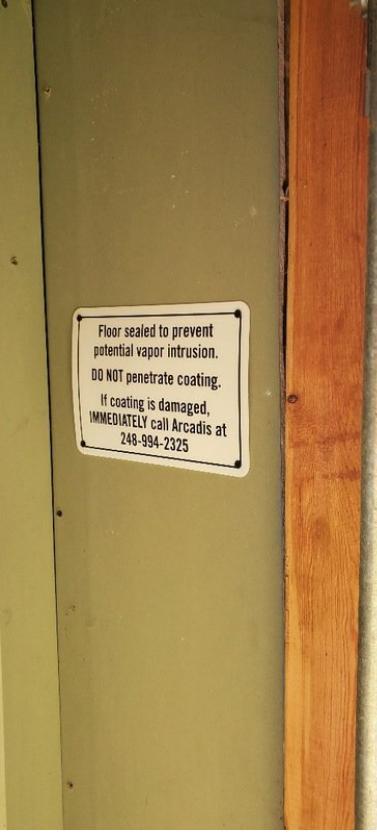
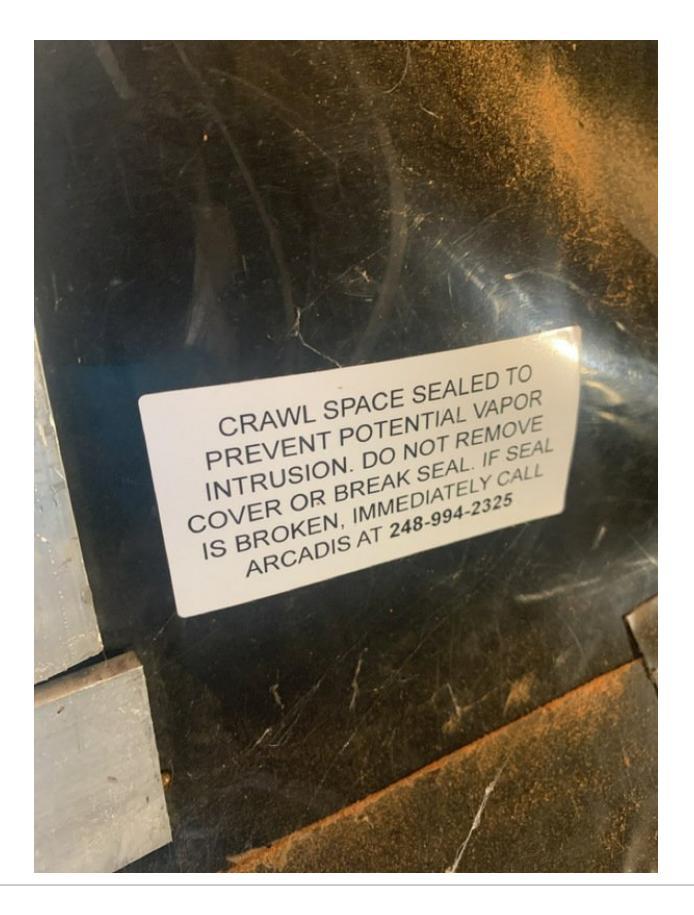
Garage Retrocoat Label Photos

Garage Retrocoat		
Is retrocoat damaged or missing?	No	
Crawlspace Barrier		
Is water present on the vapor barrier?	No

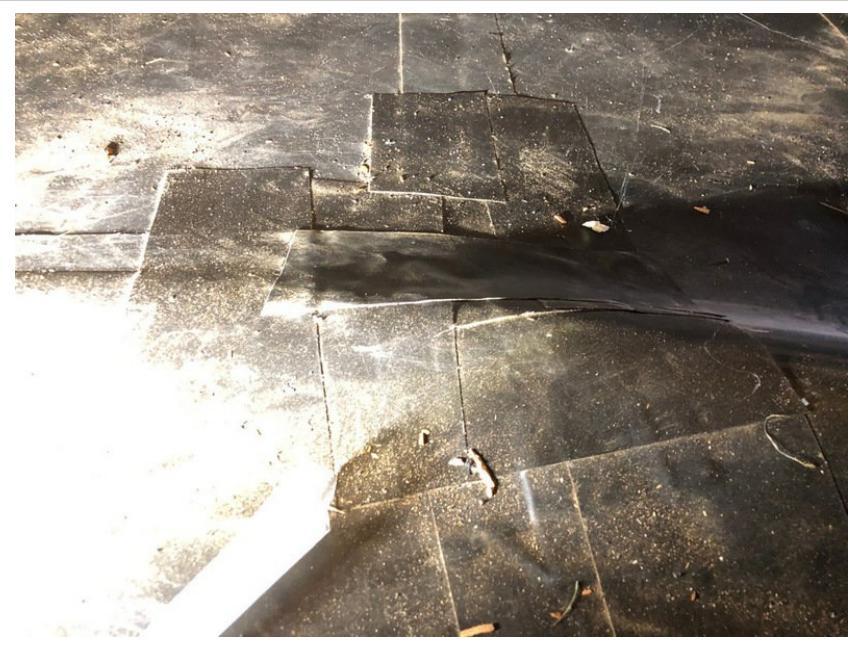
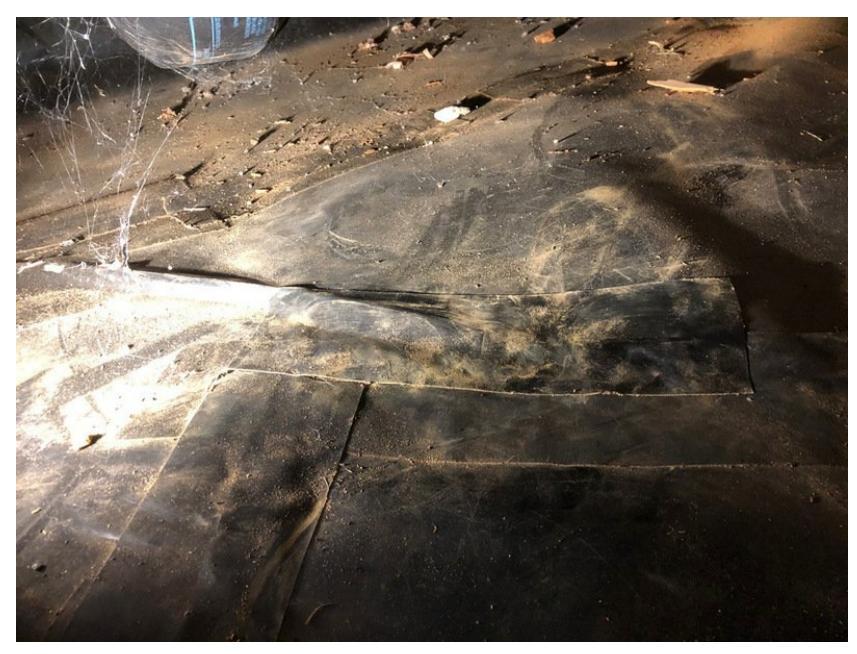
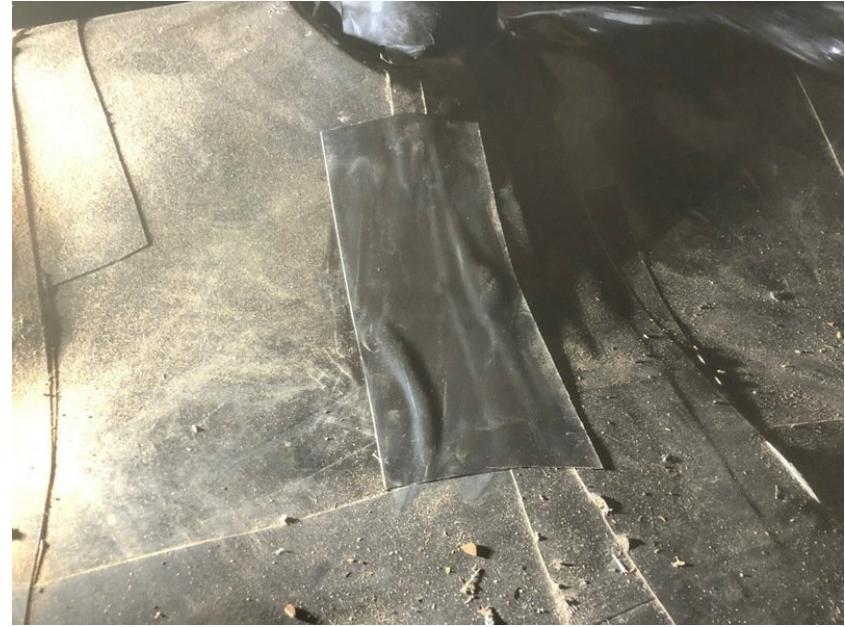
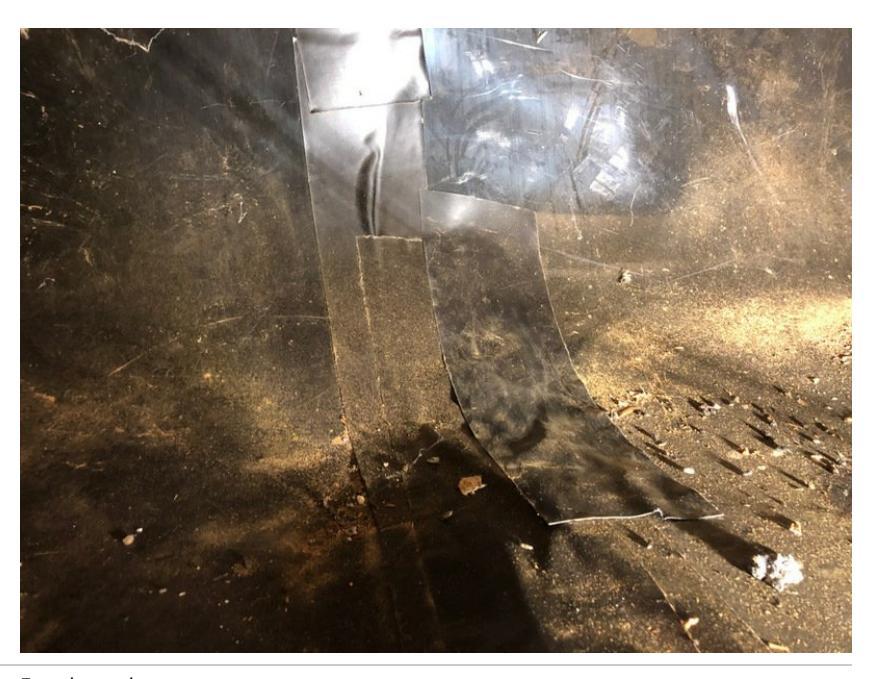
Sealing Repair Photos

Were any vacuum monitoring points not accessible? Please specify.	No
Do all vacuum monitoring points meet -0.02 in w.c. threshold?	No
Which ones don't and why?	All
Proposed modifications to address vacuum?	Transmitter is installed at SSMP-2
Were any ball valve positions changed?	No

Were seam repairs completed during this visit?	Yes
Were system repairs completed during this visit?	Yes
Additional sealing completed:	Installed patches where needed
Sealing Completion Date	2021-03-08

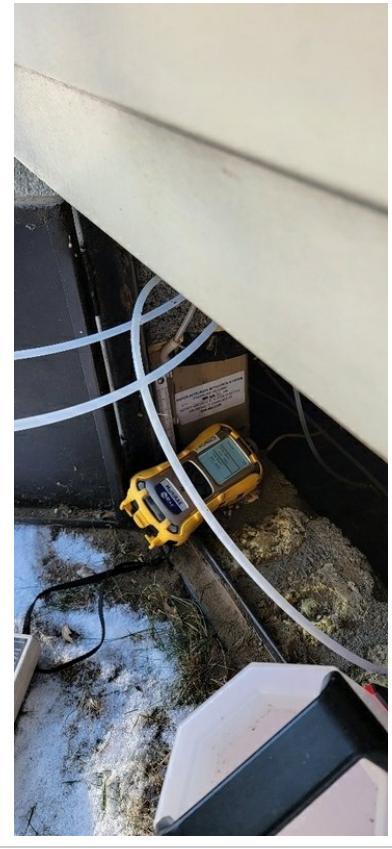
Common Label Photos

Do any drain seals need to be repaired or replaced?	No
Garage Retrocoat	
ls retrocoat damaged or missing?	No
Crawlspace Barrier	
ls water present on the vapor barrier?	No
Labels	
Are labels present at the pipe, control panel, u- tube, and breaker?	Yes

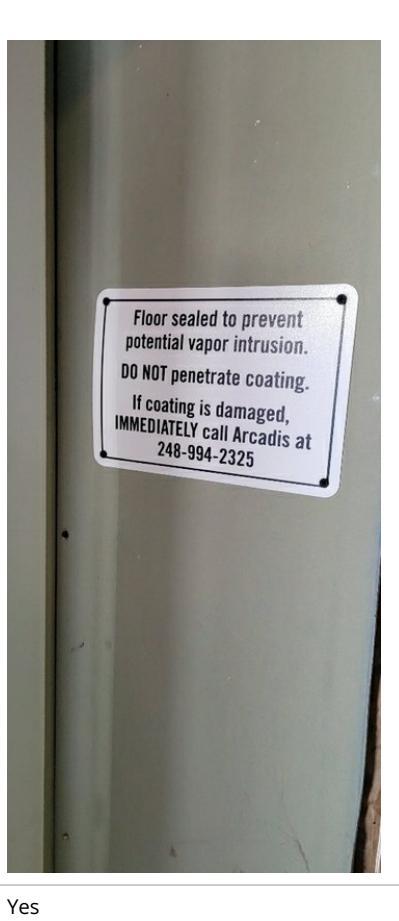
Garage Retrocoat Label Photos

Are labels present at the garage retrocoat?

Yes

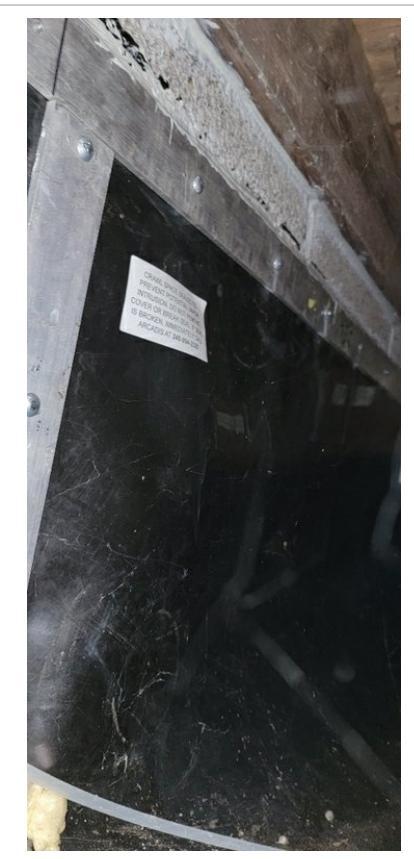
Barrier Label Photos

Are labels present at the crawlspace barrier?
