# MEMO

Ford Livonia Transmission Plant  
Wastewater Treatment Plant Process Waste Line Break Memo  
Livonia, Michigan

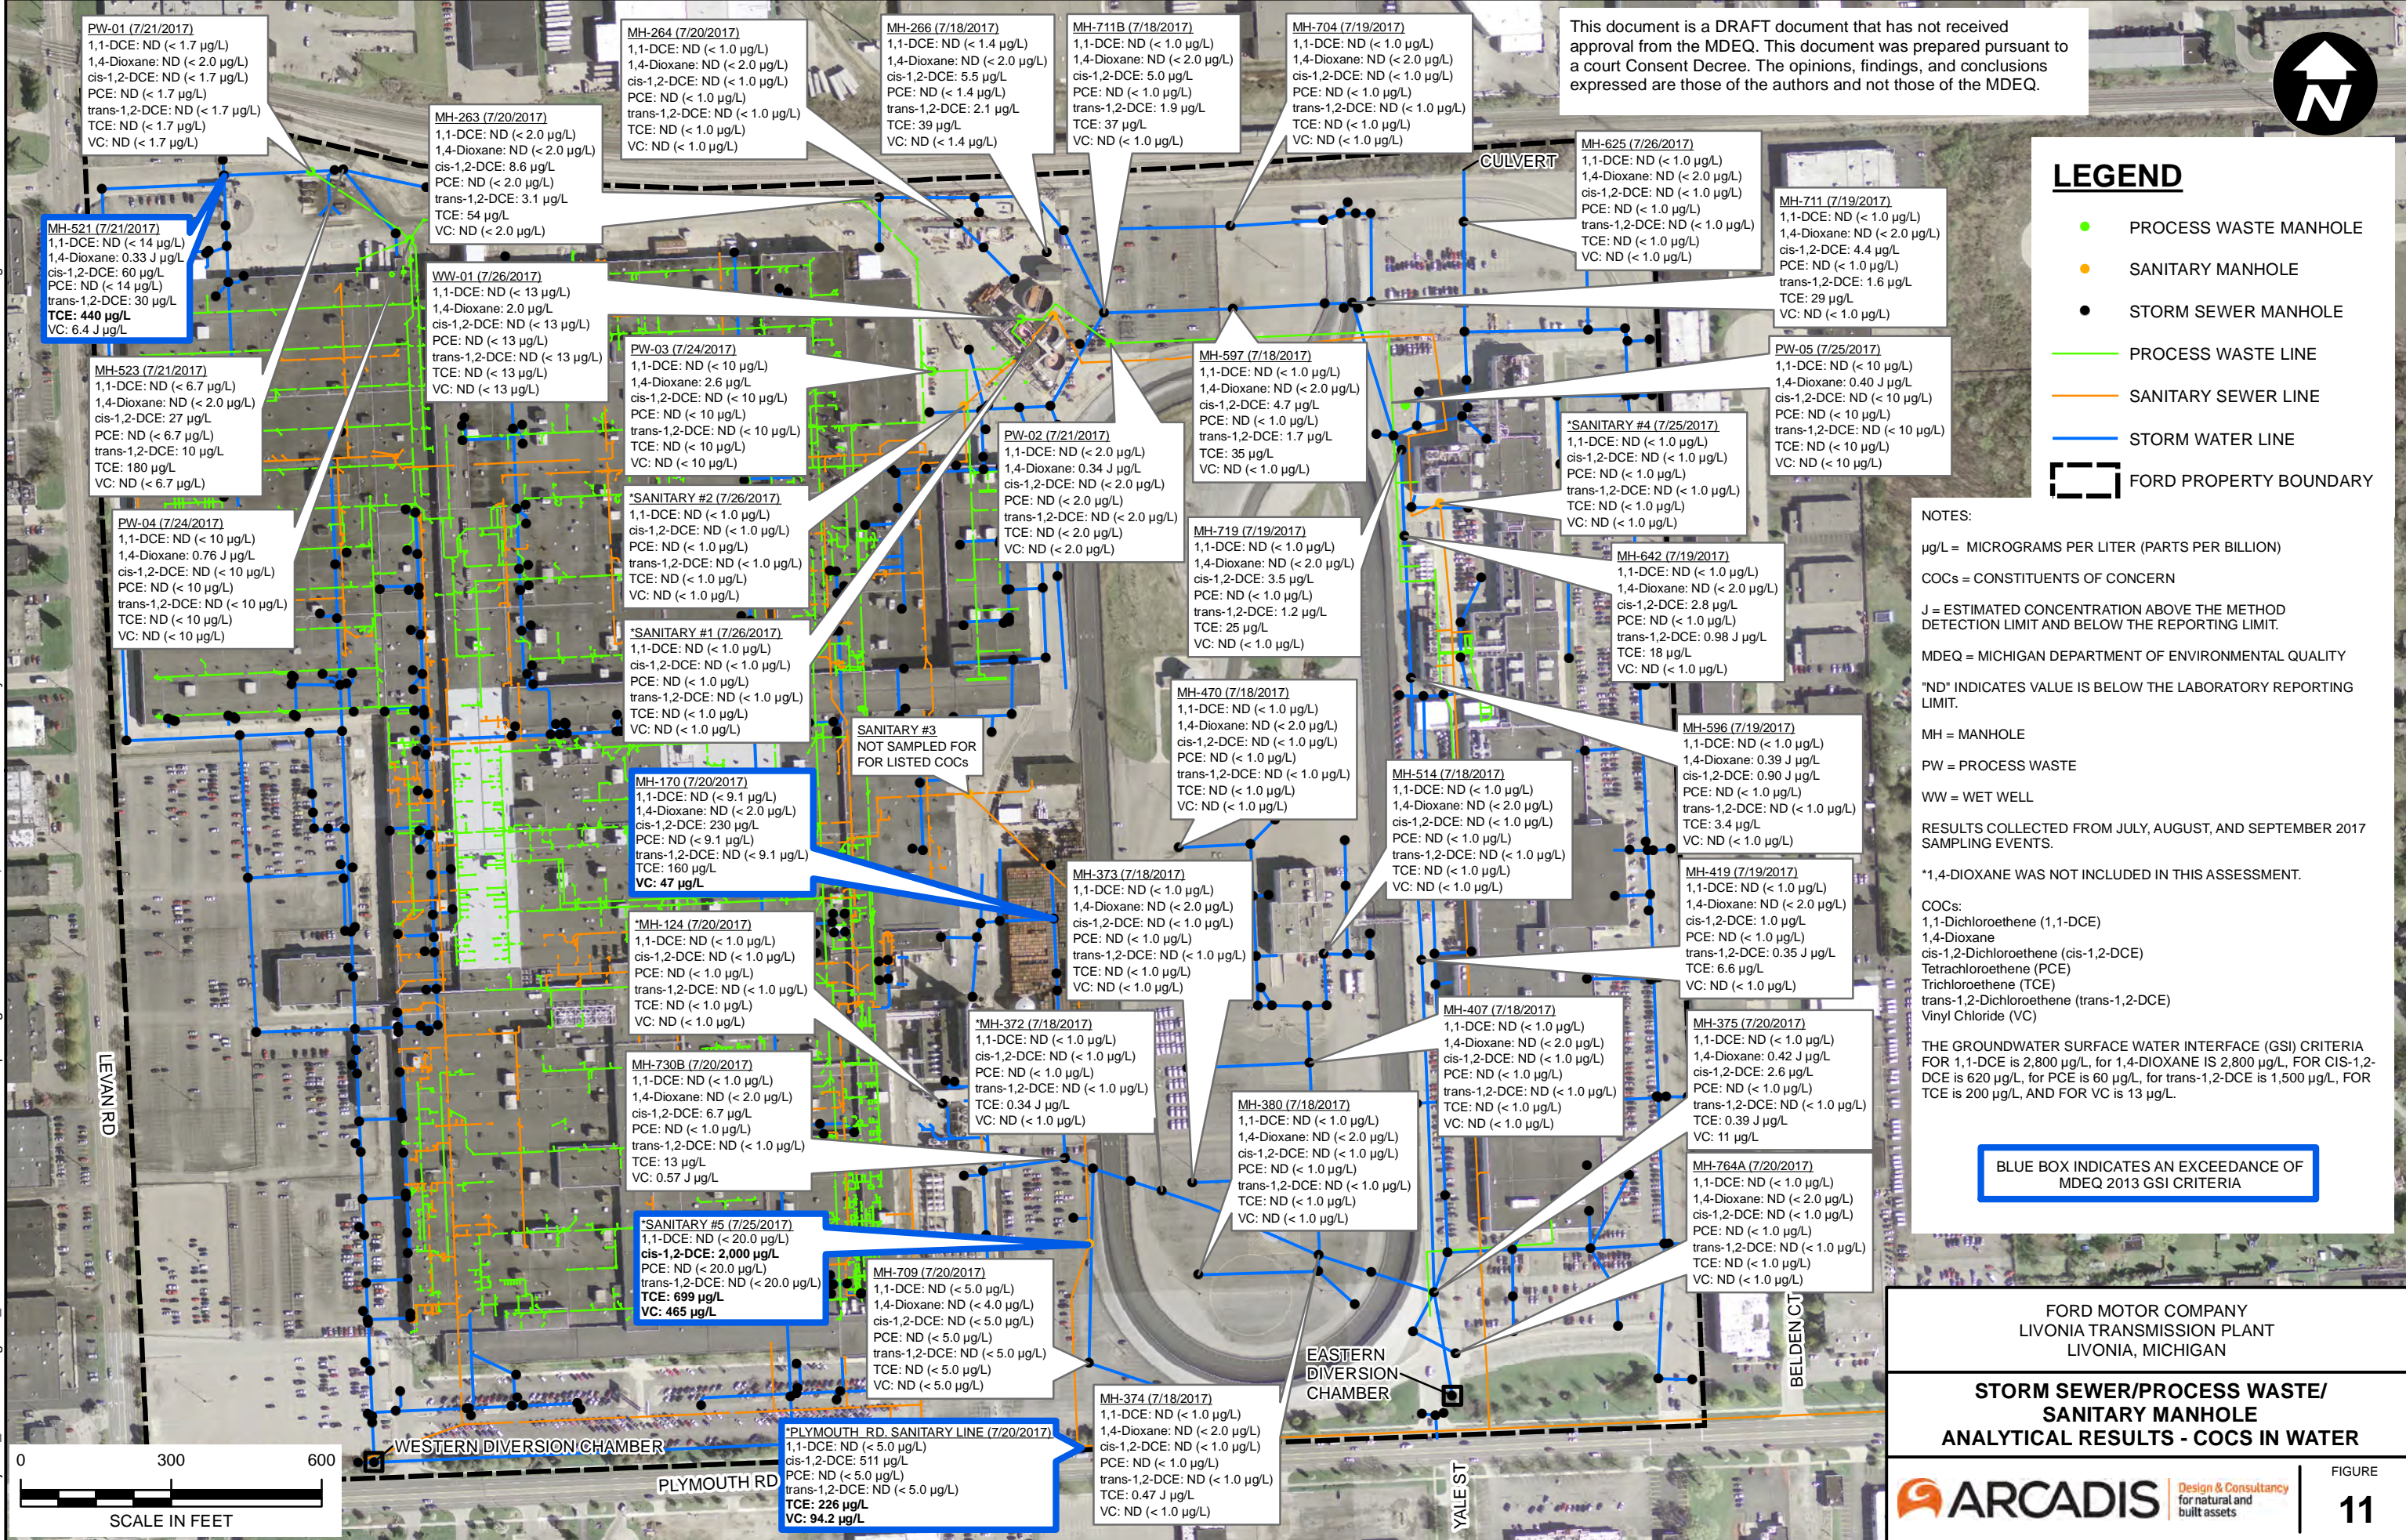
**STORM SEWER/PROCESS WASTE/  
 SANITARY MANHOLE  
 ANALYTICAL RESULTS - COCS IN WATER**

- Ford provided the results from sampling that was conducted at five (5) manholes associated with the WWTP process waste lines. The data was provided to EGLE in the November 22, 2017 Progress Report. Samples collected from the five (5) manholes associated with the WWTP process waste lines identified low/estimated detections of 1,4-Dioxane, but no exceedances of the Site COCs (**Attachment 2**).
- On September 25, 2019, Ford collected a sample from the absorbent pads used to clean up the release and the results showed no detections for 1,1-dichloroethene, tetrachloroethene, trichloroethene, or vinyl chloride (**Attachment 3**).
