### **MEMO**

Utility Corridor Assessment – Monthly Update for the ResAP IRA Activities 36200 Plymouth Road, Livonia, Wayne County, Michigan Consent Decree No 2:1712372-GAD-RSW (CD)

# **Utility Corridor Response Activity Plan for Interim Response Activities - Update**

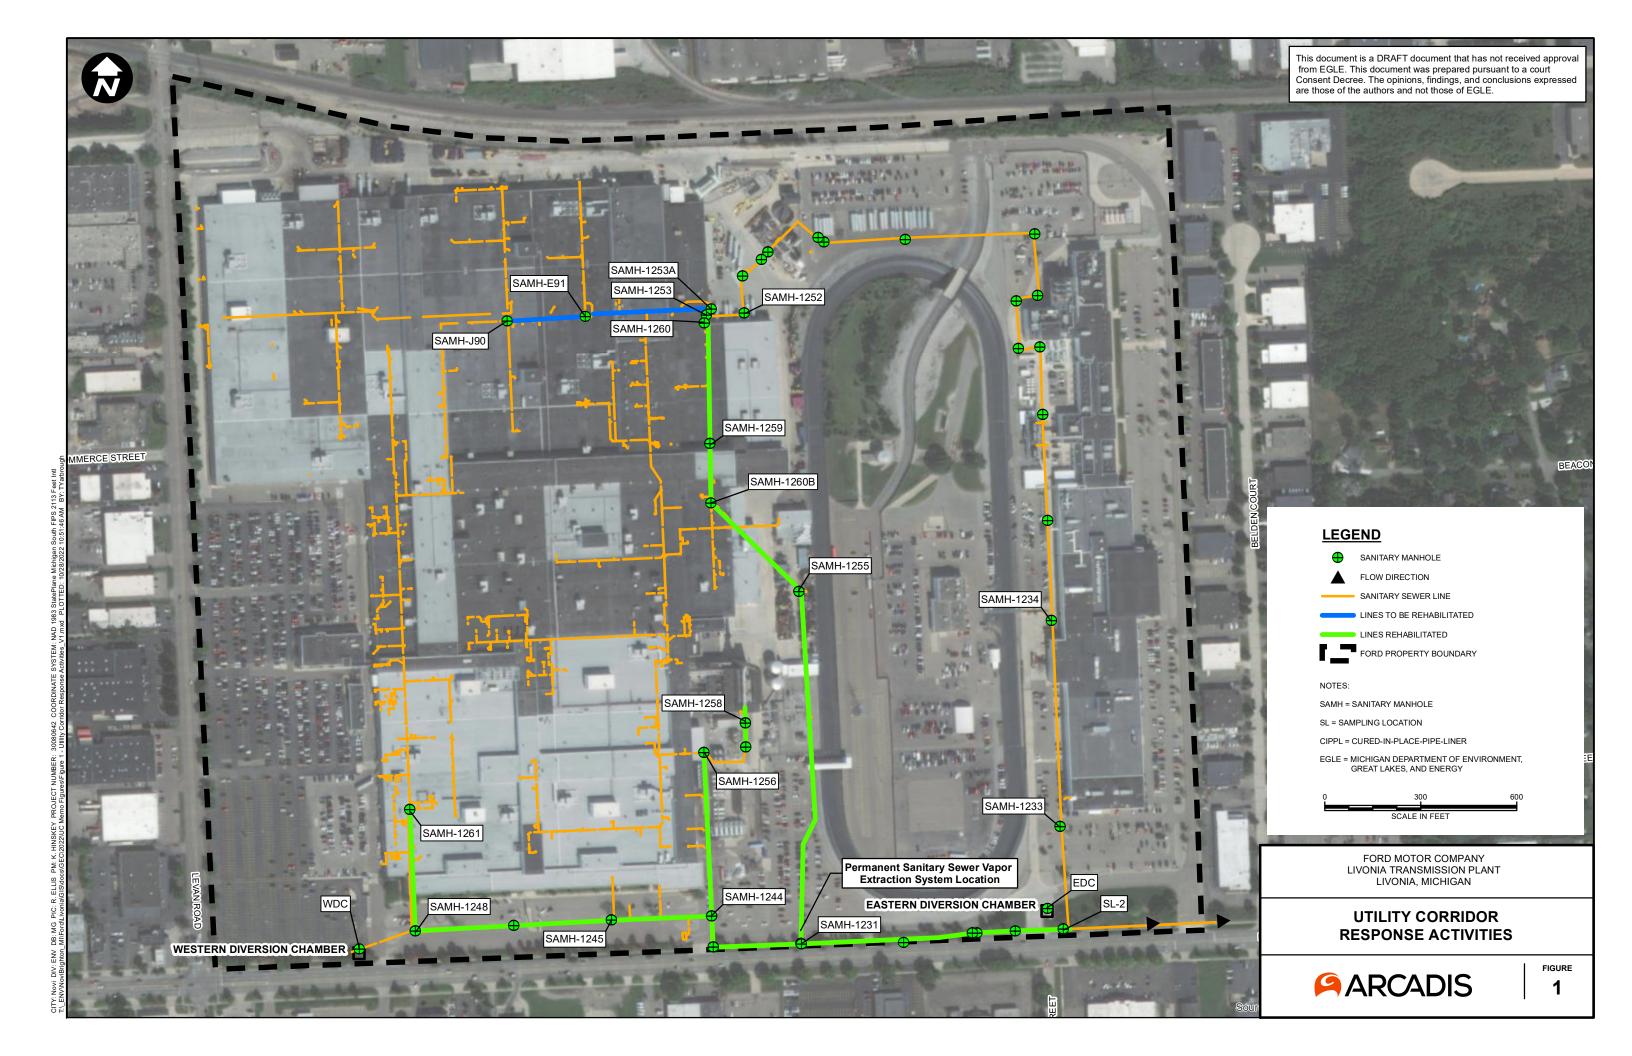
## Figure 1

The sanitary sewer vapor extraction (SSVE) system has been operating at a flowrate of approximately 900 cubic feet per minute (cfm) since August 10, 2022, except for two periods of shut down that occurred in late October 2022 and mid-November 2022 as described below. Location of the SSVE system is provided in **Figure 1**. Compliance sampling continues to be completed monthly in accordance with the sampling frequency described in the ResAP IRA.

The rehabilitation of two 425-foot segments of sanitary pipe inside the LTP (SAMH J90 to SAMH E91 and SAMH E91 to SAMH 1253A) (**Figure 1**) is scheduled to take place over the weekend of December 2, 2022. Additional details will be provided to EGLE during the tri-weekly meetings and in the December 2022 monthly submittal.

**Utility Corridor Response Activities**
